## FINAL REPORT

**AAIU Synoptic Report No: 2004-002**  
**AAIU File No: 2002-0024**  
**Published: 23/1/2004**

<b>Aircraft Type and Registration:</b>	Schweizer Model 269C <sup>1</sup> EI-LRS	
<b>No. and Type of Engines:</b>	1 x Lycoming HIO-360-D1A	
<b>Aircraft Serial Number:</b>	S1701	
<b>Year of Manufacture:</b>	1995	
<b>Date and Time (UTC):</b>	3 May 2002 @ 10.00 hrs	
<b>Location:</b>	Lisacul, Co. Roscommon	
<b>Type of Flight:</b>	Private	
<b>Persons on Board:</b>	Crew - 1	Passengers - 0
<b>Injuries:</b>	Crew - 0	Passengers - 0
<b>Nature of Damage:</b>	Economic write-off	
<b>Commander's Licence:</b>	PPL(H)	
<b>Commander's Age:</b>	54	
<b>Commander's Flying Experience:</b>	313 hours of which 211 were on type	
<b>Information Source:</b>	AAIU Field Investigation

The helicopter was hovering after take-off when it swung uncontrollably to the left. The skids made ground contact and the helicopter toppled. The Investigation concluded that the clutch cable had separated, resulting in a loss of transmitted engine power.

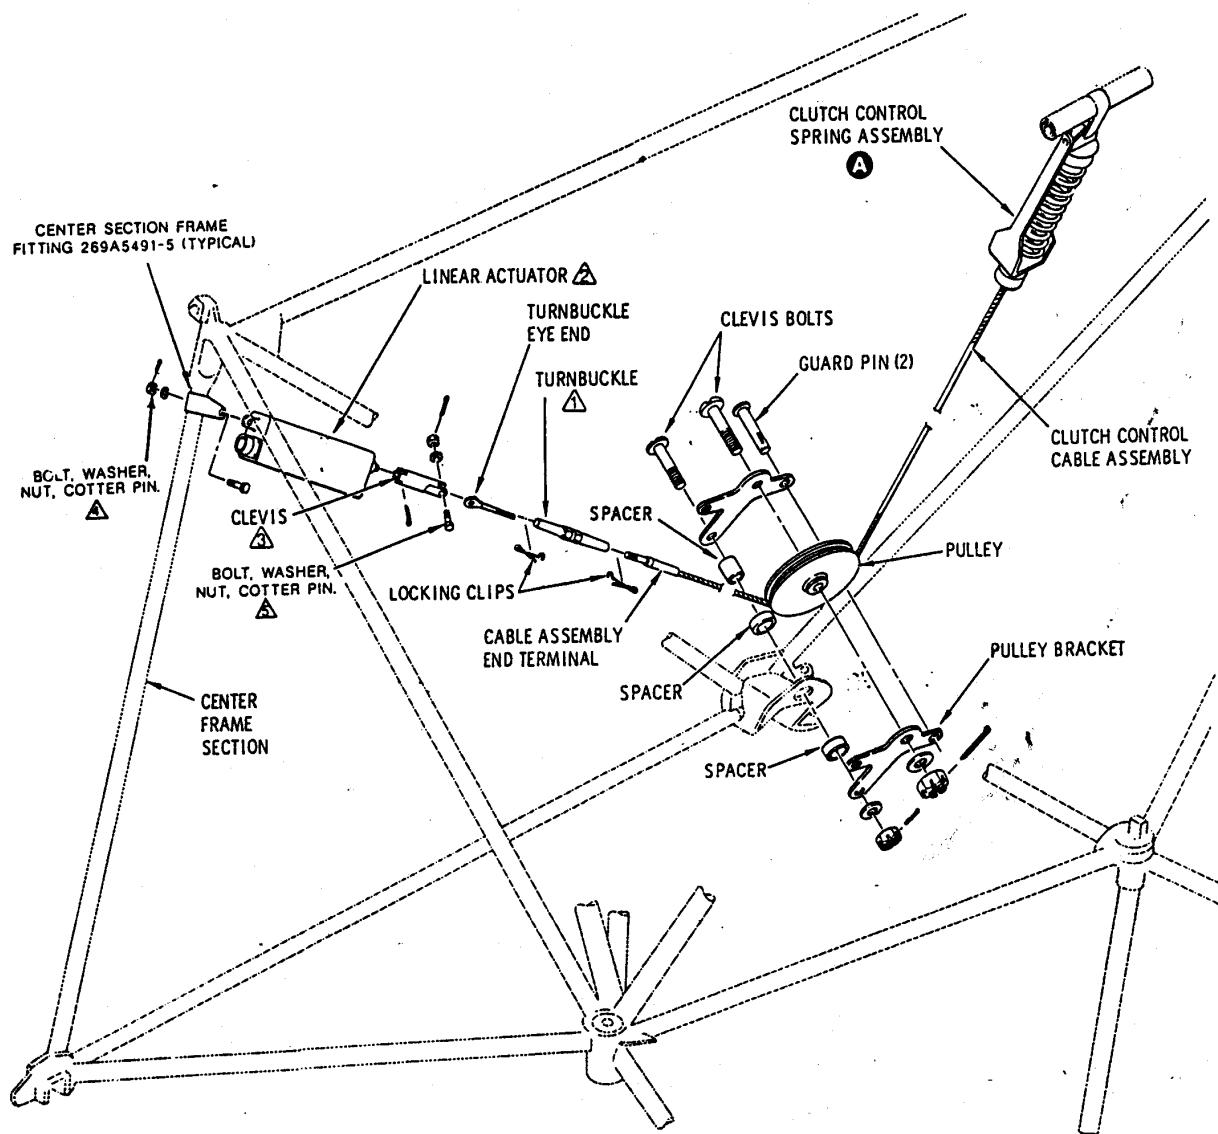
Layout of Clutch System Components

The clutch control cable assembly, (**Appendix A**), connects the linear actuator to the idler pulley, and consists of a cable, adjustment turnbuckle and a clutch control spring assembly. The cable assembly terminates at the linear actuator end in a turnbuckle and has a swaged ball terminal at the other end, which is held in the clutch control spring assembly, (**Appendix B**). The correct tension in the cable is set by adjusting the turnbuckle until the internal springs in the clutch control spring assembly are compressed to a degree that the spring guide alignment band is in line with the black bands on the housing strap (**Appendix B**). The maintenance manual specifies that the linear actuator should be retracted (i.e. the cable should be under tension) when this adjustment is being made. It also states that when the mark is aligned, the tension in the cable will be 230 lbs (+ or - 5 lbs).
