FINAL REPORT

AAIU Synoptic Report No: 2004-003
AAIU File No: 1999/0035
Published: 30/01/04

Aircraft Type and Registration:	B737-448, EI-BXI
No. and Type of Engines:	Two CFM 56 Turbofans
Aircraft Serial Number:	25052
Date of Manufacture:	April 1991
Date and Time (UTC):	3 June 1999 @ 05.45 hrs
Location:	Stand 34, Dublin Airport
Type of Flight:	Public Transport
Persons on Board:	Boarding in progress
Injuries:	Nil reported
Nature of Damage:	Nil
Commanders Licence:	ATPL
Commanders Flying Experience:	15,000 hours, of which 12,000 were on type.
Information Source:	Station Manager, ATC Dublin

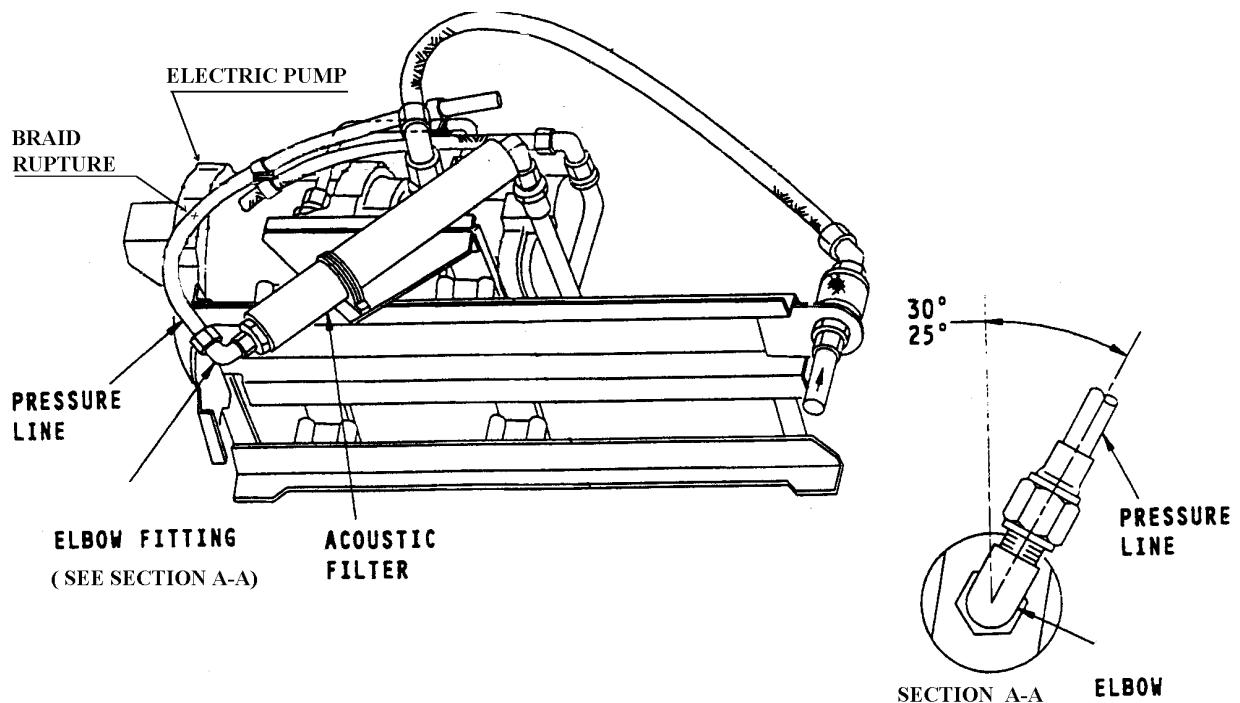
As the pump change was already in progress immediately following this incident, an exact measurement of the clock angle was never made although the engineer felt there was approximately $\frac{1}{4}$ inch between the hose and the wires prior to disturbance.

Diagram from the Maintenance Manual showing correct “clocking” of the pressure line when fitting the hydraulic pump to the aircraft.

The Maintenance Organisation should instruct their staff to always ensure reference to the current issue of the fitting instruction when completing a specific task. **(SR No. 7 of 2004)**

In July 1999 the Maintenance Organisation issued a Quality Advisory Notice to staff informing them of the requirement to refer to the Aircraft Maintenance Manual Chapter 29-15-17 and 29-15-22 when fitting an hydraulic pump or acoustic filter to this aircraft type.

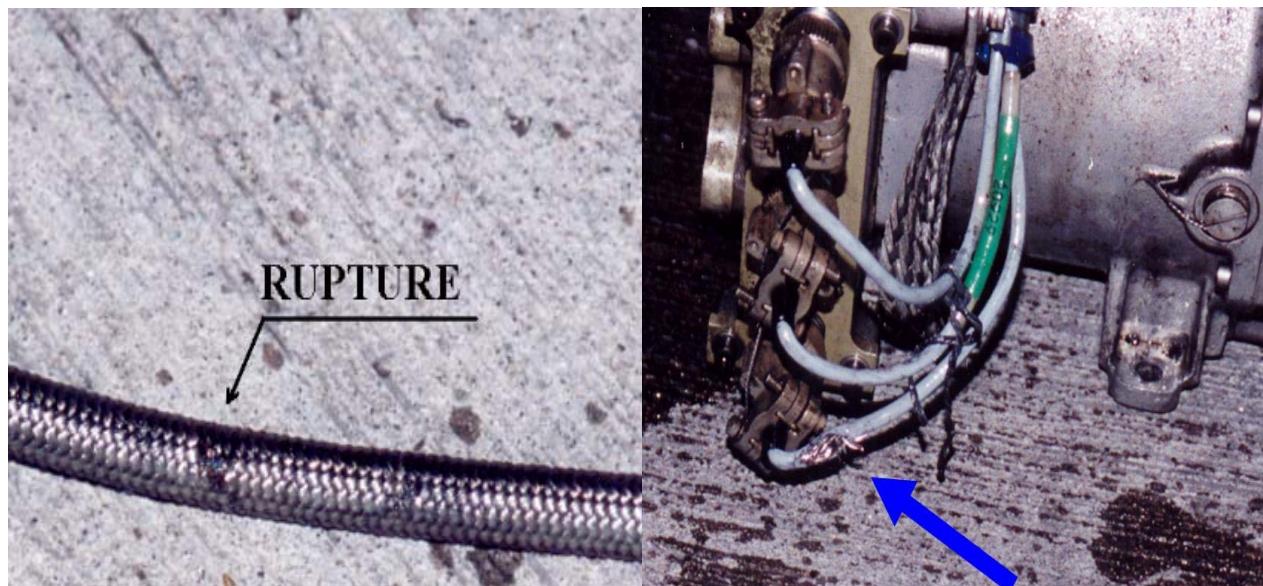
In the follow-up technical examination, it was found that metal braid on a hydraulic flexible pipe had caused a chaffing of the insulation of the “C” phase wire of the electrical supply to the “B” Systems hydraulic pump. This pump is located in the right main wheel well (see photo, **Appendix A**). As the insulation wore away in service, the wire became exposed. During this incident the voltage on the wire arced across to the metal braid, puncturing the hydraulic pipe and causing the hydraulic fluid to escape. This resulted in a large amount of smoke/vapour emanating from the wheel well.

The distance between the hydraulic pressure hose and the electrical cable was insufficient to ensure safety.

An electrical short between the supply to the “B” System hydraulic pump and the metal braid on the flexible hydraulic pipe caused that pressure line to burst.

Left photo, showing part of the ruptured flexible pressure hose which chaffed the insulation of phase “C” supply to the electrical hydraulic pump. The arrow at right indicates the resulting damage to this insulation.

The pressure line and the hydraulic pump were replaced. An operational and leak check were carried out and both found satisfactory. The aircraft was then released back to service.
