FINAL REPORT

AAIU Report No: 2004-004
AAIU File No: 2000/0032
Published: 6/2/2004

Operator:	UPS
Manufacturer:	Boeing
Model:	B747-200
Nationality:	U.S.A.
Registration:	N520UP
Location:	Dublin Airport
Date/Time (UTC):	12 May 2000 @ 13.25 hrs

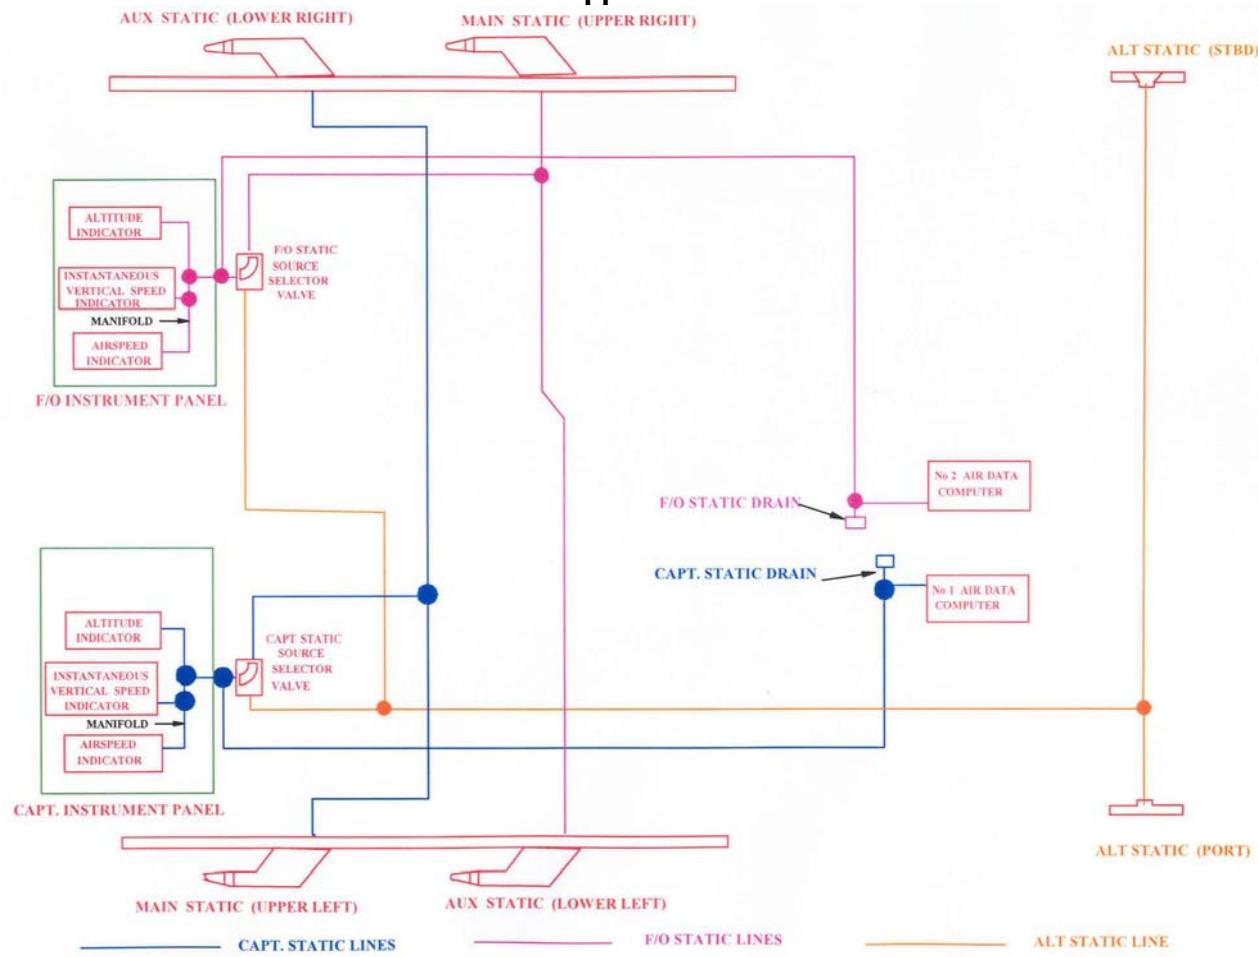
Appendix A

The upper left (main) probe forward static port (S1) is connected to the lower right (aux) probe rear static port (S2) and this is the Captain's instrumentation main static source. This provides static pressure inputs to his ASI, altimeter and IVSI. The lines coming from the static probes are routed through a selector valve and then into a manifold that in turn distributes the static pressure to his instruments. The selector valve allows the Captain to select static pressure from the standard probes, as noted above (NORMAL position) or from the common alternative static source (see below). Between the selector valve and the manifold, a tee piece junction is located. From this junction the static line is connected to the No.1 Air Data Computer and the static line drain (Captain's side).

Similarly the upper right (main) probe forward static port (S1) is connected to the lower left (aux) probe rear static port (S2) and this is the First Officer's (F/O) instrumentation main static source.

Both Air Data Computers and their associated drains are located in the forward A&E Bay. The drains are to drain moisture from the system. Normally these drains are sealed by means of blanking caps. However, it is possible to connect instrumentation onto these drains for the purpose of performing leak checks on the static system. This requires removal of the blanking caps.

The other static ports on the main and aux probes are not connected to flight instruments (nor to the drains in the A&E bay that are connected to the flight instrument static system) but are used to supply static air pressure to a variety of other systems, including flight control modules. The connections of these other static ports are not shown in the diagram of **Appendix A**, for reasons of clarity.

Flight Instrument Static System Simplified Schematic`

This schematic shows only the static system that is connected to the flight instruments
