FINAL REPORT

AAIU Formal Report No: 2004-006

Operator:	Ryanair
Manufacturer:	Boeing
Model:	B737-200 ADV
Nationality:	Irish
Registration:	EI-COA
Location:	Charleroi, Belgium.
Date/Time (UTC):	29 November 2002 @ 11:40 hrs

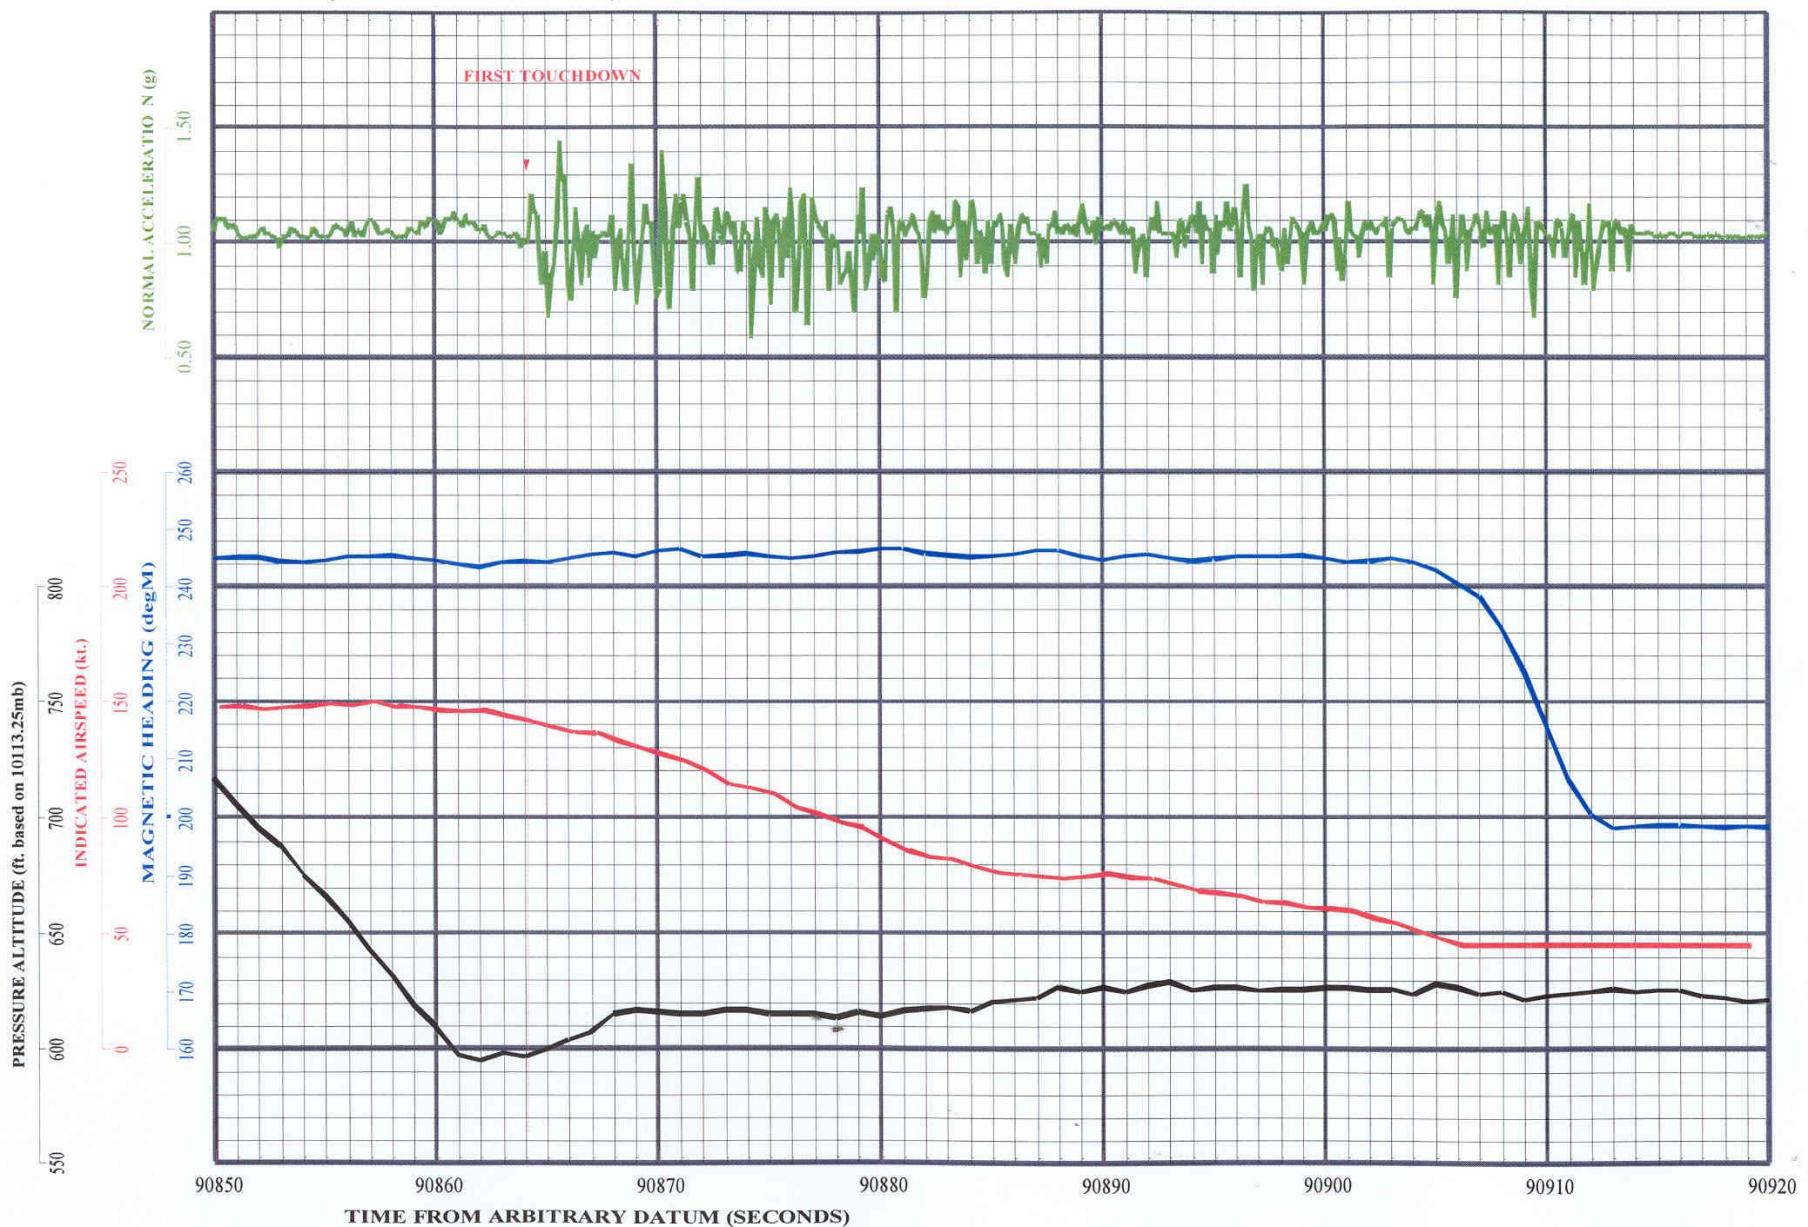
APPENDIX A

The aircraft was fitted with a Cockpit Voice Recorder (CVR) and a Flight Data Recorder (FDR), as standard. Both recorders were retrieved by the Belgian Authorities and sent to the UK AAIB facility at Farnborough for downloading of data. The CVR recordings relevant to the incident had been overwritten and were of no benefit to the investigation. The FDR data was downloaded, and copied to AAIU. Relevant information obtained is produced, in part, at (Appendix A).

B737-230, REGISTRATION EI-COA, OVERRUN AT BRUSSELS ON 29 NOV. 2002

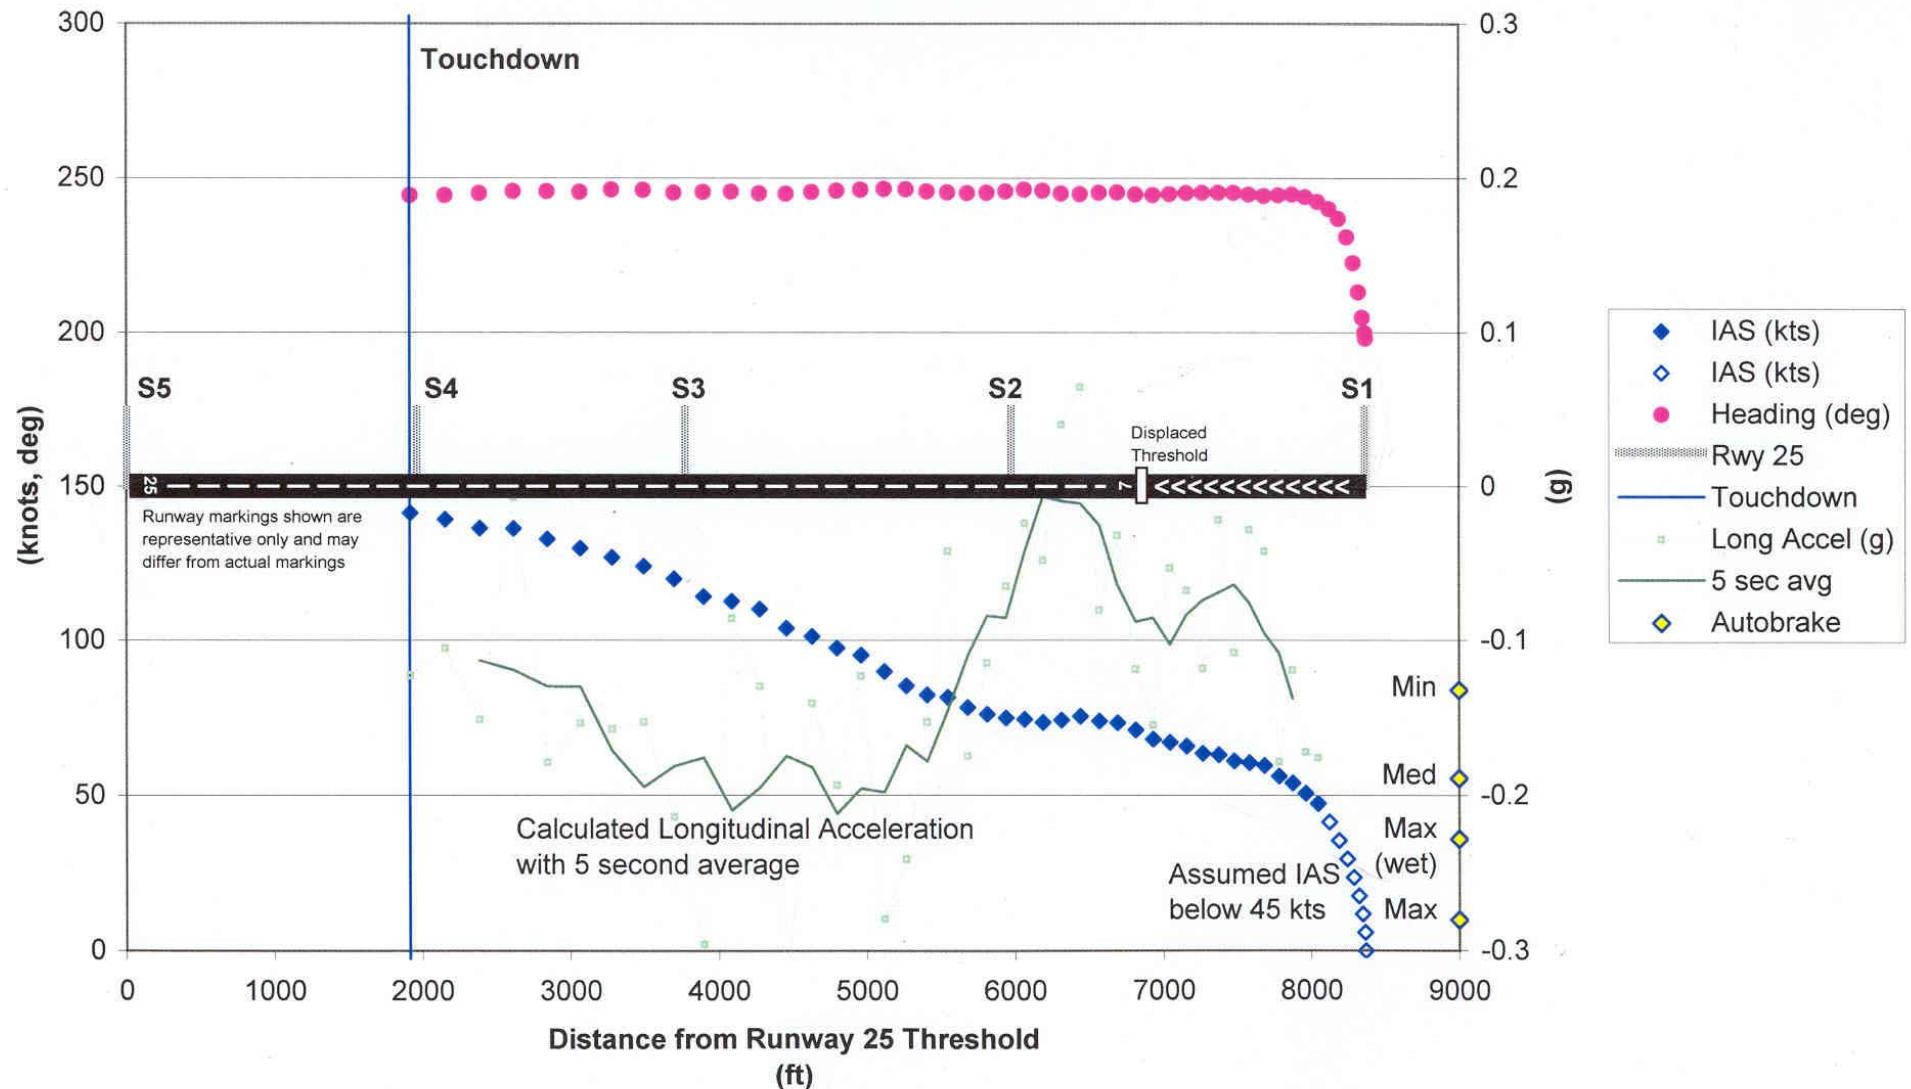
APPENDIX B

The attached plot (**Appendix B**), derived from data downloaded from the FDR, shows the speed down the runway, position of the various taxiways and calculated deceleration levels. As airspeed is not recorded accurately on the FDR below 45 kt, a constant deceleration is assumed between the last valid value and the time the aircraft came to a rest. These points are depicted as hollow diamonds on the plot. The Captain recalled turning on to S1 at 60 kt or less and this correlates with the FDR data, which shows that the turn to S1 was initiated at an indicated airspeed of 50 kt. At about 70 kt and at an appropriate point as determined by the Captain, braking was commenced. However, the deceleration did not approach the previously achieved value. It was at this late phase of the landing that the stopping technique used by the Captain did not have the desired effect. Repeated brake application and finally continuous brake application failed to achieve a safe taxi speed, as the aircraft turned into exit S1 and, very quickly, the aircraft vacated the taxi-way, with its nosewheel and number 3 mainwheel in the grassy overrun area. The aircraft then stopped and the crew shutdown the engines.

3.1.9 The FDR data shows a small decrease in airspeed from 80 kt approx at S2 to 50 kt at the runway end. This was not a safe taxi speed.

3.1.10 When the Captain commenced braking somewhere between S2 and S1, the Manufacturers Recommended manual braking technique, of smoothly applying a constant brake pedal-pressure for the desired braking was not applied. Several attempts at reducing the speed by modulating the brakes were unsuccessful as the brake pedal pressure was being released and efficiency lost.

RYR 737-200 EI-COA Runway Overrun
