FINAL REPORT

AAIU Formal Report No: 2004/014
AAIU File No: 2002/0038
Published: 10 Sept 2004

Operator: Private
Manufacturer: Beechcraft/Raytheon
Model: Beechcraft Bonanza A36 (modified)
Nationality: U.S.A.
Registration: N7205R
Location: Ballyneale Stud, Ballingarry, Co Limerick
Date/Time (UTC): 9 August 2002 at 11.15 hrs

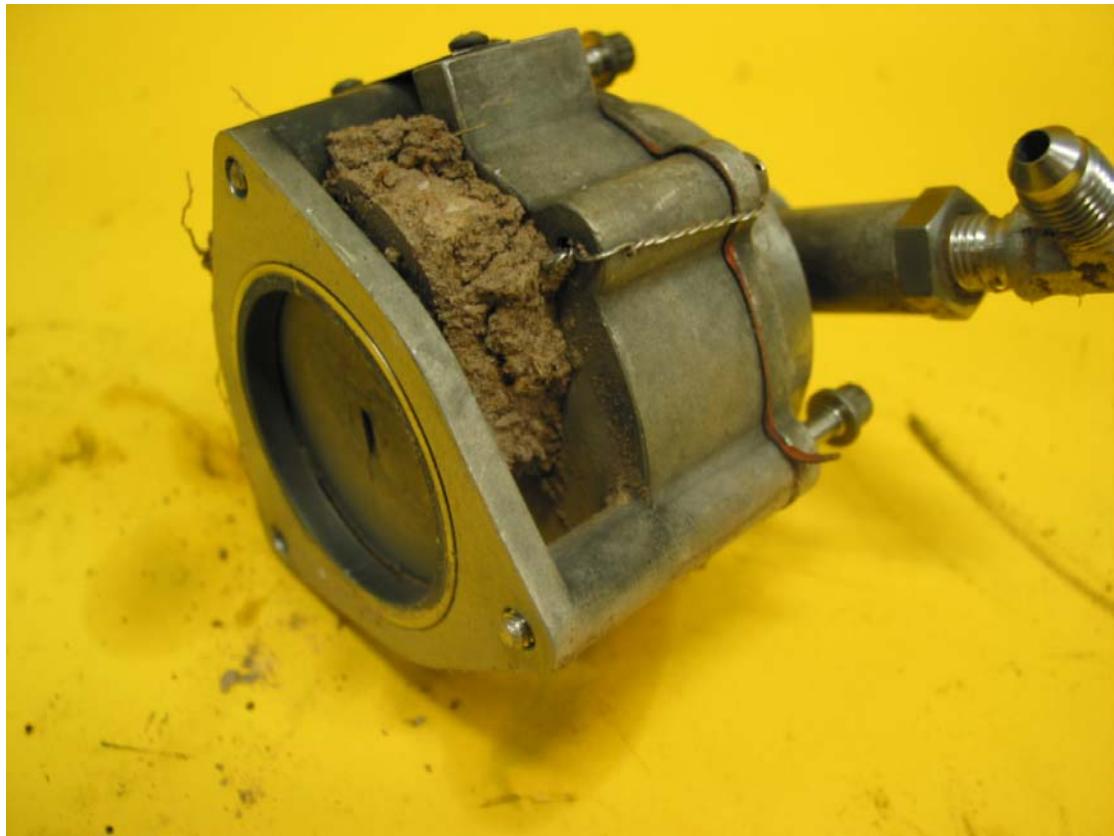
Appendix A

- The bleed valve was found in the closed position following the accident. In the normal power-off configuration a spring pushes this valve to the open position. It was held in the closed position by impacted clay, which had become lodged between the valve plate and the body during the crash sequence (**Appendix A**). When the clay was removed, the valve returned to the open position. It was closed by hand and, after release, again returned to the open position. Referencing Rolls Royce Allison chart for bleed valve operation (**Appendix B**), this shows that the bleed valve is fully closed at 82% N1 (max) with an ambient temperature of -70° F, and at 100% N1 with an ambient temperature of 145° F. The temperature at the time of the accident was 60.8° F. Using the Rolls Royce Allison chart this temperature would result in bleed valve closure at 93% N1. Between 63% and 93% N1 (max) the bleed valve would have been modulating, i.e. operating between the fully closed and fully open position. At less than 63% N1 (max), the valve would have been fully open.

This photo shows the bleed valve, as removed from the engine. The valve face can be seen in the fully closed position, in the outlet on the left side of the photo. The clay, which is jammed under the valve and holding it in the closed position, can also be seen.

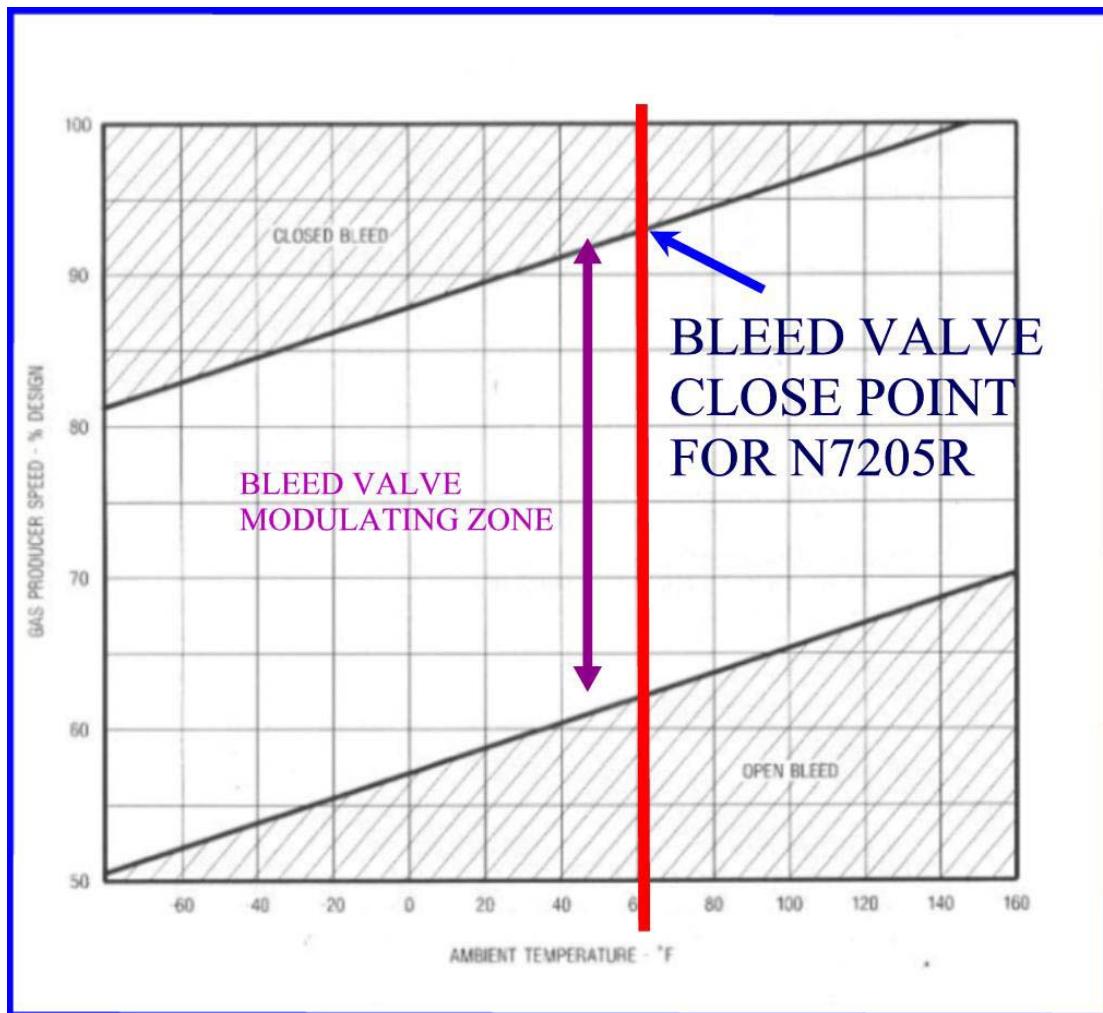
Appendix B

- The position of the bleed valve indicating the speed of the N1 system was greater than 93% of N1(max)².
- The shear failure of the starter/generator quill shaft, indicating a high rotational speed at impact. It should be noted that this shaft is only connected to the N1 system and is independent of shock load transmitted to the propeller (N2) system.
- The damage to the compressor system, and the ingress of clay through the compressor and into the combustion area.
- The propeller hub marks, indicating a propeller angle of 22.3°.

This graph shows the bleed valve position as a function of N1 speed (%) and ambient temperature. The red vertical line shows indicated the ambient conditions on the day of the accident. The graph shows that, in the conditions at the time of the accident, the bleed valve would have been fully closed at N1 greater than 93% and fully open at N1 less than 62%. Between N1 values of 62% and 93%, the bleed valve would have been modulating, i.e. between the fully open and fully closed position
