FINAL REPORT

AAIU Synoptic Report No: 2004-018

Aircraft Type and Registration:	Boeing 737-2T5	EI-CKS
No. and Type of Engines:	2 x Pratt & Whitney	JT8D-15A
Aircraft Serial Number:	52990	
Year of Manufacture:	1980	
Date and Time (UTC):	3 February 2003	@ 13.00 hrs
Location:	Dublin Airport (EIDW)	
Type of Flight:	Public Transport - Scheduled	
Persons on Board:	Crew - 5	Passengers - 122 ¹
Injuries:	Crew - 0	Passengers - 0
Nature of Damage:	Minor damage to pressurisation system	
Commander's Licence:	Air Transport Pilot's Licence	
Commander's Details:	Male, aged 35 years	
Commander's Flying Experience:	6,864 hours of which 6,284 were on type	
Information Source:	AAIU Field Investigation

SYNOPSIS

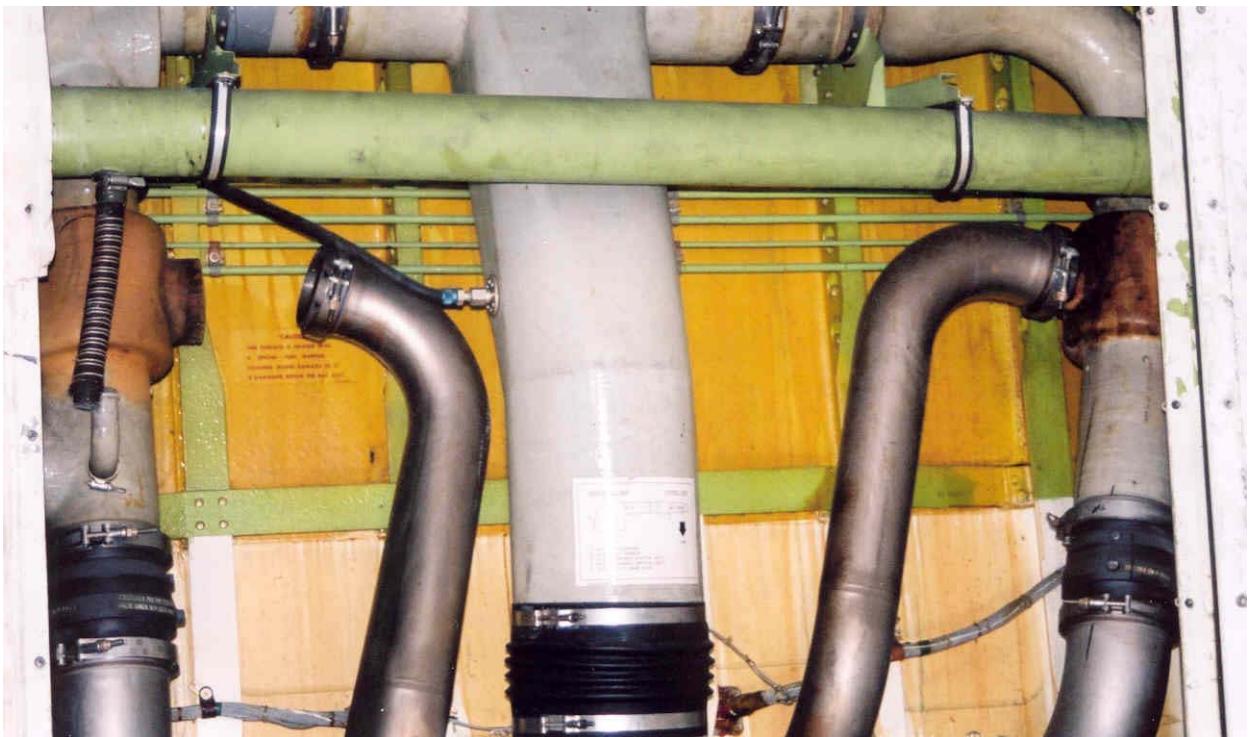
Photo 1

Subsequent inspection of the aircraft found that a duct, of approximately 100 mm diameter, which carries engine bleed air from the right engine to the right air conditioning mix chamber, had separated from the mix chamber (**Appendix A, Photo 1**). The mix chambers are located in the main cabin under-floor area, immediately aft of the forward cargo bay, in an area known as the “snake pit”. This area is underneath Row 10. When the duct separated, large volumes of engine bleed air, at a pressure, above ambient, of approximately 1 to 3 PSI (0.07 to 0.21 bar) and a temperature of approximately 320°F (160°C) entered the snake pit. This hot air then entered the main cabin area through the grill vents at the bottom of the sidewalls on both sides of the cabin fuselage. There was no evidence of burning or charring, and no obvious source of smoke generation. However, it was noted that the ducts behind the grills were heavily covered with a fine grey dust and lint (**Appendix A, Photo 2**).

This photo shows the “snake pit”, as viewed from the forward cargo hold, looking aft with the rear screen removed. It shows the failed joint on the left. The mix chamber can be seen on the extreme left. The intact LH system can be seen on the right of the photo.

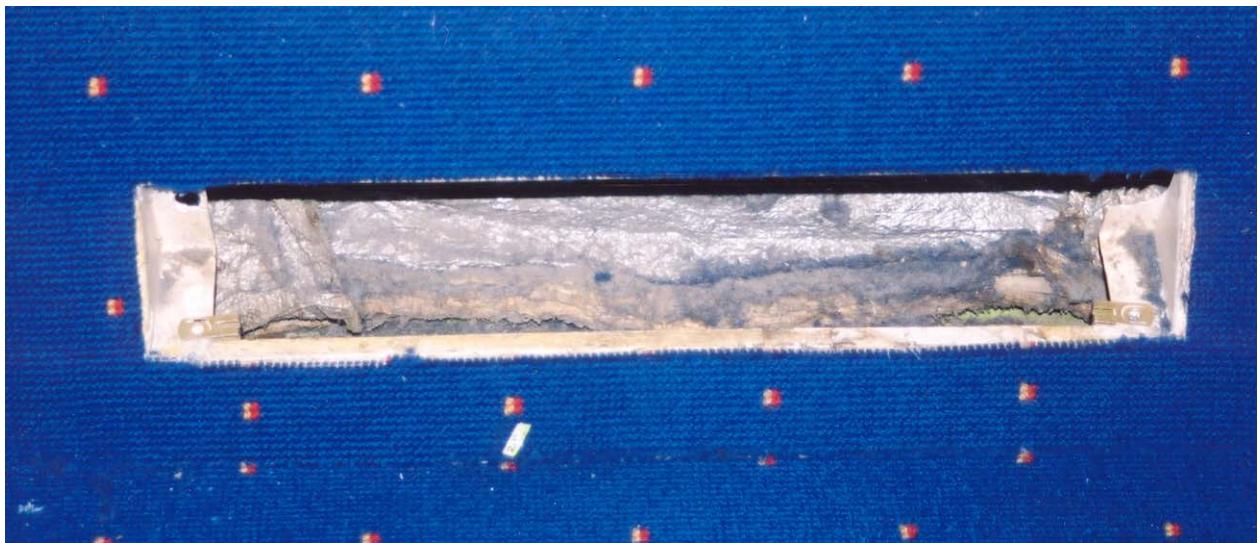
Photo 2

2.1.4 The blast of pressurised bleed air from the failed joint, rushing through the sidewall ducts and grills in the opposite direction to the normal air flow, dislodged the dust that had accumulated in these ducts and then carried the dust into the cabin, where it was mistaken for smoke. Given the presence of very hot air in the cabin, it was reasonable to confuse this visual dust with smoke.

This shows one of the sidewall ducts with the grill removed. The dust and lint that caused the smoke effect can be seen in the duct.

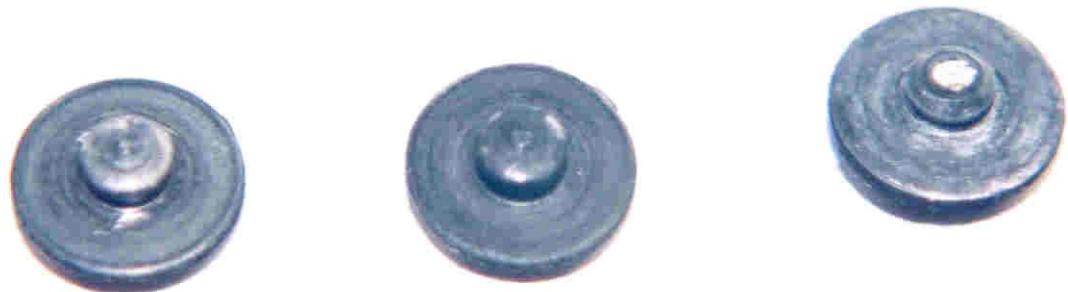
Photo 4

2.1.3 The rivet shanks were worn away by the sharp edges of the countersunk hole of the flange. Eventually the loss of material in the rivets was sufficient to cause some to fail

This shows the clenched end of the recovered rivets, with the washers still attached. The parallel shank section can be seen. The worn section is visible at the top of each rivet.

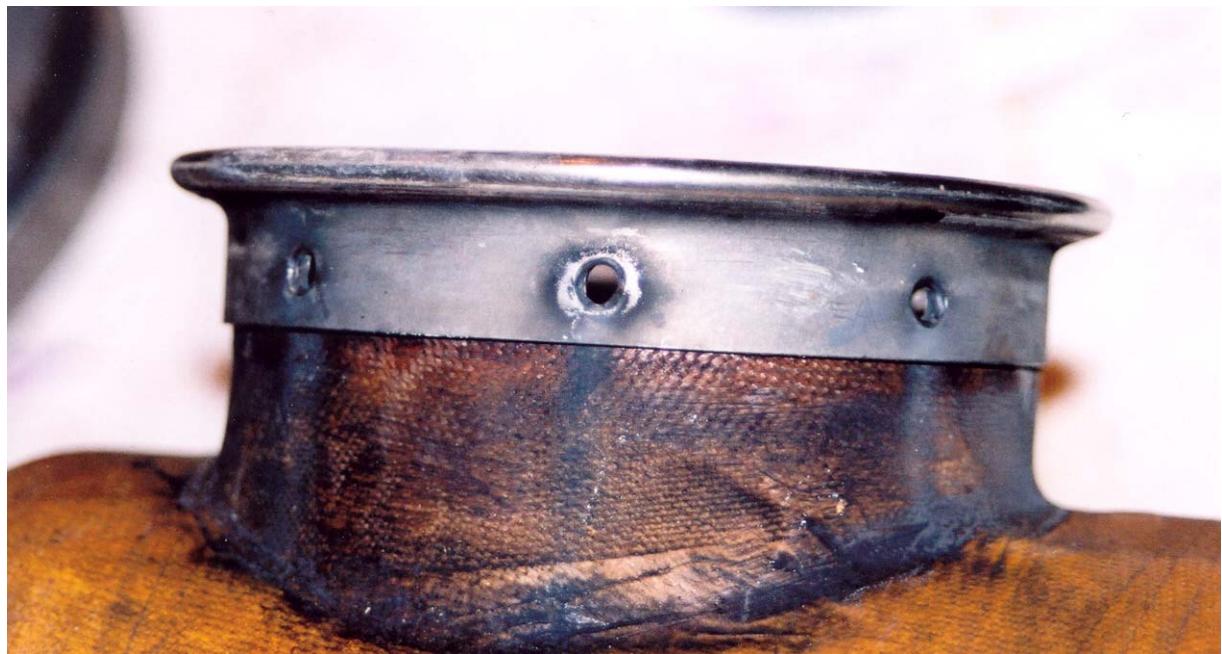
Photo 5

The Investigation found that all eight rivets failed in shear. The internal pressure in the pipe then forced the duct, with the ring and clamp attached, to depart from the mix chamber. This break allowed the bleed air to vent into the snake pit. A search of the snake pit recovered five of the countersunk heads and three of the clenched ends of the rivets in question. Inspection of the rivets fragments showed that they were of the correct material and had been correctly formed. All but one of the recovered segments exhibited a major reduction of material at a point along the rivet shank close to the countersunk head (**Appendix A, Photo 3 and Photo 4**). It was also noted that the countersink in the flange penetrated virtually the full thickness of the wall of the flange. This resulted in the absence of any parallel section bore in the flange rivet hole, with the effect of producing a sharp edge on this hole. This sharp edge bore directly on the rivet shank at the end of the countersink section of the rivet (**Appendix B**). At a point on the rivets corresponding to the countersunk edge, a gross reduction of diameter of the rivet shank was found. On some of the recovered rivets this reduction was approximately 90% of the cross sectional area. It was noted that this loss of material was caused by wear, rather than cutting, and is believed to be due to fretting. It was also noted that some wear of the rivet shank had also occurred where the rivet shank passed through the glass fibre material of the mix chamber. Some of the faces of the washers that were in contact with the composite material exhibited a polished surface, indicating movement. None of the holes in the composite material had broken or cracked at the adjacent edge, but were axially elongated by up to 0.075". Some elongation in the holes of the flange was also noted as shown in **Appendix A, Photo 5**.

This shows the flange temporarily refitted to the mix chamber. The elongated holes in the flange can be seen.

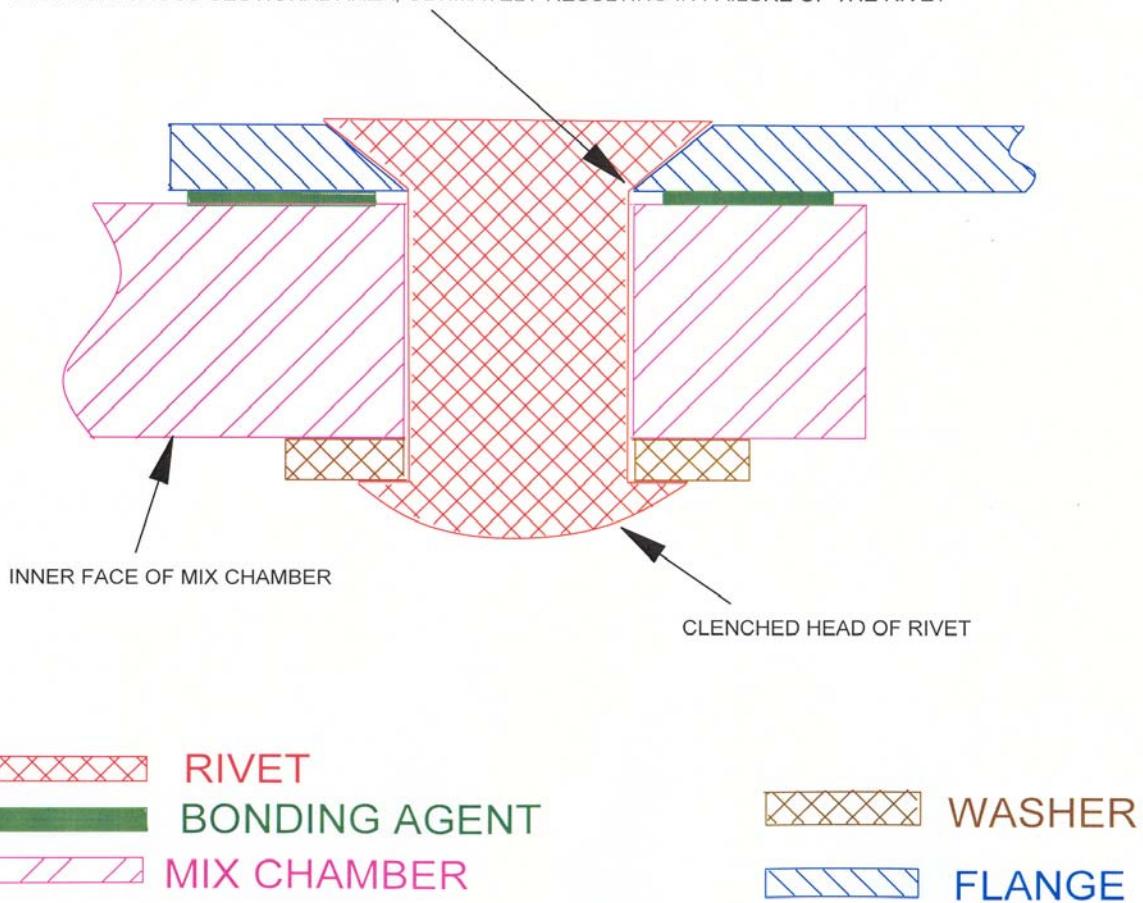
Appendix B

A total of 8 countersunk rivets are used to secure the flange to the mix chamber. The rivets are 1/8" (approximately 3 mm) diameter. The flange, which fits over the inlet of the mix chamber, is countersunk on the outer surface. The rivets pass through the ring and the composite material of the inlet. The rivets are clenched on the inner face of the inlet. In order to prevent crushing of the composite material by the axial loads of the riveting clenching process, a 5/16" (8 mm) diameter washer is inserted underneath the rivet clench (**Appendix B**).

MOVEMENT OF THE RIVETS AT THIS POINT CAUSED SEVERE WEAR AND A GROSS REDUCTION OF THE RIVET CROSS-SECTIONAL AREA, ULTIMATELY RESULTING IN FAILURE OF THE RIVET

This is a schematic drawing of the area where the failure occurred (not drawn to scale).

by simple overload. This, in turn, led to overload of the adjacent worn rivets and ended in cascade failure of all the rivets. The Investigation is of the opinion that dome head rivets would have been more suitable in this application. This would have done away with the need to countersink the rivet holes and the consequent creation of the sharp edges that bore on the rivets. A possible remedy of this problem would be to replace the flange with a new design using dome head rivets without a countersink in the flange.

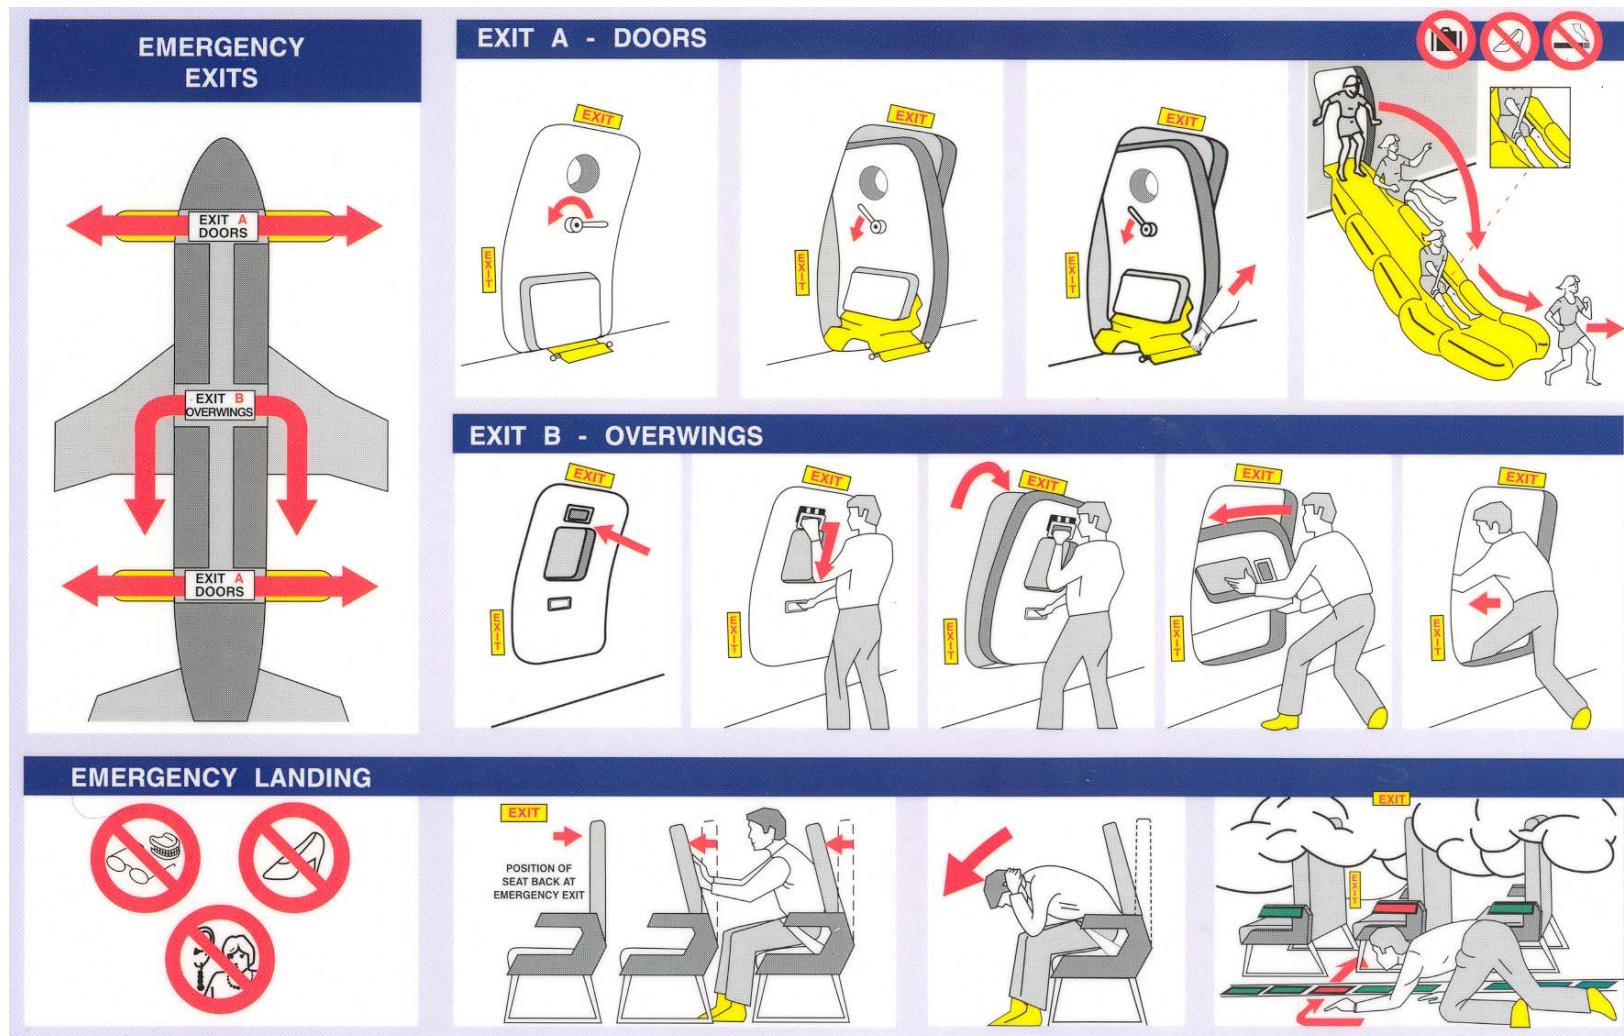
Appendix C

The Investigation examined the Operator's Passenger Safety Card, and determined that it was sufficiently clear in showing the direction that passengers should take after exiting the over-wing exits (Appendix C). The Investigation also noted that the actual exit paths were clearly marked on the aircraft wing. However the Safety Card did not provide any guidance as to how passengers should get down off the wing. The Investigation is aware that some operators of B737 include, on their safety card, a visual drawing of passengers sliding down the fully extended flap. An example of the relevant sections of such a Safety Card is shown in Appendix D.

- Some passengers, having made their way through the over-wing exit, were unsure as to where they should go next and in particular how they should get down off the wing. The absence of information in the Safety Card, as to how to get off the wing, may have been a factor in this confusion.

This is the Operator's Safety Card dealing with emergency evacuation procedures. It does not give obvious directions as to how passenger should get down off the wing.

- 4.2 The Operator should review their Safety Card to ensure that the card clarifies how passengers should get down from the aircraft wing, when using the over-wing exits in an emergency evacuation. [\(SR 36 of 2004\)](#)

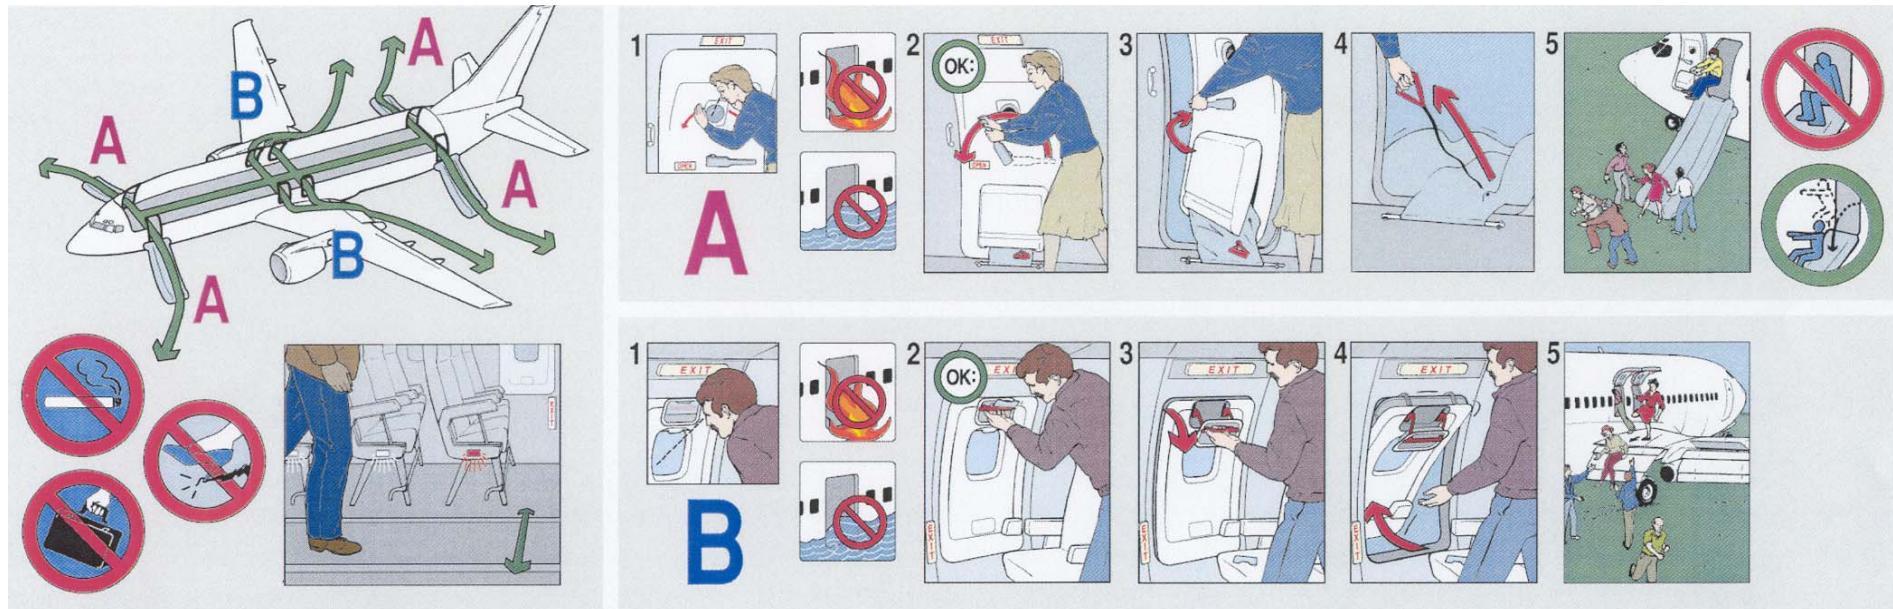
Appendix D

2.2.2 There is no doubt that in this evacuation, some passengers, who had exited onto the wing, were unsure as to how to get from the wing onto the ground. The Investigation considers that an average passenger would more easily and more completely understand the pictorial information, as presented in **Appendix D**. This in turn would reduce the potential for confusion, such as arose in this evacuation.

This is a Safety Card, used by another operator for a later version of the B737, for using the over-wing exits in an emergency evacuation. Note that it shows, pictorially, the path that passengers using the over-wing exit should take (upper left), and how they should get down off the wing (lower right).
