FINAL REPORT

AAIU Synoptic Report No: 2004-019

Aircraft Type and Registration:	Bell 206B, EI-BHI	
No. and Type of Engines:	1 x Allison 250-C20	
Aircraft Serial Number:	906	
Year of Manufacture:	1972	
Date and Time (UTC):	31 March 2003 @ 1810 hrs	
Location:	Weston Airport, Co Kildare	
Type of Flight:	Licence Proficiency Check (LPC)	
Persons on Board:	Crew - 2	Passengers -Nil
Injuries:	Crew - Nil	Passengers - Nil
Nature of Damage:	Rear portion of right hand skid severed	
Commander's Licence:	JAR ATPL (H)	
Commander's Age:	Male, 51 years	
Commander's Flying Experience:	6,200 hours of which 3,500 were on type	
Information Source:	Accident/Incident Report Form submitted by the Commander, AAIU additional enquiries.

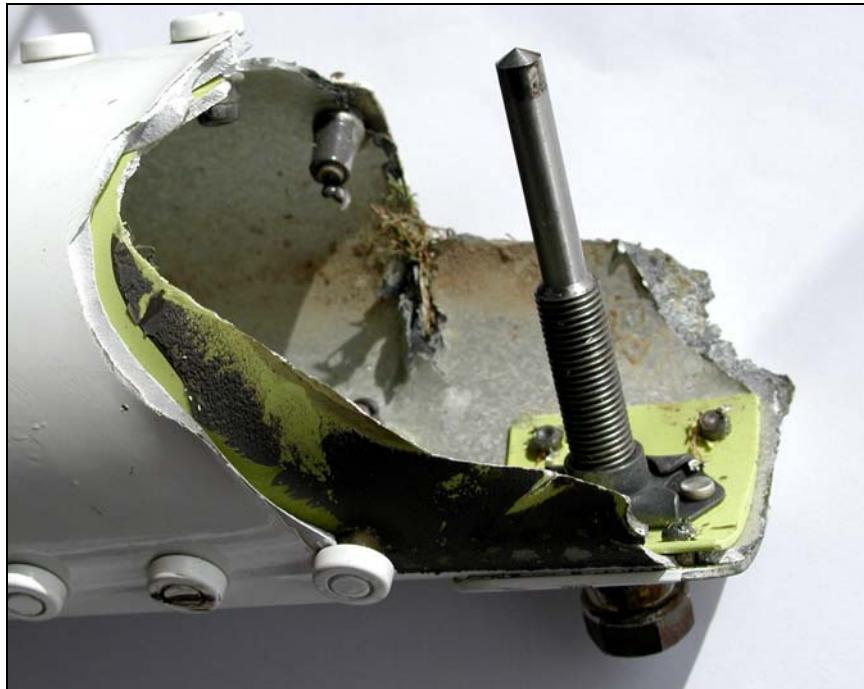
APPENDIX A

- *The aluminium tube of the skid suffered severe exfoliation corrosion at/adjacent to the holes in the tube, through which fixing of the plates was made.*
- *This extended around more than 40% of the circumference, and would have weakened the tube significantly.*
- *High strength aluminium alloys are prone to this type of corrosion, particularly in marine environments. Attack occurs at locations where a part is machined such that the transverse grain structure is exposed, as at machined holes.*
- *It would appear that the holes in the tube were not adequately protected to prevent the attack.*

The Skid Tube portion had mud on and around both Skid Shoes, which suggests that the helicopter was operated in a wet environment. There was also evidence of mud on a small area inside the tube adjacent to the fracture location. This interior tube moisture indicates that the tube was cracked in this location prior to failure. There were stress corrosion cracks in three locations and the longest was 2.5" long. The stress corrosion cracks ran in the longitudinal direction. In addition to the stress-corrosion crack locations, there were three other locations, which showed corrosion in the form of blisters or bulging of the protective coating. The most significant exfoliation corrosion was adjacent to one of the skid shoes, which are steel components. This location indicates that the exfoliation was precipitated and accelerated by galvanic corrosion.

The manufacturer concluded that if the FAA approved corrosion inspection requirements for the Skid Tube had been adhered to, the initial corrosion would have been repaired prior to the occurrence of any stress-corrosion cracking or exfoliation corrosion. They stated that, *"In the absence of stress-corrosion cracking of exfoliation corrosion, the Skid Tube failure would not have occurred."*

Photograph of skid fracture caused by a combination of exfoliation, galvanic and stress corrosion (Photo by Tony Horan)

4.1 The IAA advise operators of Bell 206 helicopters of the necessity to carry out Skid Tube Inspection and Repair Requirements every 100 hours or 6 months whichever comes first, as per the Manufacturers instructions. **(SR No. 37 of 2004)**
