# FINAL REPORT

**AAIU Synoptic Report No:2004-020**

<b>Aircraft Type and Registration:</b>	Piper PA18-150 STC 180, EI-BIK
<b>No. and Type of Engines:</b>	1 x Lycoming 0-360 A3A of 150 HP
<b>Aircraft Serial Number:</b>	18-7809088
<b>Year of Manufacture:</b>	1979
<b>Date and Time (UTC):</b>	15 August 2003 @ 18.00 hrs
<b>Location:</b>	Gowran Grange, Co. Kildare
<b>Type of Flight:</b>	Taxiing following refuelling
<b>Persons on Board:</b>	Crew - 1 Passengers - Nil
<b>Injuries:</b>	Crew - Nil Passengers - Nil
<b>Nature of Damage:</b>	Damage to starboard wing and propeller.
<b>Commander's Licence:</b>	Irish PPL
<b>Commander's Details:</b>	Male aged 70 years
<b>Commander's Flying Experience:</b>	1,417 hours (of which 460 hours were on type).
<b>Information Source:</b>	Report by gliding club flying instructor and AAIU Field Investigation

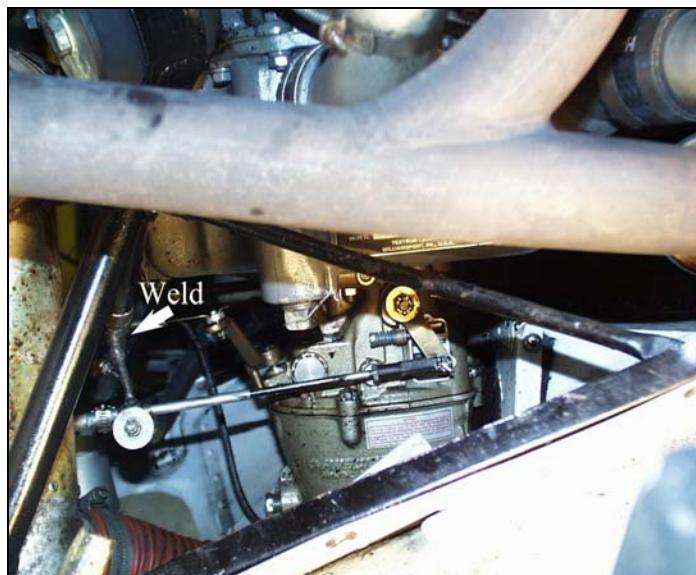
On inspection of the aircraft following the incident, the Investigation found that the securing point for the boden throttle cable had come apart (see below). This was due to the fracture of a weld at the bowden support inboard end. Closer examination indicated that at one time previously the support had broken and had been welded back on again. This weld had now fractured with the result that the bowden cable could no longer function properly. This support was fitted during the STC modification of the aircraft from a PA-18-150 to a PA-18-180.

The aircraft manufacturers said that welding of the support for something as important as the throttle control cable was not recommended. However, it was not possible to establish who carried out this repair.

- 3.3 A weld at the throttle cable support failed prior to or during propeller and wing contacting the security fencing and gate.
- 3.4 The aircraft was restarted with an obstacle immediately in front of it.
