FINAL REPORT

AAIU Synoptic Report No: 2004-021
AAIU File No: 2004/0014
Published: 09/12/2004

Aircraft Type and Registration:	Bell 206B JetRanger-II, G-AYMW	
No. and Type of Engines:	1 x Rolls Royce Allison 250 C20	
Aircraft Serial Number:	587	
Year of Manufacture:	1970	
Date and Time (UTC):	5 April 2004 @ 08.05 hrs	
Location:	Newgrange, Co. Meath, Ireland	
Type of Flight:	Aerial Work	
Persons on Board:	Crew-1	Passengers - 2
Injuries:	Crew-1 (Serious)	Passengers - 2 (Minor)
Nature of Damage:	Extensive	
Commander's Licence:	IAA issued JAA CPL (H)	
Commander's Details:	Male, aged 47 years	
Commander's Flying Experience:	5,499 hours of which 1,176 were on type	
Information Source:	Field Investigation, AAIU Report Form submitted by Pilot.

SYNOPSIS

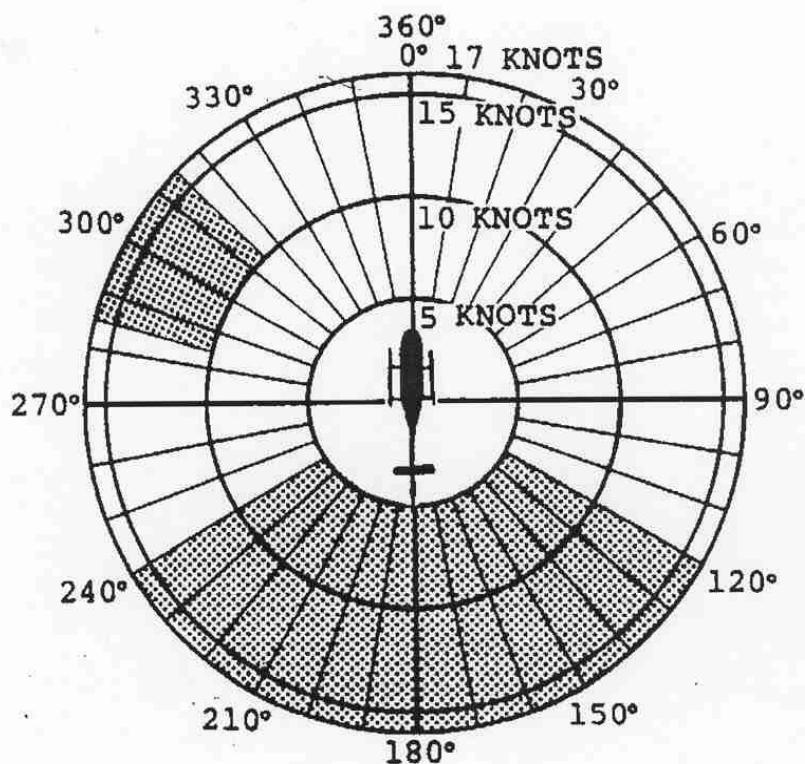
RELATIVE WIND CHART

An unanticipated right yaw may occur when operating in the shaded areas of the chart.

This chart refers to unanticipated right yaw and does not replace the critical relative wind azimuth chart in the performance section of the flight manual which refers to tail rotor control margin.

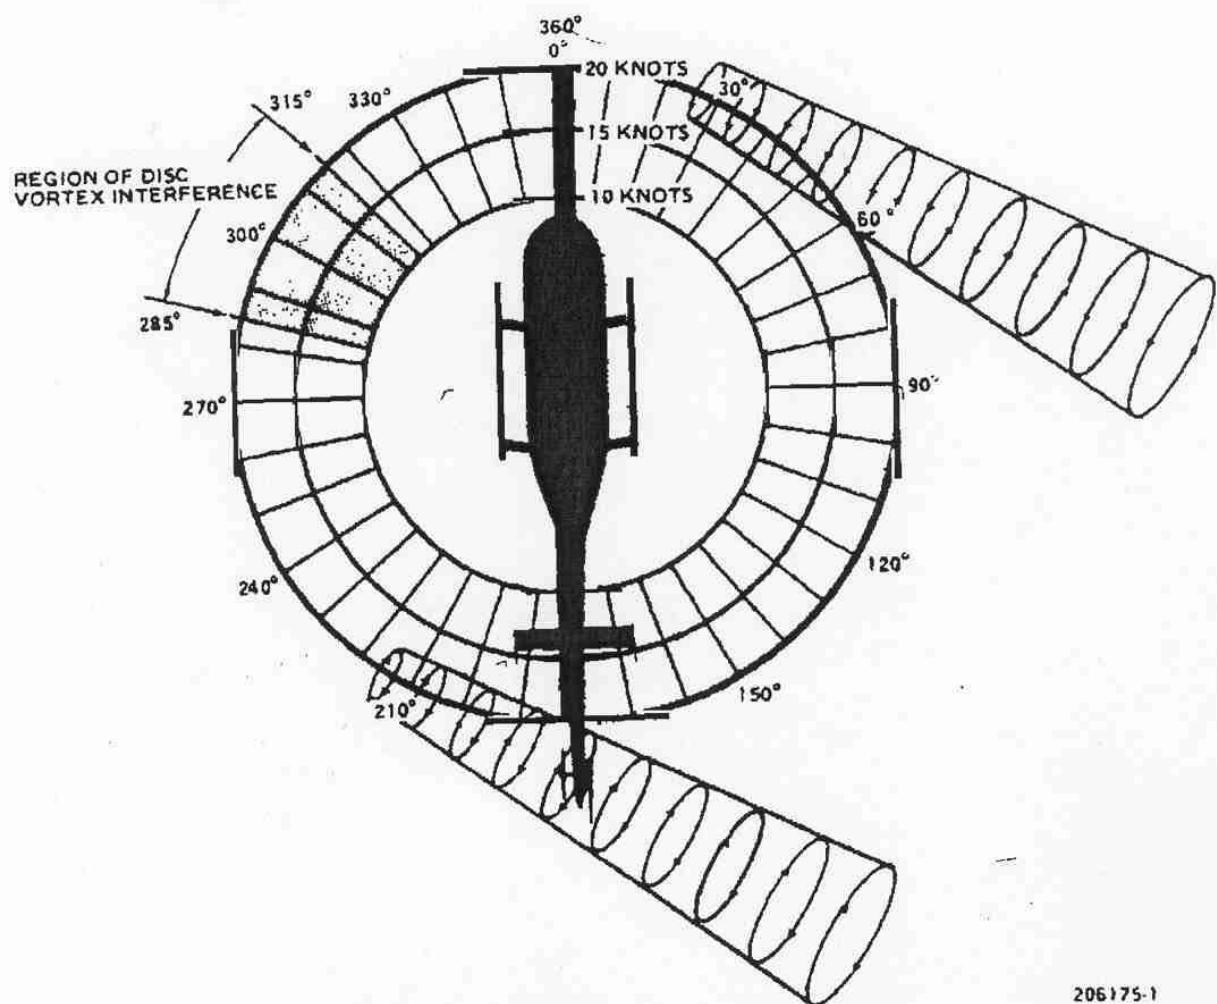
FIGURE 2. MAIN ROTOR DISC VORTEX INTERFERENCE

Winds within this region, as shown in Figure 2, can cause the main rotor vortex to be directed onto the tail rotor. The effect of this main rotor disc vortex is to change the tail rotor angle of attack. Initially as the tail rotor comes into the area of the main rotor disc vortex during a right turn, the angle of attack of the tail rotor is increased. This increase in angle of attack requires the pilot to add right pedal (reduce thrust) to maintain the same rate of turn. As the main rotor vortex passes the tail rotor, the tail rotor angle of attack is reduced. The reduction in angle of attack causes a reduction in thrust and a right yaw acceleration begins. This acceleration can be surprising, since the pilot was previously adding right pedal to maintain the right turn rate. Analysis of flight test data during this time verifies that the tail rotor does not stall. The helicopter will exhibit a tendency to make a sudden, uncommanded right yaw which, if uncorrected, will develop into a high right turn rate. When operating in this region, the pilot must anticipate the need for sudden left pedal inputs.

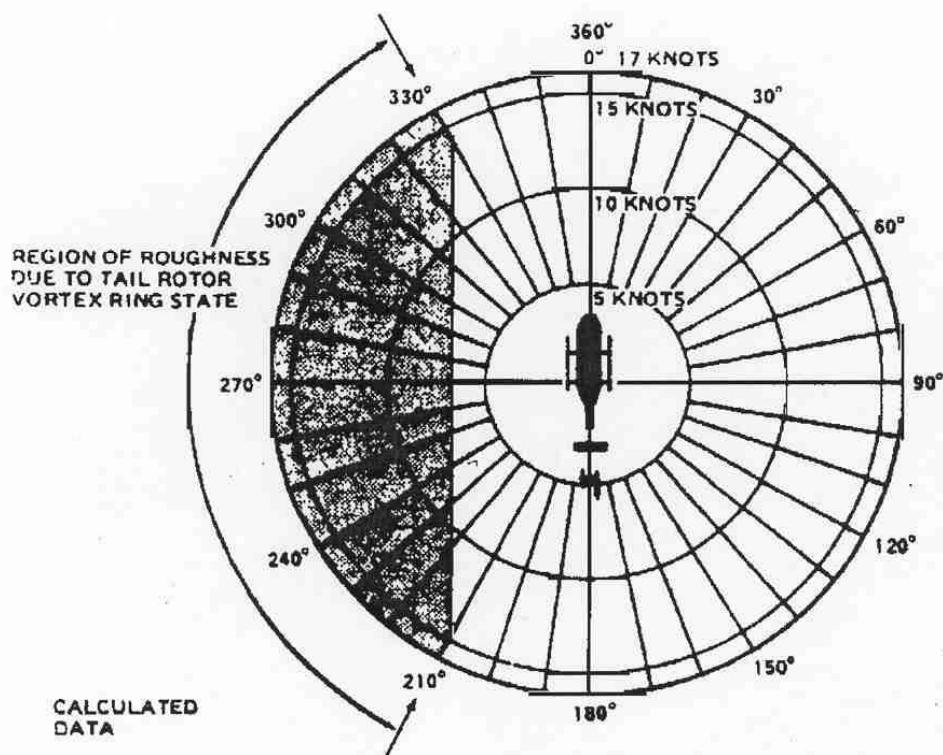
FIGURE 3. TAIL ROTOR VORTEX RING STATE

Winds within this region, as shown in Figure 3, will result in the development of the vortex ring state of the tail rotor. The vortex ring state causes tail rotor thrust variations which result in yaw rates. Since these tail rotor thrust variations do not have a specific period, the pilot must make corrective pedal inputs as the changes in yaw acceleration are recognized. The resulting high pedal workload in tail rotor vortex ring state is well known and helicopters are operated routinely in this region. This characteristic presents no significant problem unless corrective action is not timely. If a right yaw rate is allowed to build, the helicopter can rotate into the wind azimuth region where weathercock stability will then accelerate the right turn rate. Pilot workload during vortex ring state will be high; therefore, the pilot must concentrate fully on flying the aircraft and not allow a right yaw rate to build.
