FINAL REPORT

AAIU Report No: 2004-023
AAIU File No: 1997-0009
Published: 20 May 2005

Operator: Air Zimbabwe
Manufacturer: Boeing
Model: 707-330B
Nationality: Zimbabwe
Registration: Z-WKU
Location: Shannon Airport, Ireland
Date/Time (UTC): 10 March 1997, 23.15 hrs

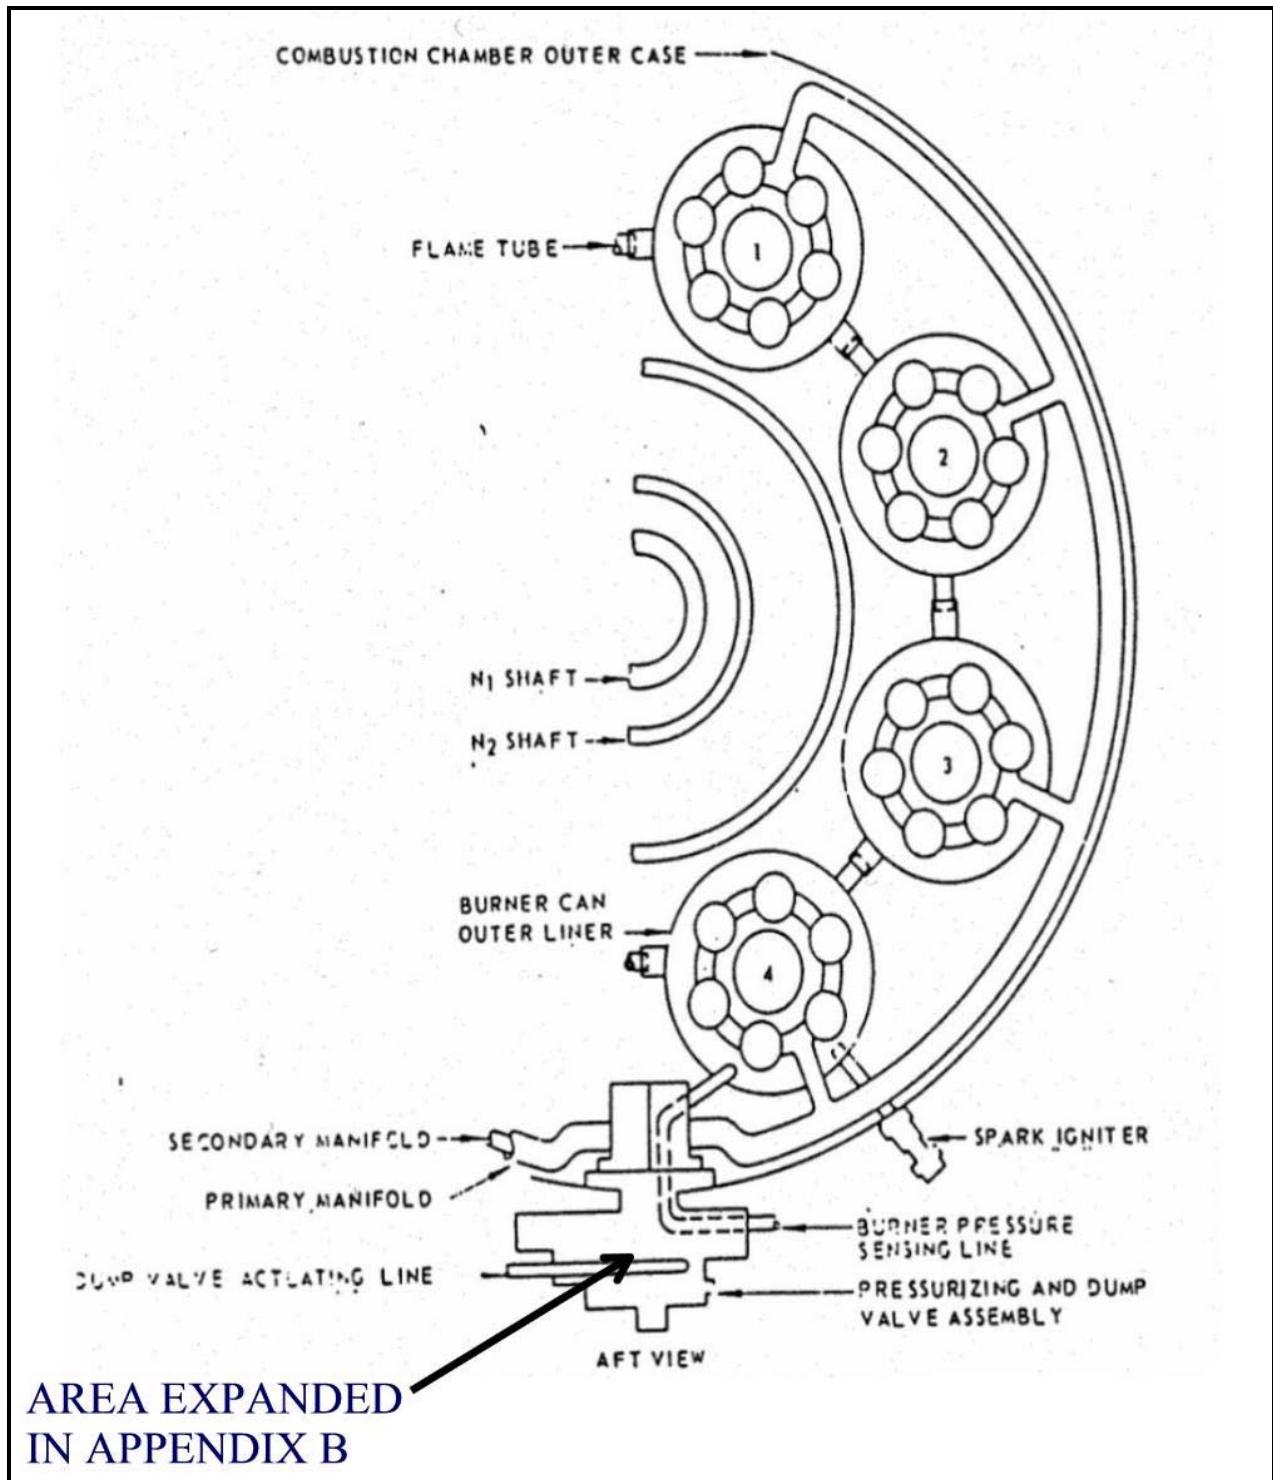
Appendix A

VIEW OF THE FUEL MANIFOLD ASSEMBLY

THE P&D VALVE IS AT THE BOTTOM OF THE DIAGRAM

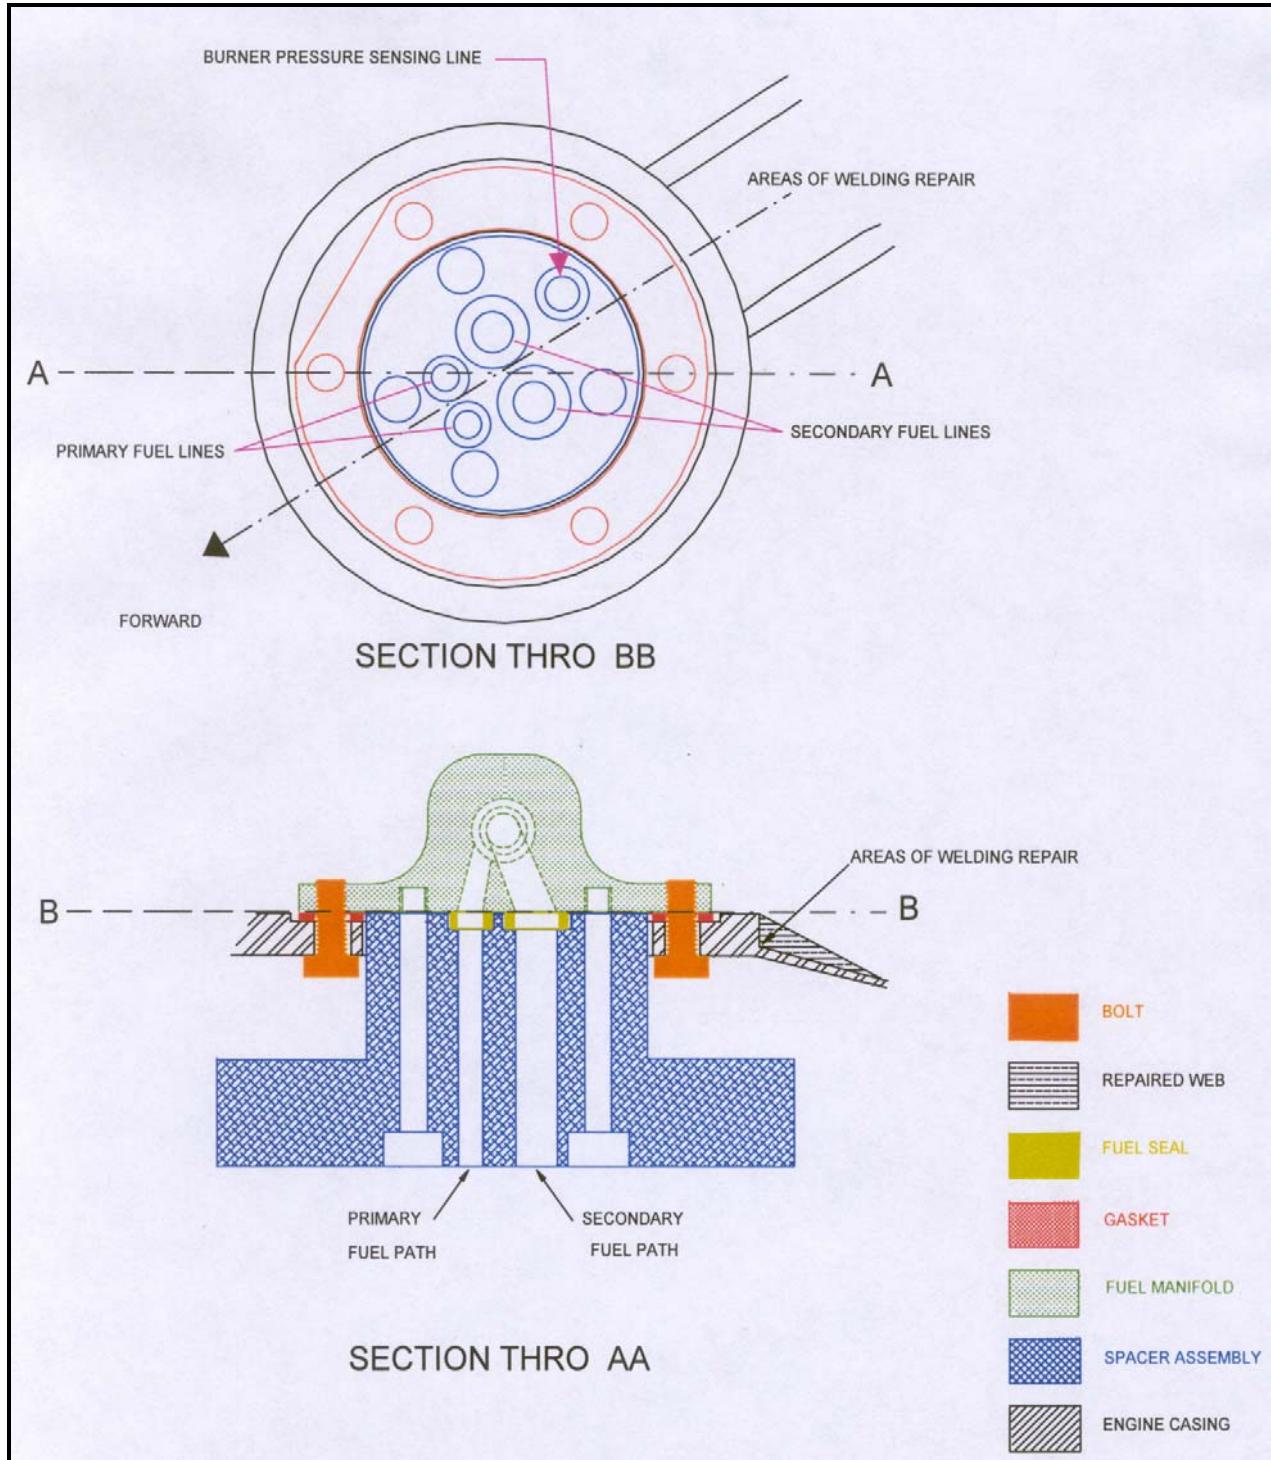
Appendix B

1.6.4.2 The attachment of the P&D Valve Assembly is shown in **Appendix B**. The fuel manifold comprises of a right hand section and a left hand section, and is clamped to a flat bearing surface, known as the mounting-boss, on the inside of the diffuser casing. Three 12-point bolts secure each section. A copper gasket seals this joint. A spacer assembly is fitted through a hole in the diffuser casing, located directly underneath the manifold assembly. The spacer assembly is secured to the manifold assembly by means of four socket head cap screw bolts. There are four fuel paths through the spacer assembly, into the manifolds. The front two paths supply primary fuel to the left and right fuel manifolds respectively, and the rear two paths supply secondary fuel, again one to each of the left and the right fuel manifolds. Each of these four fuel paths is sealed by a metal seal at the spacer/manifold interface. The P&D valve is then bolted, underneath, to the spacer assembly.

SKETCH OF THE P&D VALVE MOUNT LAYOUT

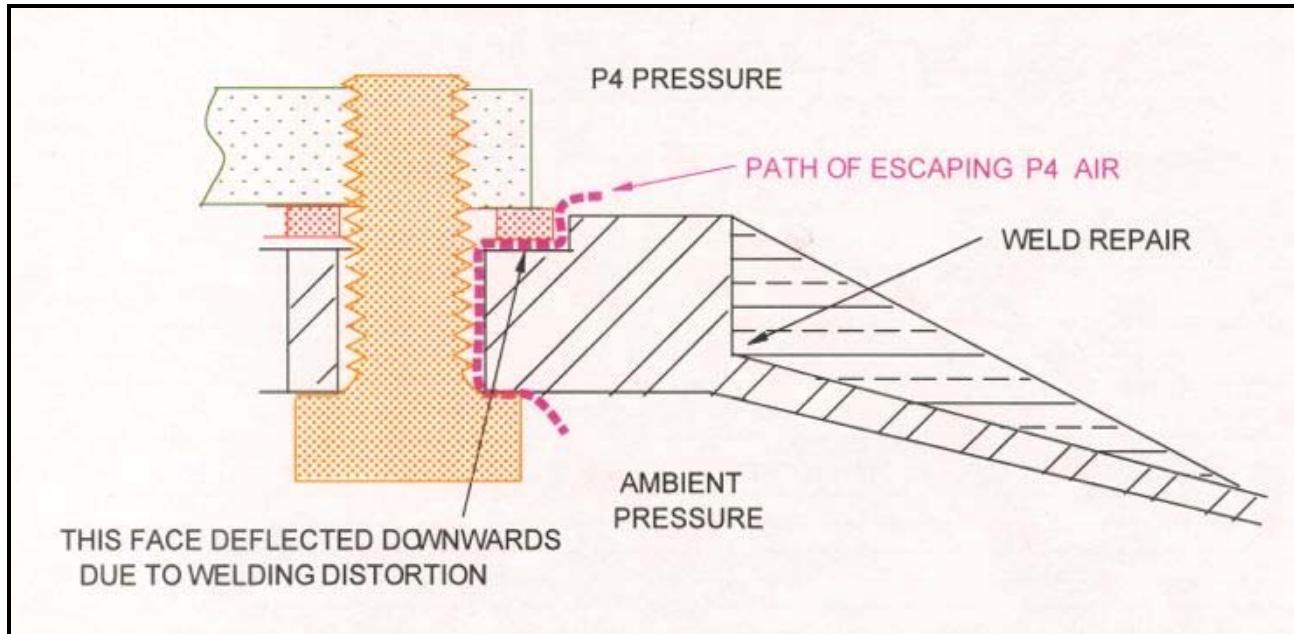
Appendix C

2.1.4 The distortion of the mounting face for the P&D valve allowed P4 air, at a pressure of up to 175 PSI above ambient atmospheric pressure, to leak past the copper gasket, into the bolt hole in the diffuser casing and to escape under the bolt head. Furthermore, the distorted mounting face and the distortion of the boss would have exacerbated the possibility of a leak under the bolt head. Initially this leak would have been extremely small. The initial path of this leak is shown in **Appendix C**.

ENLARGED VIEW OF THE BOLT AREA
SHOWING THE PROBABLE PATH OF
THE INITIAL LEAK

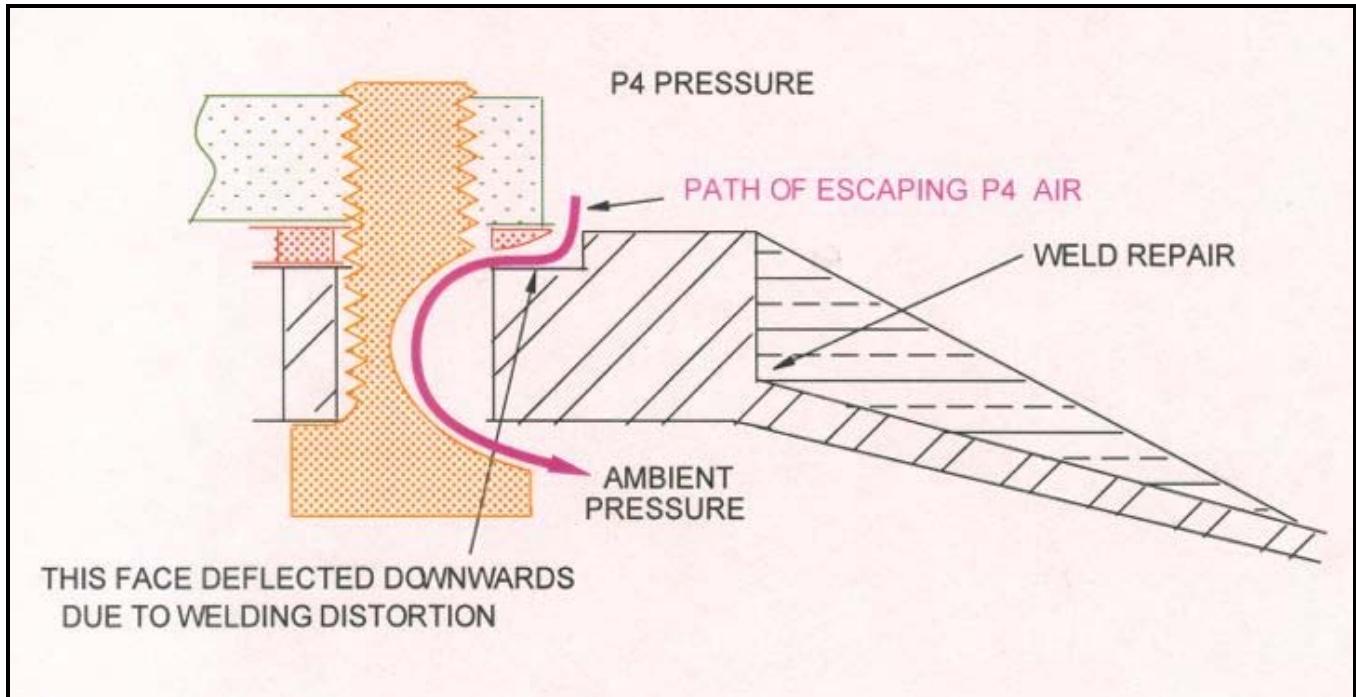
Appendix D

2.1.5 Over an extended period of operation this air leak, mixed with fuel, gradually eroded portions of the bolt, the bolt hole in the diffuser casing and the fuel manifold, producing a larger hole, and thereby increasing the rate of erosion. This situation is shown in **Appendix D**. The extent of the bolt erosion is shown in **Appendix F, Photo 1**.

ENLARGED VIEW OF THE BOLT AREA
SHOWING THE EROSION OF THE BOLT
CAUSED BY THE LEAK

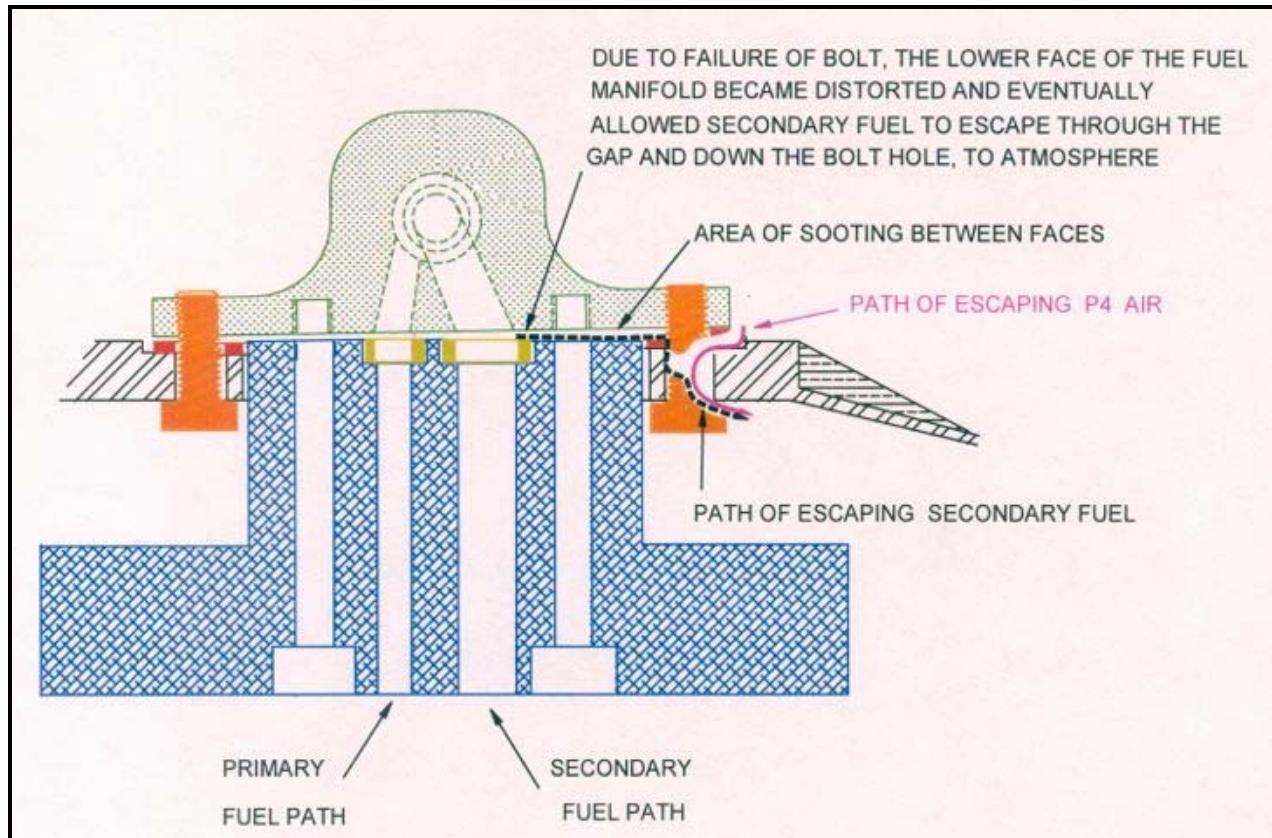
Appendix E

2.1.6 Ultimately the cross-sectional area of the bolt was reduced by P4 air/fuel erosion to such an extent that it failed in tension. This allowed the corner of the base of the fuel manifold to distort away from the P&D valve spacer assembly. This distortion would have been exacerbated by thermal stresses but also by the pressure of the secondary fuel; that is when the secondary fuel supply was activated, the fuel pressure assisted in opening up a gap between the fuel manifold face and the spacer, through which secondary fuel was able to escape. The burning on the surface of the manifold heat shield would have increased the normal thermal stresses on the manifold area. This burning was probably caused by a faulty fuel nozzle allowing fuel to drip onto the manifold which would have ignited and burned on the hot surface of the shield. The path of the fuel leak is shown in **Appendix E**.

ENLARGED VIEW OF THE P&D VALVE ASSEMBLY
SHOWING THE SITUATION
AFTER THE FAILURE OF THE BOLT

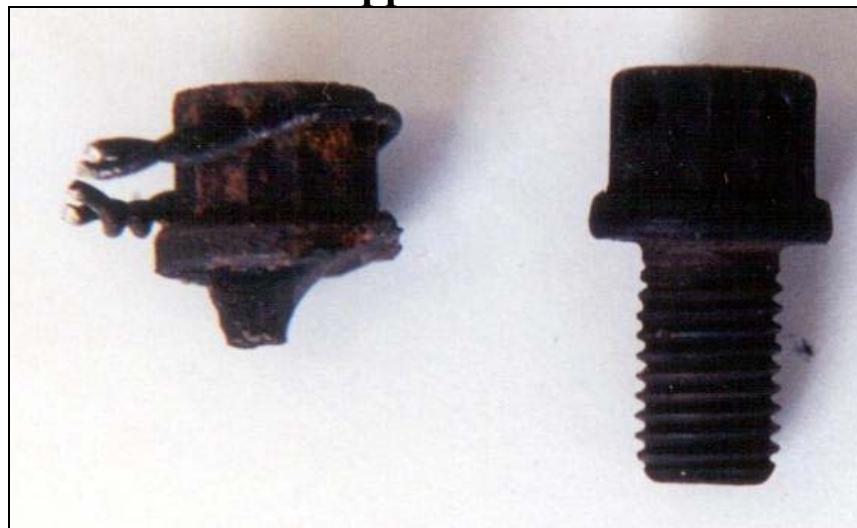
PHOTO 1

1.16.4 The engine was again powered up, and identical results were obtained. The engine was then removed from the test cell and stripped down. It was determined that the failed bolt was one of the six 12 point bolts that secure the internal fuel manifolds to the boss of the engine diffuser casing. The copper gasket at this interface was found to have failed at the hole relating to the failed bolt. It was also noted that there was an area of soot accumulation at the interfaced between the fuel manifold and the P&D valve mounting-boss, between the secondary fuel line orifice and the failed bolt.

**VIEW OF THE ERODED BOLT (LEFT)
AND AN UNDAMAGED BOLT (RIGHT)**

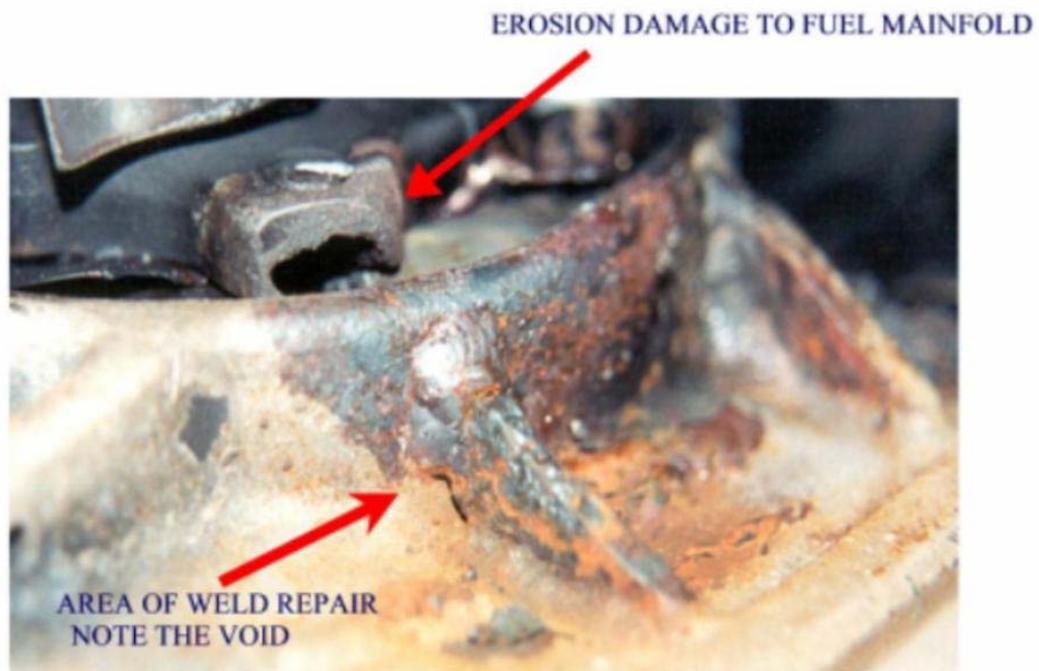
PHOTO 2

2.1.2 The boss on the diffuser casing, onto which the P&D valve is mounted, had been repaired by the welding of the supports to the side of the boss. Even after an extended period of use, the poor quality of this weld was evident.

2.1.3 The mounting face for the P&D valve assembly, on the boss of the diffused casing had been distorted as a result of the welding repair.

2.1.13 The records of the diffuser casing do not show when the welding repair to the boss support was done. However, during the course of the pressuring and leak testing of the case following the repairs in September 1995, it would have been necessary to remove the P&D valve support. If the air leak had been present at that time, it is probable that erosion of the bolt and the bolt-hole would have been found. This would indicate that the welding repair to the supports did not pre-date September 1995. The repair area is shown in **Appendix F, Photo 2**.

3.1.2 The diffuser casing had undergone a welding repair in the area of the supports to the flanges of the P&D Valve Support Boss. This repair was poorly executed and caused distortion of the boss.

**PHOTOGRAPH OF THE INTERIOR OF THE DIFFUSER CASE SHOWING
THE P&D VALVE MOUNTING-BOSS& DETAILED THE EROSION
DAMAGE TO THE FUEL MANIFOLD AND THE DEFECTIVE WELD REPAIR**
