## FINAL REPORT

**AAIU Synoptic Report No: 2005-002**

<b>Aircraft Type and Registration:</b>	Schweizer 269 (300 CBi), EI-FUN	
<b>No. and Type of Engines:</b>	1 x Lycoming HIO-360-G1A	
<b>Aircraft Serial Number:</b>	0155	
<b>Year of Manufacture:</b>	2003	
<b>Date and Time (UTC):</b>	21 February 2004 @ 15.40 hrs	
<b>Location:</b>	South of Runway (RWY) 07/25 Weston Aerodrome (EIWT)	
<b>Type of Flight:</b>	Flight Instruction	
<b>Persons on Board:</b>	Instructor - 1	Student - 1
<b>Injuries:</b>	Instructor - Minor	Student - Nil
<b>Nature of Damage:</b>	Beyond economic repair	
<b>Commander's Licence:</b>	UK CPL (H)	
<b>Commander's Details:</b>	Male, aged 41 years	
<b>Commander's Flying Experience:</b>	2,932 hours of which 565 were on type	
<b>Information Source:</b>	AAIU Accident Report Form submitted by the Instructor Pilot. AAIU Field Investigation.

### **SYNOPSIS**

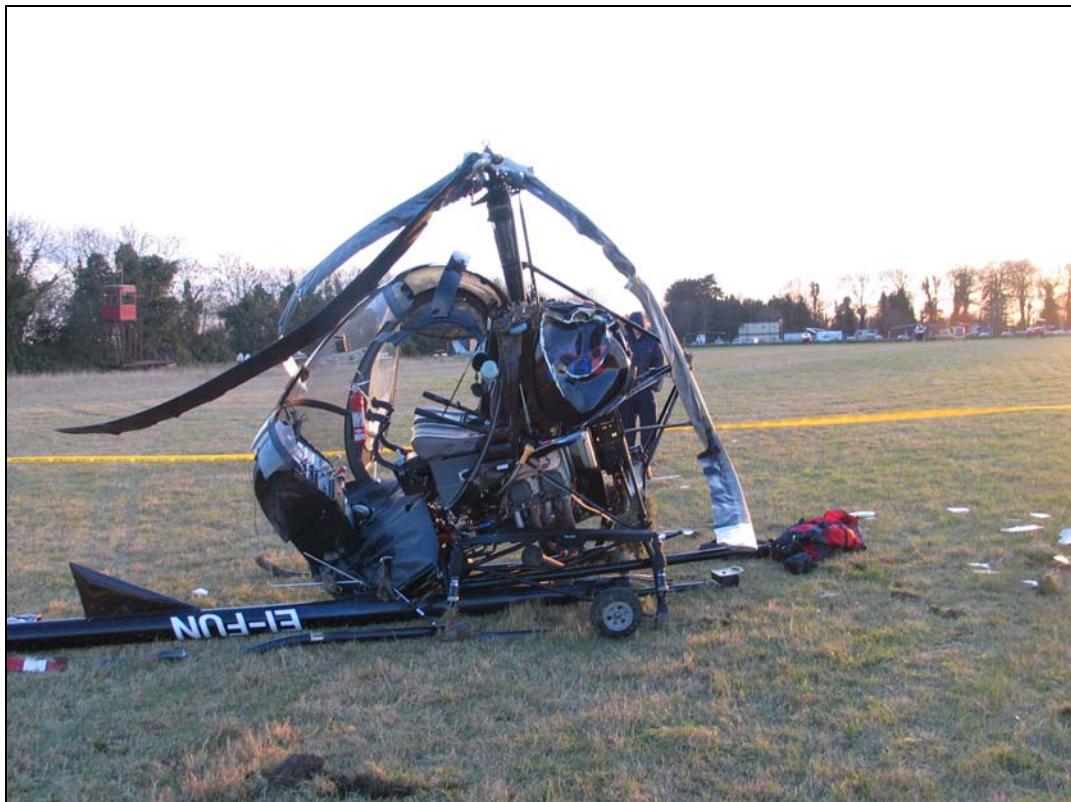
Fig 1.

In his submitted Accident Report Form, the Instructor recalled that, *“The angle of bank was much too steep. As the aircraft (helicopter) was banking left, the student pulled back on the cyclic to start the flare part of the manoeuvre. The helicopter was unable to hold altitude and the main rotor blades struck the ground. The front skid struck the ground and the helicopter rolled, coming to a stop in an upright condition (See Fig 1). The engine had stopped. I turned the switches and fuel off and we both exited the helicopter”*.

For the accident flight, the downwind segment of the run, terminated just short of an aircraft parking area and other aviation related facilities. If a helicopter were to experience an engine or control failure on the downwind segment, the pilot would have no clear run-off area to attempt a recovery. In addition, the selected training area is flanked on the north side by the main runway and to the south by a tree-lined hedgerow. The relatively confined nature of the selected operating area, coupled with the high ground speed experienced on the downwind segment of the manoeuvre, may have caused the student pilot to become tense on the controls, and ultimately this would have affected his sensitivity to control inputs.

This photograph shows where the helicopter came to rest, following the blade and skid contact with the ground, having completed 90° of the 180° turn and flare. The aircraft parking area and related aviation facilities as mentioned at 1.4.2 of the Report can be seen in the right-hand background. The boundary hedgerow can be seen on the left-hand side of the photograph.

2.1 The Irish Aviation Authority (IAA) should review the suitability of the designated helicopter training area's for dynamic low-level manoeuvres at Weston Aerodrome.  
**(SR 01 of 2005)**

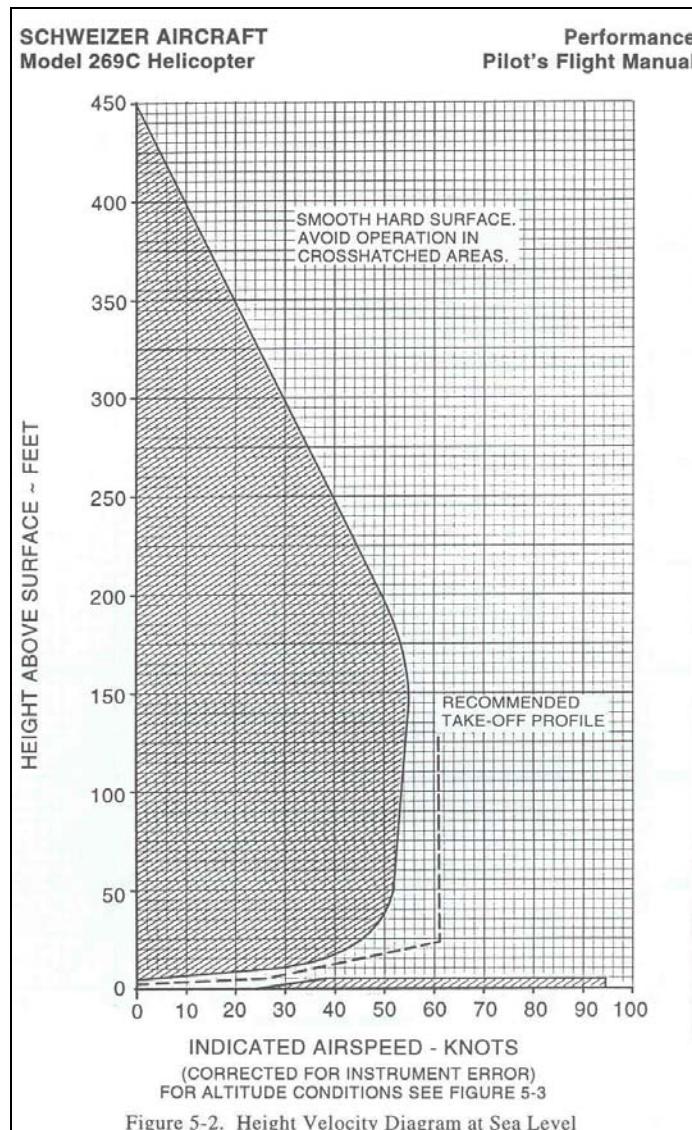
## Appendix A

For a turn and flare or flare and turn Quick Stop manoeuvre there is an additional factor relating to the safe clearance between the main rotor blade tips and the surface, especially at the point where the angle of roll (bank) is highest. The entry height to be chosen should be high enough to avoid danger to the tail rotor during the flare and the main rotor blades during banking, but low enough to stay out of the crosshatched or shaded areas of the height/velocity diagram (contained in the Flight Manual) throughout the manoeuvre. In addition, this height should be low enough that you can bring the helicopter to a safe hover during the recovery. An example of the Height Velocity Chart for a Schweizer 296C helicopter is presented as **Appendix A** to this report.

This graph assumes a zero wind condition
