FINAL REPORT

AAIU Synoptic Report No: 2005-013
AAIU File No: 2004/0066
Published: 20/06/05

Aircraft Type and Registration:	ATR 72 – 202, EI-RED
No. and Type of Engines:	2 x Pratt and Whitney PW 124B
Aircraft Serial Number:	373
Year of Manufacture:	1994
Date and Time (UTC):	15 December 2004 @ 10.47 hrs
Location:	Eastern end of Runway (RWY) 26 Galway Airport (EICM)
Type of Flight:	Scheduled Public Transport
Persons on Board:	Crew - 4 Passengers - 31 + 1 Child
Injuries:	Crew - Nil Passengers - Nil
Nature of Damage:	Nil
Commander's Licence:	Irish ATPL issued by the IAA
Commander's Details:	Male, aged 64 years
Commander's Flying Experience:	Approximately 21,000 hours, of which 3,000 were on type
Information Source:	The Operator, AAIU Incident Report Form submitted by Captain, Field Investigation.

SYNOPSIS

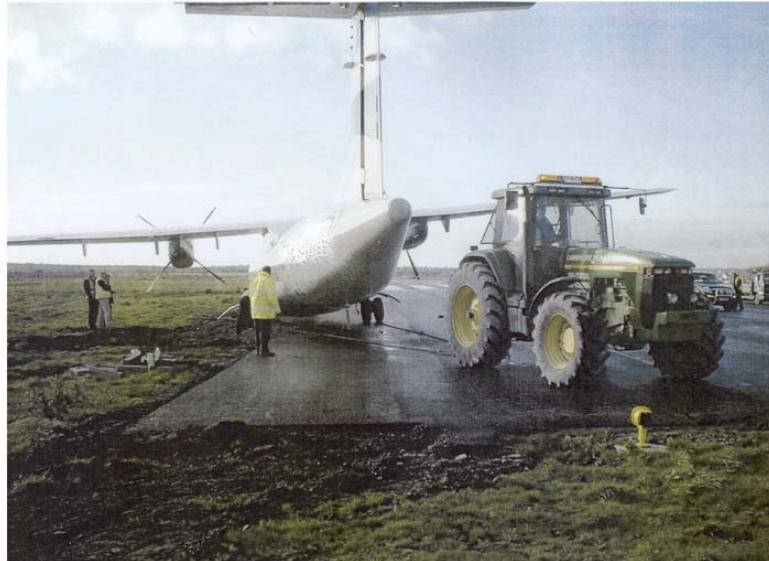
EI-RED exited the ramp through Taxiway Bravo and backtracked along the centreline of RWY 26 towards the displaced threshold³. On reaching the displaced threshold, the aircraft commenced a reversal of direction within the area between the displaced threshold and the end of the runway, by initially turning left off the centreline and then right. The turn was normal until approximately through 90° (right) when it was noticed by the PF that the turn was somewhat wide, but not excessively so. The turn was continued. Neither flight crew member was aware of a pavement excursion until it was felt that the aircraft was not turning normally, followed quickly by the LH MLG leaving the runway. The aircraft was immediately stopped and Air Traffic Control (ATC) was advised. The No. 1 engine was shut down, while the No. 2 engine was left in HOTEL mode (engine running with prop brake engaged). The Captain made a public address (PA) advising the passengers that the aircraft had left the runway and was stuck in situ. The passengers and crew made a normal exit from the rear port door and were ferried back to the terminal building. The Captain reported that the passenger's reaction was calm and that no injuries or trauma occurred. In addition, the Captain did not report any skidding or slipping, while performing the turn manoeuvre.

An inspection of the site determined that, as the aircraft's turn progressed through approximately 90° (facing south), the NLG departed the paved surface. As the turn continued west, the NLG tracked along the grass close to the runway edge. The LH MLG then left the paved surface by 0.5 of a metre (m) and continued for approximately 3m until the aircraft was stopped. No damage was caused to the aircraft or the undercarriage. Some wheel rutting damage was cause to the ground adjacent to the runway edge.

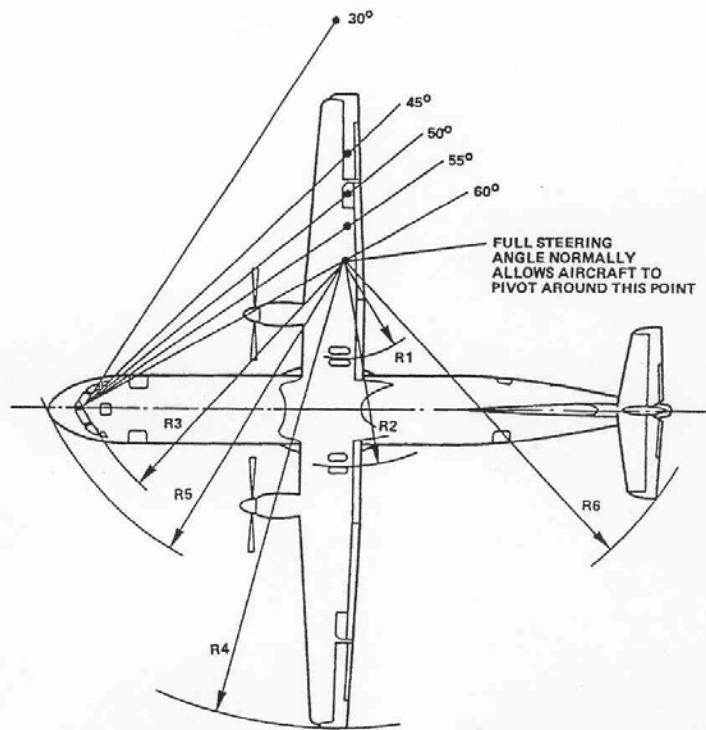
APPENDIX A

Chapter 4 of the ATR 72 Flight Crew Operational Manual (FCOM) provides information on airplane turning capability and manoeuvring characteristics. Section 4.2 provides a figure and table showing the turning radii (R), with no slip angle, for various steering angles ranging from 30° to 60° (**Appendix A**). R2 measures the turn radius, from the centre point of the turn radius to the outer main undercarriage wheel. R3 of the table measures the turn radius from the same pivot point to the nose wheel.

Table 1 below has been complied by the Investigation in order to bring parts of Appendix A and B together and calculates the minimum pavement width required for steering angles of 30°, 45°, 50°, 55° and 60°. These figures are referenced against the runway width at Galway (30m). The minimum pavement width required includes a safety margin of approximately 0.71m on either side of the 180° turn. Column A refers to the minimum pavement width required and Column B refers to the measured difference (on either side of the turn) between the minimum pavement width required and the actual runway width of 30m.

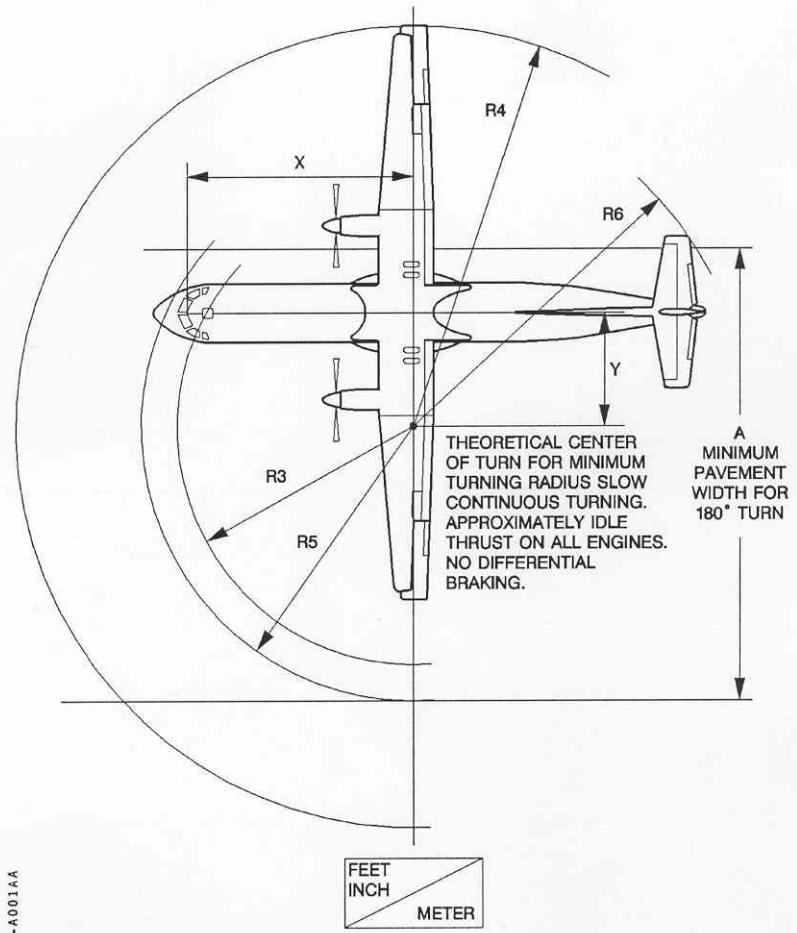
APPENDIX B

Additional information is provided in the FCOM with regard to turning capability on the ground (**Appendix B**). Using a 60° turning angle the minimum pavement width for an 180° turn is given at A as 21.40m.
