FINAL REPORT
SERIOUS INCIDENT

**to
ATR 42**

EI-CBK

AAIU Formal Report No: 2005-014
AAIU File No: 2003/0043
Published: 11 August 2005

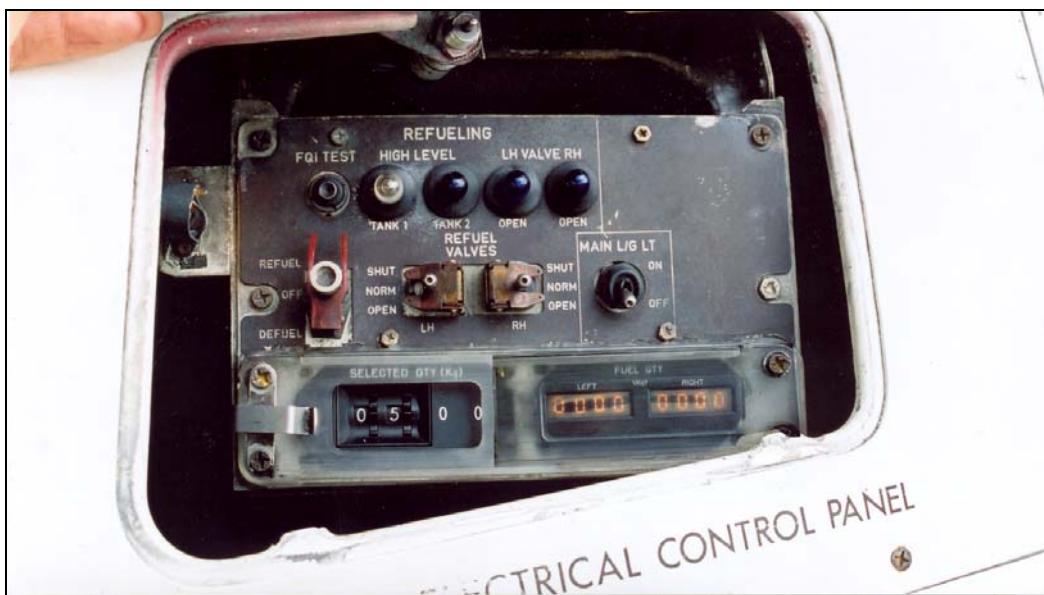
Photo 1

This shows the Electrical Refuelling Control Panel located in the RH Fairing when inspected at Shannon. The blue valve lights can be seen on top of the panel, just to the right of centre. Note the refuelling quantity pre-select at 500 kg in bottom right, and the LH and RH fuel gauges, indicating zero, at bottom right.²

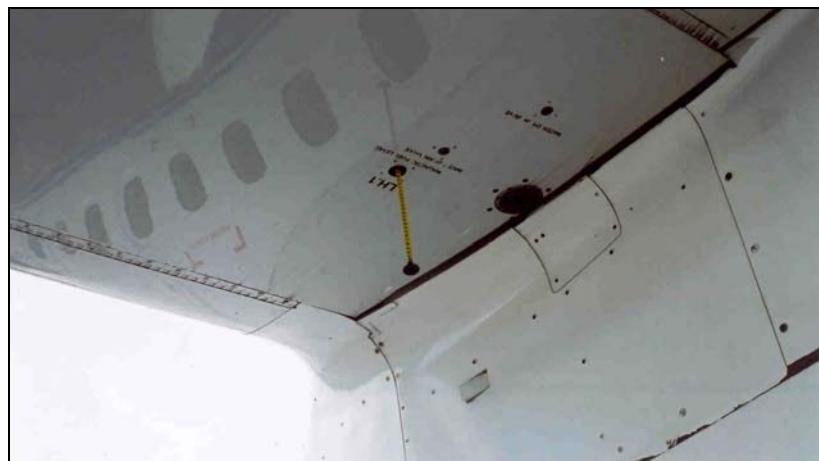
Photo 2

This shows the LH Inner Drip Stick deployed to read LH Fuel Tank contents at Shannon.

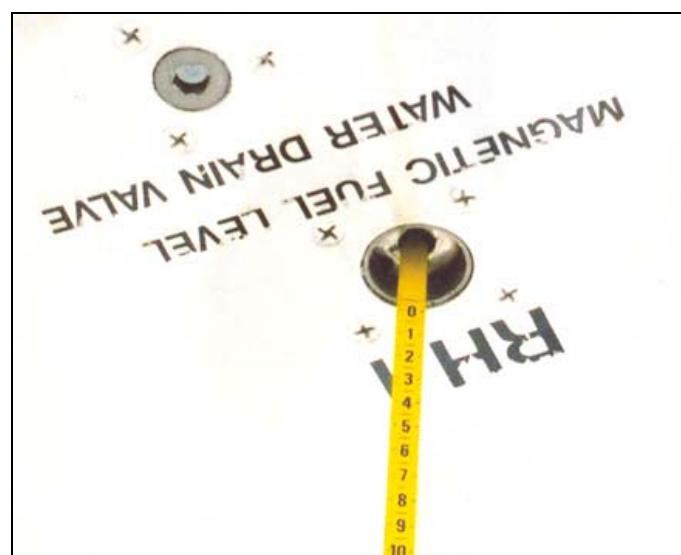
Photo 3

This shows the RH Inner Drip Stick indicating a reading of zero as recorded at Shannon after the incident.

The aircraft was inspected by the Investigation the day after the event. It was noted that the RH fuel tank was empty. This was measured by a dip check and confirmed by performing a physical drain of the tank. It was also determined that the LH tank contained 480 kg of fuel, by doing a drip check. Inspection of the Electrical Refuelling Control Panel in the fairing showed that the selected fuel quantity was 500 kg.

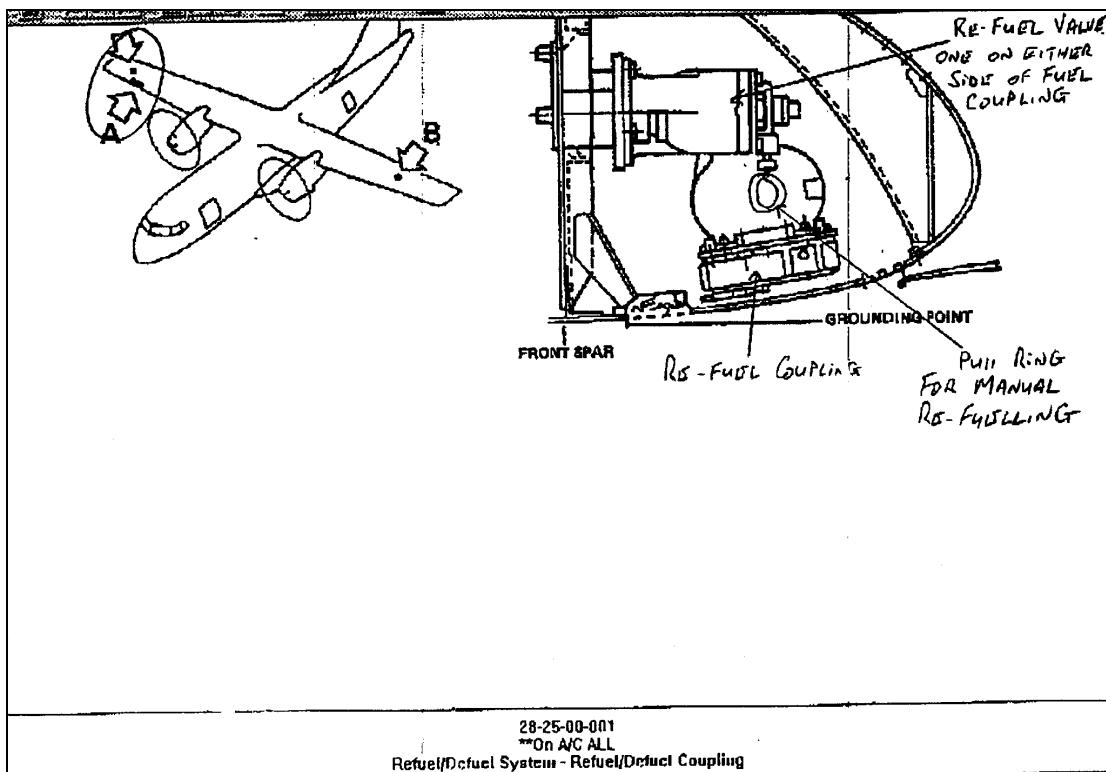
Annex D

The Investigation could not find, within the Operator's Flight Manuals or any other documentation, any diagrams which detail the location and operation of the manual Toggle Rings, located in the wing refuelling panel, which are used to manually open the refuelling valves. In Chapter 28 of the ATR 42 Maintenance Manual there is a diagram which shows the location of the refuelling point in the wing and also includes a section of the fuelling point and the pull triggers. A copy of this page, with hand written explanation notes, is reproduced in **Annex D**. It should be noted that the Maintenance Manual is not readily available to flight crews.

This is taken from Chapter 28 of the ATR 42 Maintenance Manual. Ref A on the left diagram shows the location of the pressure refuelling point which was used for refuelling of EI-CBK on the day of the incident. The gravity refuelling points (Ref B) were not used. The right diagram shows a section through the wing at the pressure refuelling point, and shows the triggers (pull ring) for opening the valve to the RH fuel tank.
