FINAL REPORT

AAIU Synoptic Report No: 2005-018

Aircraft Type and Registration:	B737-800, EI-CSA	
No. and Type of Engines:	2 x CFM 56-7B	
Aircraft Serial Number:	29916	
Year of Manufacture:	1999	
Date and Time (UTC):	21 July 2004 @ 13.40 hrs	
Location:	Approach to Skavsta Airport, Sweden	
Type of Flight:	Public Transport	
Persons on Board:	Crew - 6	Passengers - 184
Injuries:	Crew - Nil	Passengers - Nil
Nature of Damage:	None	
Commander's Licence:	Airline Transport Pilot's Licence	
Commander's Details:	Male, aged 38 years	
Commander's Flying Experience:	5,000 hours approximately (of which 1,500 were on type)	
First Officer's Flying Experience:	700 hours (of which 400 were on type)	
Information Source:	Reports received from the Operator and Pilots. AAIU Field Investigation.

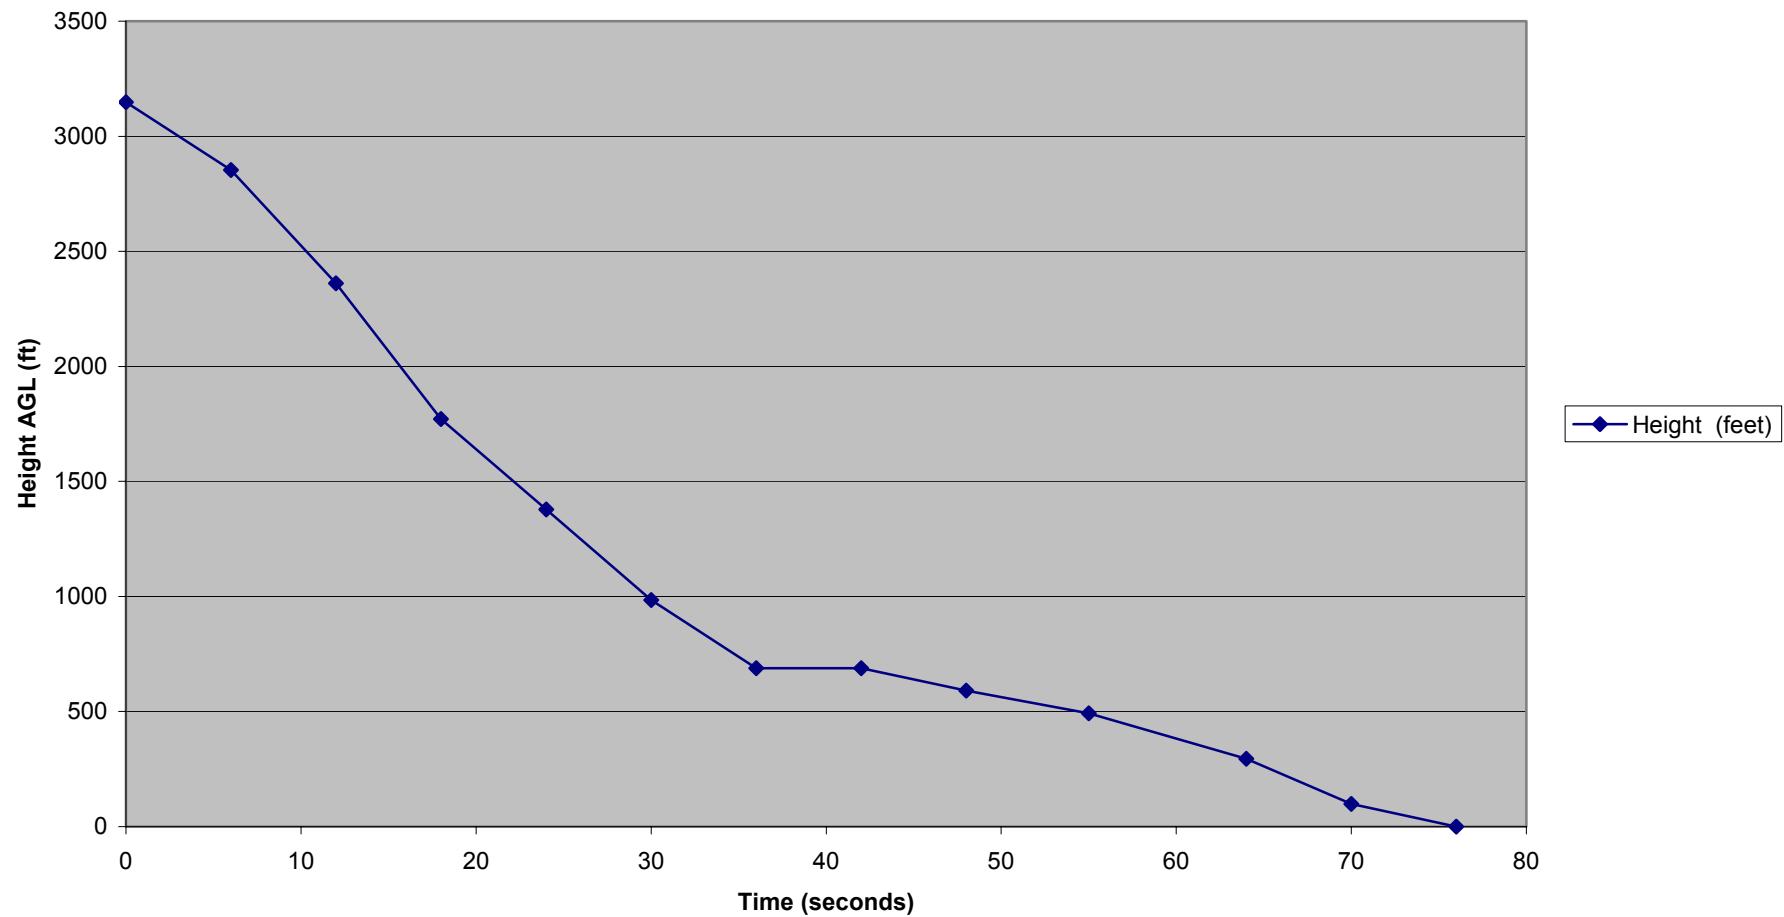
Appendix A SKAVSTA Radar Data

To assist with the investigation, a routine request was made to the Swedish AIB to retrieve the Radar and ATC Audio Tapes pertinent to this incident. The Accredited Representative (ACCREP) subsequently advised that he had ordered the required tapes from the Skavsta Airport Authorities. On 28 September 2004, Radar derived data (**Appendix A**) showing the last 3,000 feet of the approach was received from the ACCREP. Later, on 3 December 2004, a message was received from the ACCREP informing the AAIU that the ATC Audio tape was destroyed when the Skavsta Airport Authorities tried to copy it for the Swedish AIB. Thus, a potentially valuable source of primary information was lost to the investigation. This is regrettable.

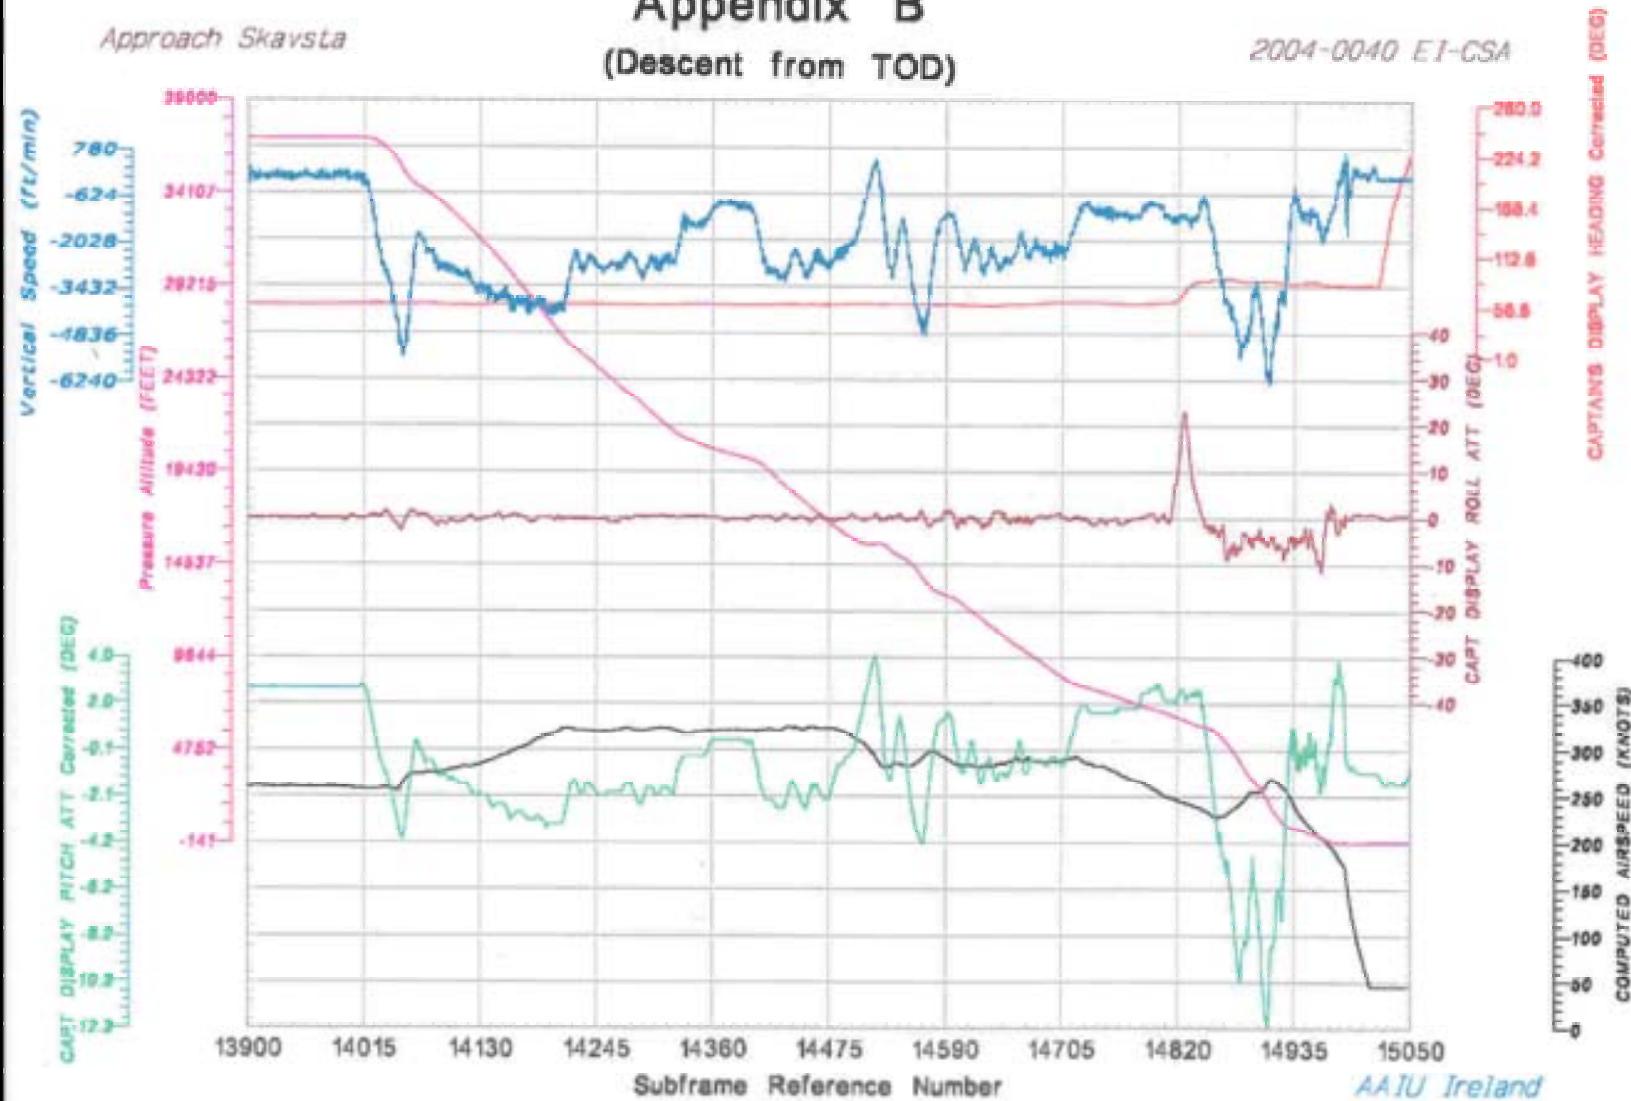
Appendix B
(Descent from TOD)

Nose down pitch reached 12.3° which, in turn, with the use of side slip contributed to excessive Rates of Descent (ROD), up to 6,200 fpm were recorded, and excessive speeds for flap deployment (**Appendix B and Appendix C**). These, in turn, led to GPWS alarms sounding which were ignored by the PF, as were the speed and height warning inputs from the PNF. All of the foregoing led to an unnecessarily high speed landing. In his written statement the PF attempted to address his behaviour over that fifteen minute period. He stated, *inter alia* "*I cannot understand what possessed me to continue the approach, I have replayed these events in my mind hundreds of times and, at no instance, do I arrive at the decision I took. I became fixated and lost sight of the big picture. It was only at such a late stage that the events taking place around me actually penetrated my mind; but by then I found myself in the landing roll*" and "*I cannot understand myself how it was possible for me to show such poor judgement. I can only imagine that certain personal stresses and tiredness affected my ability to think rationally. I do not offer this as an excuse but merely an insight into my deficiency for logical thought*".
