FINAL REPORT

AAIU Synoptic Report No: 2005-019

Aircraft Type and Registration:	Cessna 210J, EI-AWH	
No. and Type of Engines:	1 x Continental IO0520-J	
Aircraft Serial Number:	210-59067	
Year of Manufacture:	1969	
Date and Time (UTC):	9 May 2004 @ 18.29 hrs	
Location:	Cork Airport (EICK)	
Type of Flight:	Private	
Persons on Board:	Crew - 1	Passengers - 2
Injuries:	Crew - Nil	Passengers - Nil
Nature of Damage:	Port undercarriage damaged	
Commander's Licence:	Irish PPL	
Commander's Details:	Male, aged 47 years	
Commander's Flying Experience:	1,225 hours (of which 205 were on type)	
Information Source:	Station Manager, Cork Airport.

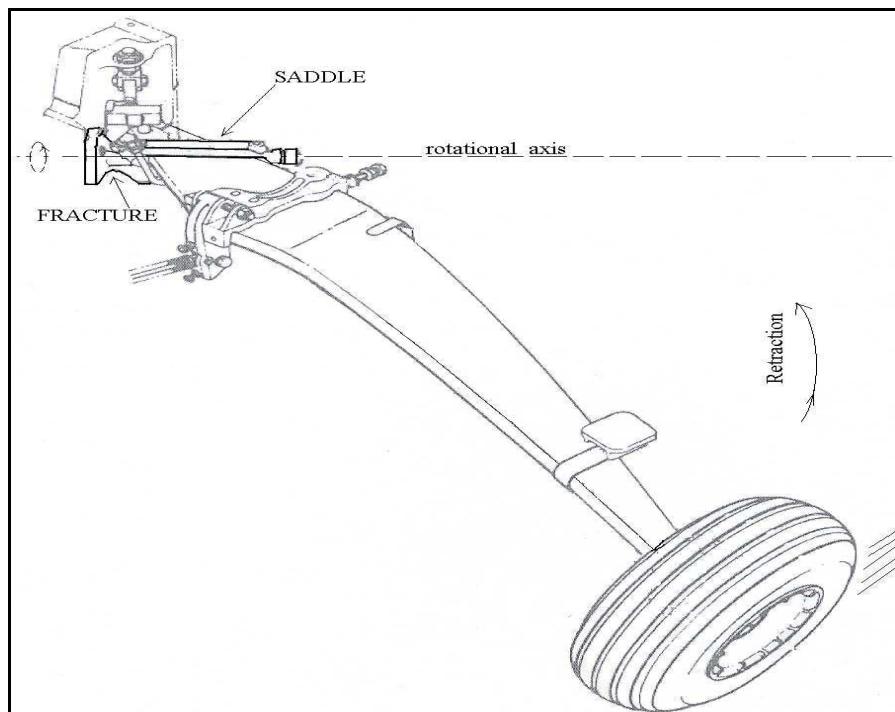
The aircraft was removed to the hangar area and jacked up. On inspection it was found that the port undercarriage saddle assembly P/N 1241423-1 had cracked and had broken up, which left the port leg dangling in flight. An inspection of the starboard saddle revealed, that there was a crack in the same area of the saddle, although the saddle had not fractured. (See Appendix A)

Sketch showing location of saddle in the LH undercarriage.

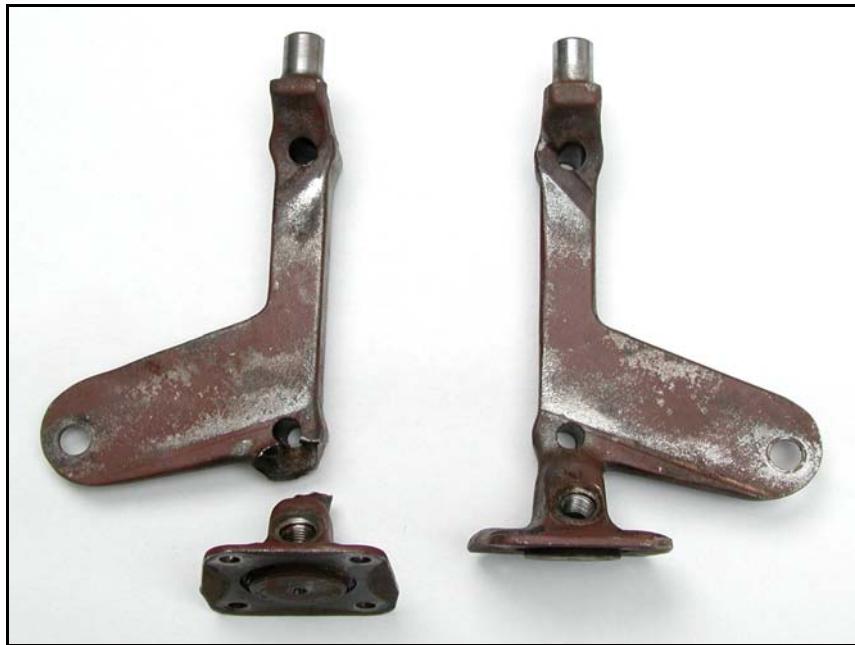
- * Failure of the LH saddle occurred through fatigue cracking.
- * There was no material or manufacturing defect associated with the fracture.
- * The RH saddle was cracked at a location corresponding to the area of initiation of the failure in the LH saddle.
- * Bruising/oxidation suggested that cracking was present for a considerable time prior to the final failure.

The port main landing gear saddle was found fractured due to fatigue failure.

The 7.5 inch long fractured LH Saddle Assembly P/N 1241423-1 (Forging P/N 1241423-497) and cracked RH Saddle Assembly P/N 1241423-2 (Forging P/N 1241423-498).

1. The manufacturer should ensure that aircraft components, which have been modified or improved, be identified by a dash number added to the original part number. **(SR 18 of 2005)**

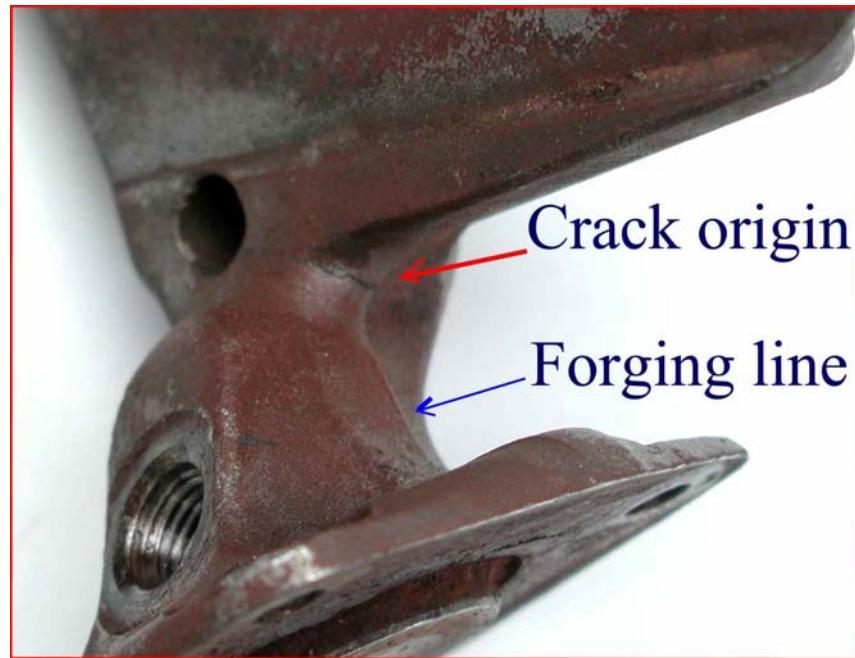
The AD also makes reference to replacing saddles *"with improved saddles of the same part number"*. The improved saddle is identified by having a shot peened surface, smoothed out radii and has the parting line 0.1 inch step of the forging removed. (See Appendix B)

The LH saddle which fractured had a smooth radius at the fracture area. The RH saddle had a forged 0.1 inch step line and obviously came from a different batch. It was not possible to determine if these saddles were installed at aircraft assembly or whether one or both were installed at a later date. The fact that there were improved saddles in circulation, at different times and with the same part number as the earlier design, compounds the problem.

Above: Photo of cracked RH saddle showing the original forging line.
