FINAL REPORT

AAIU Synoptic Report No: 2005-021

Aircraft Type and Registration:	A/C No 1: Cessna F 172M, EI-GSE A/C No 2: Cessna 172M, EI-STT (Parked)
No. and Type of Engines:	A/C No 1: 1 x Avco Lycoming O-320-E2D A/C No 2: 1 x Avco Lycoming O-320-E2D
Aircraft Serial Number:	A/C No 1: 1105 A/C No 2: 172-66228
Year of Manufacture:	A/C No 1: 1974 A/C No 2: 1975
Date and Time (UTC):	05 March 2005 @ 11.00 hrs approx
Location:	Weston Aerodrome (EIWT)
Type of Flight:	Private
Persons on Board:	A/C No 1: Crew - 1 Passengers - Nil A/C No 2: Crew – Nil Passengers – Nil
Injuries:	A/C No 1: Crew - Nil
Nature of Damage:	A/C No 1: Starboard wingtip damaged A/C No 2: Rudder damaged
Commander's Licence:	A/C No 1: Private Pilots Licence (PPL)
Commander's Details:	Male, aged 41 years
Commander's Flying Experience:	177 hours, of which 83 were on type
Information Source:	Aircraft Incident Report submitted by Pilot. AAIU Field Investigation

SYNOPSIS

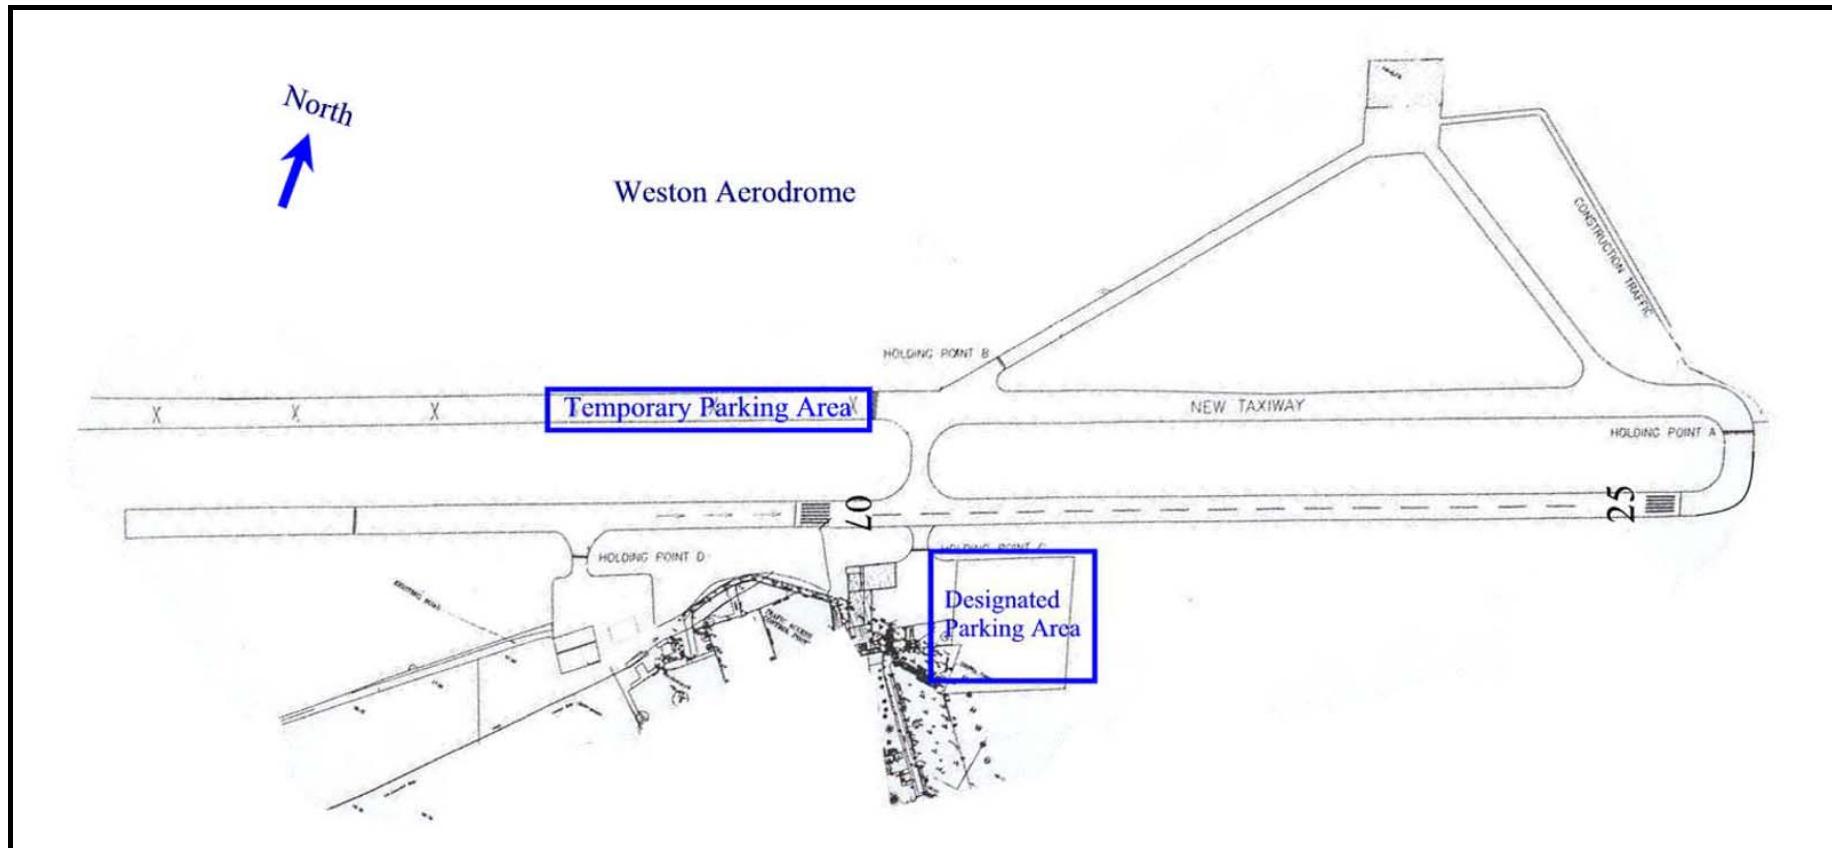
Appendix A

The Pilot hired EI-GSE from a Weston based flight training school for the purpose of conducting local circuits and a navigational exercise (NAVEX). The aircraft was parked at an area referred to as the, “western taxiway extension”. A general runway/taxiway map is presented as **Appendix A** to this report.

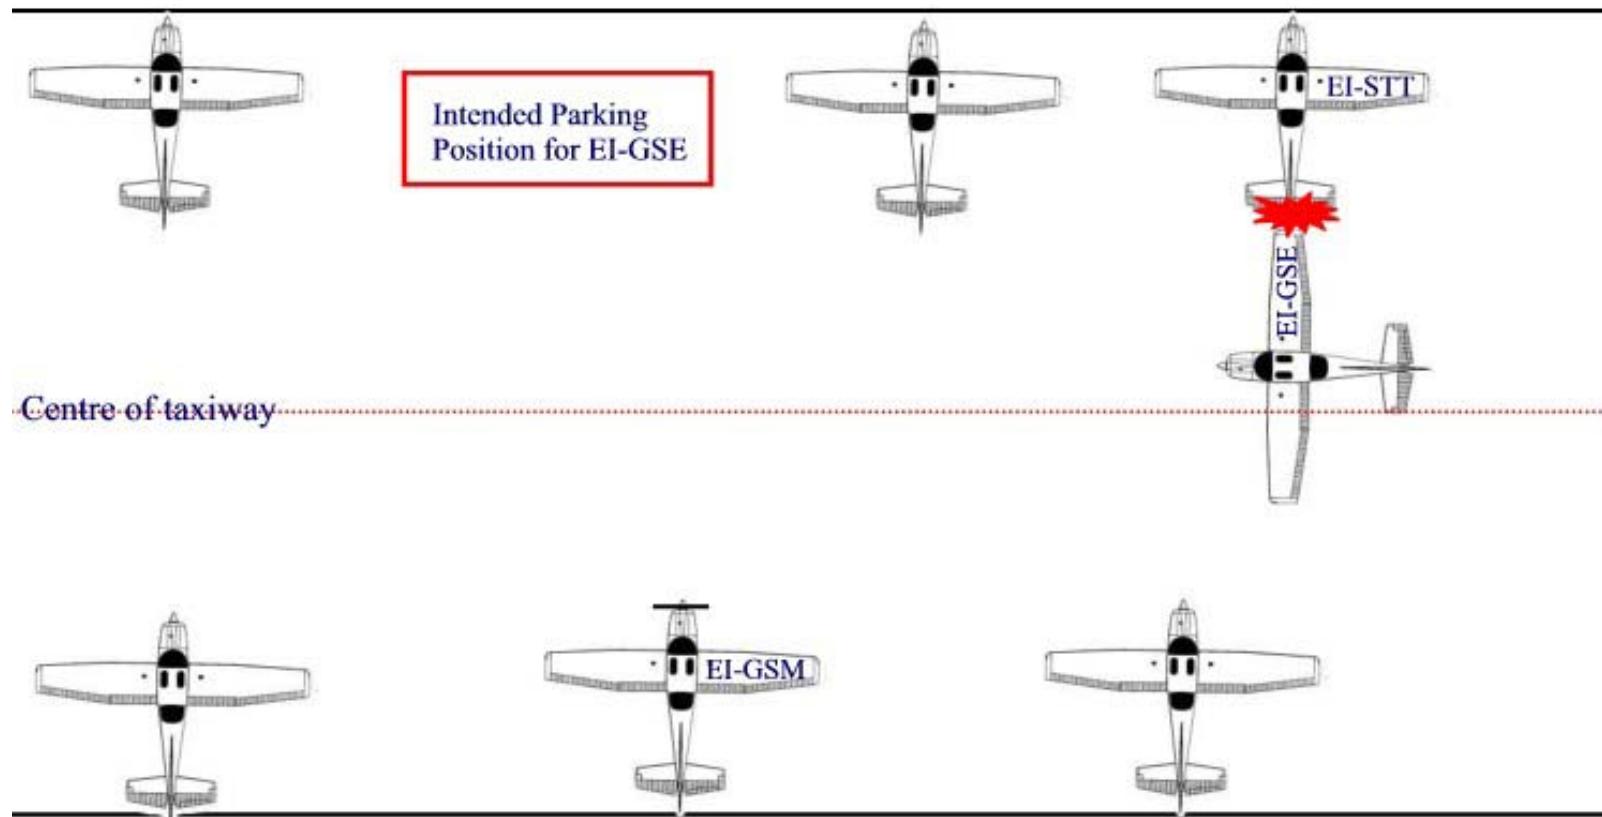
Appendix B

While manoeuvring EI-GSE along the taxiway, another aircraft (EI-GSM), which was parked on the left hand side of the temporary parking area (**See Appendix B**) called for taxi and advised the Aerodrome Flight Information Service (AFIS) that he had EI-GSE in sight. The AFIS requested EI-GSM to hold its position for the taxiing EI-GSE. EI-GSM acknowledged this request and held position.

On approaching the entrance to the temporary parking area, the Pilot of EI-GSE observed, ahead of his position, a number of parked aircraft on either side of the parking area. The aircraft on the left hand side were facing nose out to the centre of the taxiway, while the aircraft on the right hand side had their tails pointing back towards the centre of the taxiway. Amongst the line of aircraft parked along the left hand side, the Pilot reported seeing (in his 10 o’clock position) EI-GSM parked with its engine running. The Pilot informed the investigation that; *“Conscious of the presence of this aircraft with engine running, I manoeuvred EI-GSE right of the centre of the taxiway extension, in order to maintain additional separation from the started aircraft”.*

The parking area did not comply with the minimum separation distances established in Annex 14 and AML No 003, as the aircraft stand taxi lane centre line clearance to the object was significantly less than 12 metres (ICAO) and 15 metres (IAA).

Temporary Aircraft Parking Area Western Extension to Northern Taxiway

Approximate position of
aircraft at time of impact

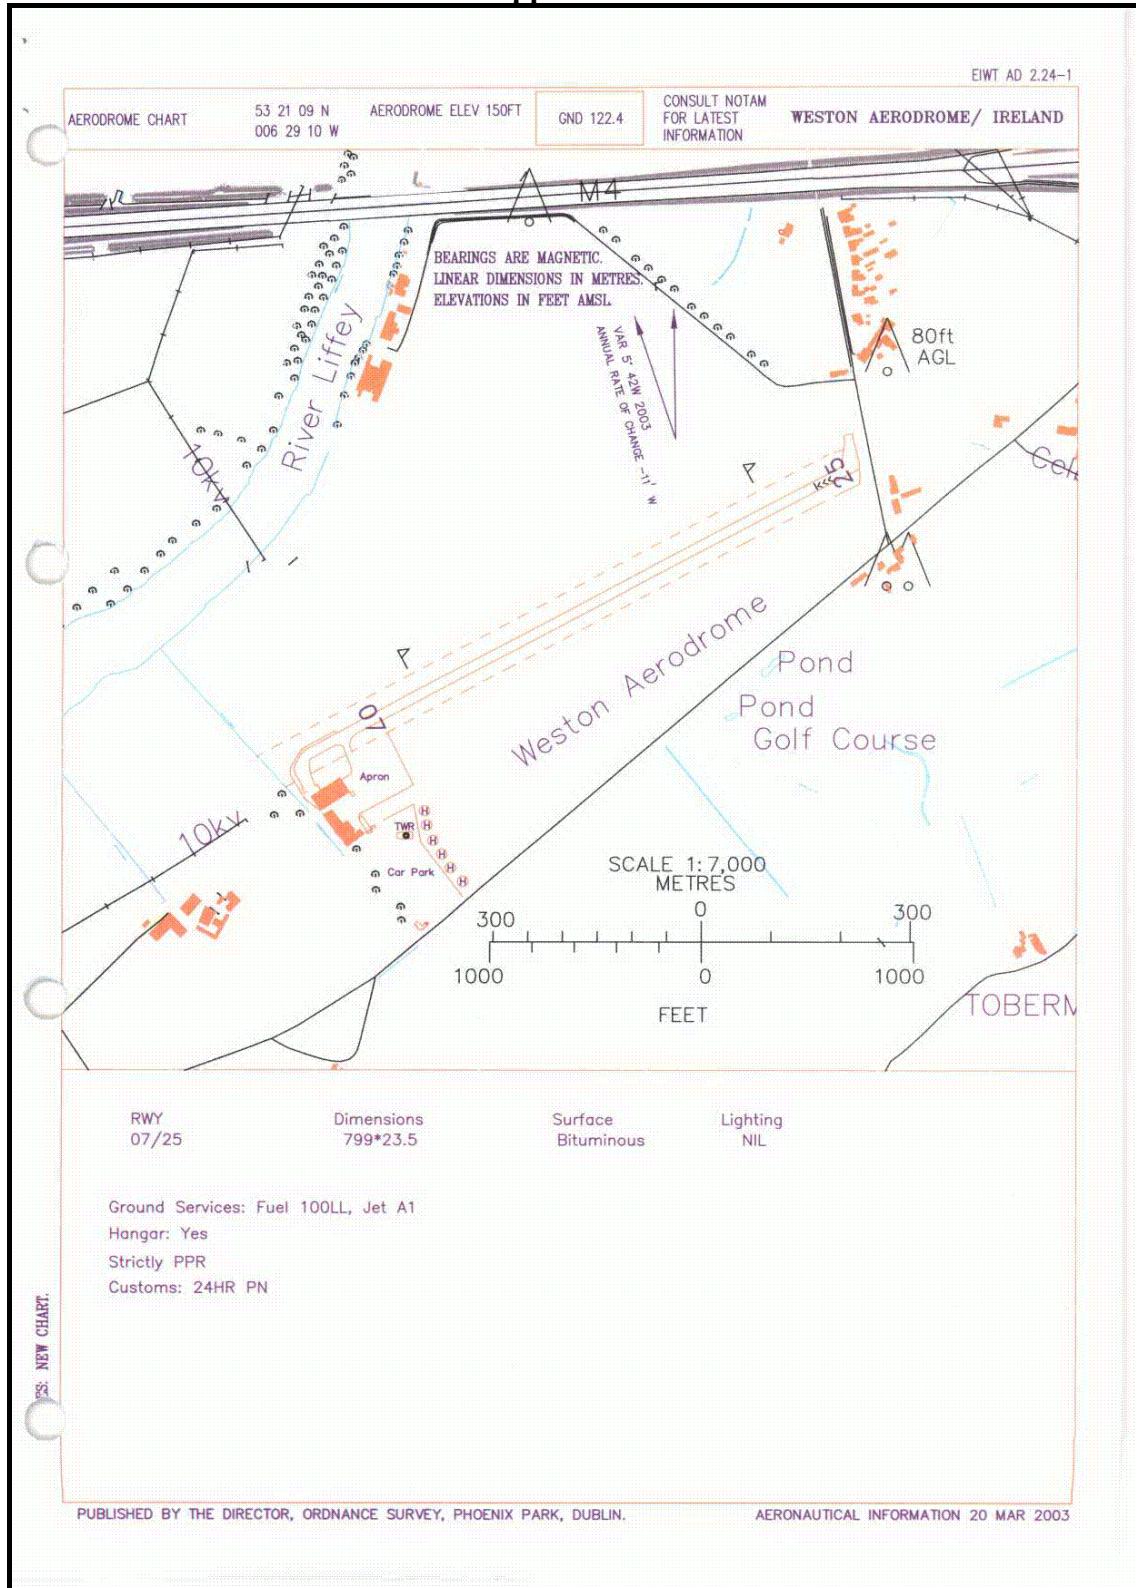
Appendix C

Under Part 3 – Aerodromes (AD), a wide variety of detailed information is provided on Aerodromes/Heliports. The Weston Aerodrome Chart (EIWT AD.2.24-1), which was in force at the time of this particular event, is presented as **Appendix C** to this report. The Chart shows, among other things, a single runway (RWY) 25/07, which measures 799 metres in length and 23.5 metres in width. In addition, the chart shows a taxiway to a parking apron and a number of helicopter parking stands. The recently constructed facilities are not portrayed on this chart.

The AIP for Weston Aerodrome did not include the new fixed aviation facilities that were present at Weston at the time of this event, as such facilities had not been sanctioned for use by the IAA, nor had they even been proposed for approval by the IAA.
