AAIU Synoptic Report No:2005-022

Aircraft Type and Registration:	Rutan Long-EZ, EI-CMR
No. and Type of Engines:	1 x Avco Lycoming O-235 flat four Piston engine
Aircraft Serial Number:	Homebuilt
Year of Manufacture:	2003
Date and Time (UTC):	28 June 2003 @ 15.30 hrs
Location:	Bunmahon, Co. Waterford.
Type of Flight:	Private, Experimental
Persons on Board:	Crew-1 Passenger-1
Injuries:	Crew-Nil Passenger-Nil
Nature of Damage:	Surface scratches to wings and fuselage
Commanders Licence:	CPL
Commanders Age:	Male, aged 36 years
Commanders Flying Experience:	1,193 hours of which 7 hours were on type.
Information Source:	Waterford ATC and Tramore Gardai. AAIU report form submitted by Pilot

SYNOPSIS

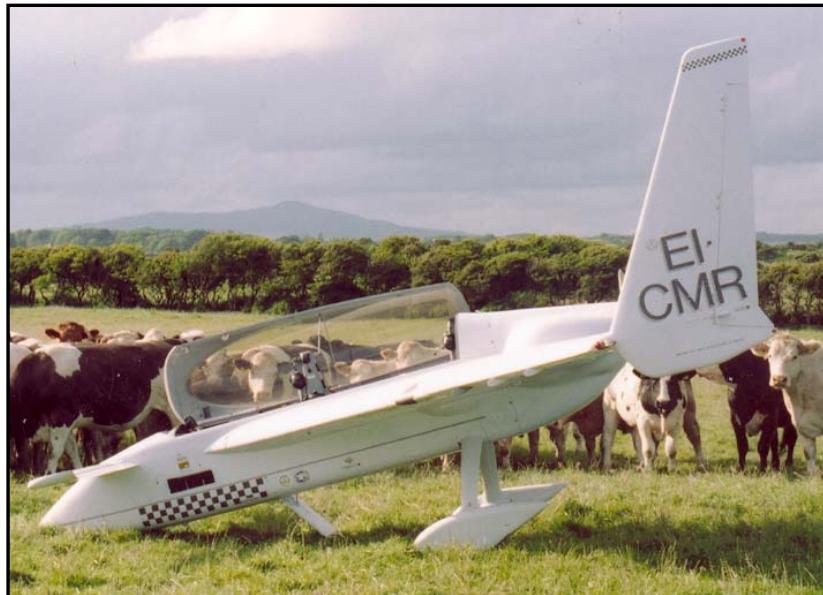
There was no apparent structural damage to the aircraft with only slight abrasions to the paintwork. There was minor non-structural damage to the underside of the airframe, the top and bottom surfaces of both wings and the undercarriage fairings. The propeller was also damaged by the electric wire fence.

The aircraft, with its nose undercarriage retracted, following its forced landing in a field at Bunmahon, Co.Waterford.
