FINAL REPORT

AAIU Synoptic Report No: 2005-024
AAIU File No: 2004/0058
Published: 14/11/05

Aircraft Type and Registration:	Robinson R44 Raven 2, G-IVEN	
No. and Type of Engines:	1 x Lycoming IO-540-AE1A5	
Aircraft Serial Number:	10442	
Year of Manufacture:	2004	
Date and Time (UTC):	2 November 2004 @ 14.30hrs	
Location:	One mile east of Cork Airport	
Type of Flight:	Private	
Persons on Board:	Crew - 1	Passengers - none
Injuries:	Crew - Nil	Passengers - Nil
Nature of Damage:	Nil	
Commander's Licence:	UK PPL (H)	
Commander's Details:	Male, aged 31 years	
Commander's Flying Experience:	106 hours, of which 25 were on type	
Information Source:	Pilot contacted AAIU

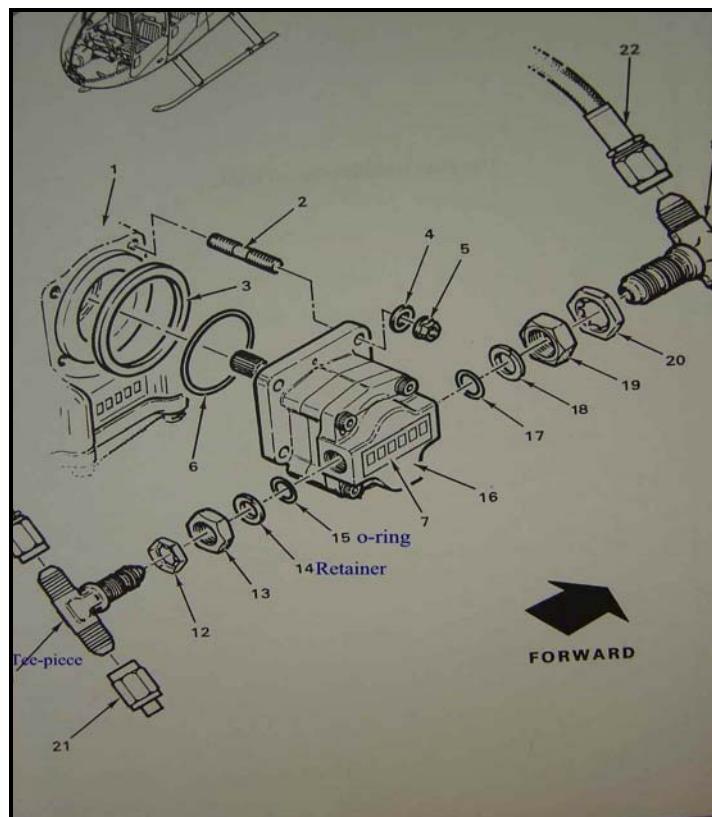
APPENDIX A

The engineer detected that the leak was coming from a tee-piece union on the output side of the hydraulic pump. He removed the union (see drawing of pump in **Appendix A**) and noted that the O-ring retainer (Part No. MS 28773-04) had a ring mark around it, indicating that the associated union nut (Part No. D452-6) was tightened too far up the union and distorted the retainer. The O-ring was not damaged but had a distortion in the same location as the retainer. Replacing the retainer rectified the defect.

The helicopter manufacturer advised that the retainer (which seats the O-ring seal) had not been installed properly at helicopter manufacture. The manufacturer could not visually inspect the retainer when installing the tee fitting in the pump, as after installation the retainer is hidden. The manufacturer depended solely on a leak check with normal system pressure after assembly to verify that the installation was correct.

The hydraulic system pressure loss was due to faulty installation of a retainer ring at the output of the hydraulic pump during manufacture.

The manufacturer revised procedures to visually inspect the retainers and O-ring seals to verify that the assembly is correct at sub-assembly stage before the fittings are installed in the final assembly.

It is recommended that the manufacturer should issue a Servicing Instruction detailing the correct installation procedure for the hydraulic system retainer and O-ring seal assemblies.
(SR 23 of 2005)
