FINAL REPORT

AAIU Synoptic Report No: 2005-025
AAIU File No: 2004/0028
Published: 21/11/05

| Aircraft Type and Registration: | Thruster TST Mk1 Microlight, G-MTKD |

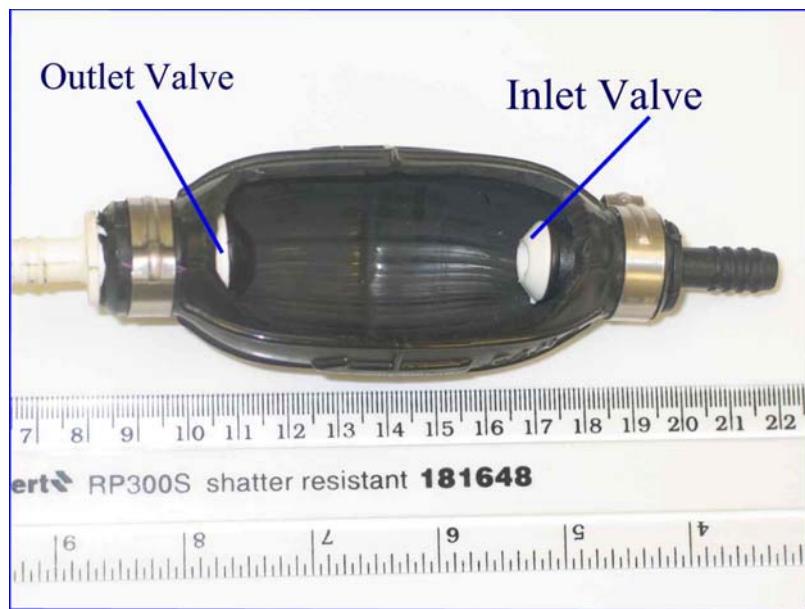
APPENDIX A

The Thruster TST Mk1 is a two seat 3 axis microlight with a maximum all up weight (MTOW) of 361 kg and is manufactured in the UK. The fuel supply system for the Rotax 503 engine incorporates a primer bulb, which is used for starting the engine from cold (See Appendix A). The fuel enters the bulb at one end through a non-return valve (which consists of a small plastic or steel ball at the inlet to the bulb). When the bulb is squeezed the ball blocks the inlet and at the same time the fuel is forced out through the valve at the other end and up to the engine.

In June 2002, an Airworthiness Directive (AD) was issued by another microlight manufacturer, which related to a problem with the fuel primer bulb fitted to some engines. The primer bulb outlet valve is held in place by a snap-in plastic ring. If the snap-in ring detaches, the valve can float around inside the primer bulb and block the outlet in a random manner, causing fuel starvation to the engine. The AD outlines a process of locking the snap ring with locking wire.

Some microlights do not require a primer bulb to be fitted in the fuel supply line to prime the engine, particularly if the supply line to the engine is short. If not fitted, some owners turn the propeller prior to starting. The danger of the ball blocking the outlet fuel supply was considered sufficient to require an Airworthiness Directive and, in one case, a Service Bulletin to be issued to cover this malfunction. Other operators have installed a flexible bypass line to the primer bulb but, if not operated properly, this may defeat the whole purpose of the primer system. In this incident, the inlet ball came loose due to wear and found its way up to the outlet of the primer bulb.

The inlet ball valve of the primer bulb came loose due to wear and found its way up to the primer bulb outlet.

The inlet ball valve blocked the supply of fuel to the engine resulting in engine fuel starvation and engine stoppage.

Cut-away view of similar type of Primer Valve showing the inlet and outlet snap-in rings which retain the ball valves in place.

It is recommended that the aircraft manufacturer require that the primer bulb be replaced every 300 flying hours or two years, whichever comes first. [\(SR 24 of 2005\)](#)
