FINAL REPORT

AAIU Synoptic Report No: 2005-026

Aircraft Type and Registration:	Islander BN-2B-26, EI-CUW
No. and Type of Engines:	2 x Avco Lycoming O-540-E4C5
Aircraft Serial Number:	2293
Year of Manufacture:	1998
Date and Time (UTC):	16 June 2004 @ 17.05 hrs
Location:	Weston Aerodrome
Type of Flight:	Ferry Flight
Persons on Board:	Crew - 1 Passengers - Nil
Injuries:	Crew - Nil Passengers - Nil
Nature of Damage:	Starboard Aileron mass-balance damaged.
Commander's Licence:	CPL
Commander's Details:	Male, aged 37 years
Commander's Flying Experience:	6,461 hours (of which 1065 were on type)
Information Source:	Operator

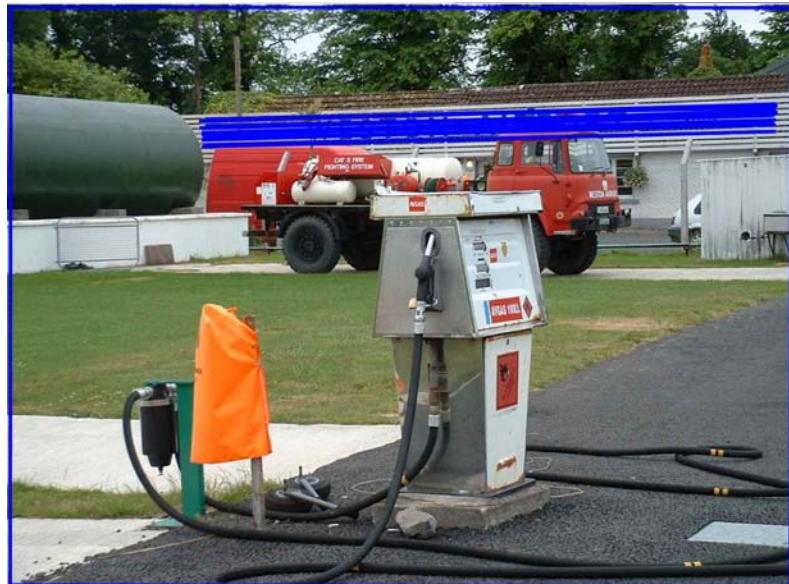
APPENDIX A

The Avgas fuel storage installation at this aerodrome consisted of an overground fuel tank with an underground feed pipe to a standard forecourt petrol dispenser (**See Appendix A**). The dispenser is sited at the edge of a tarmacadam ramp, adjacent to the aircraft parking area. The fuel outlet from the dispenser feeds an adjacent fuel filter and from there, to the refuelling nozzle via a 30 metre hose. A fire extinguisher is available on site. There were inadequate markings on the ground to warn personnel that they were in the vicinity of a dangerous substance.

4.1 Airport Management should seek urgent advice from the Airworthiness Department of the IAA on the current safety standards applicable to Avgas dispensers at Airports.
[\(SR 25 of 2005\)](#)
