FINAL REPORT

AAIU Synoptic Report No: 2006-003
AAIU File No: 2005/0014
Published: 13/03/06

Aircraft Type and Registration:	Medway Eclipser 912 Microlight EI-CTC
No. and Type of Engines:	1 x Rotax 912
Aircraft Serial Number:	158/137
Year of Manufacture:	1999
Date and Time (UTC):	5 March 2005 @ 1400hrs
Location:	Stradbally, Co. Laois
Type of Flight:	On ground
Persons on Board:	Crew - 1 Passengers - Nil
Injuries:	Crew - Nil Passengers - Nil
Nature of Damage:	Collapse of starboard undercarriage and propeller damage
Commander's Licence:	UK PPL(M)
Commander's Details:	Male, aged 39 years
Commander's Flying Experience:	260 hours, all on microlights.
Information Source:	National Microlight Association of Ireland

The microlight aircraft's undercarriage collapsed whilst the aircraft was being taxied at a private airfield near Stradbally, Co.Laois.

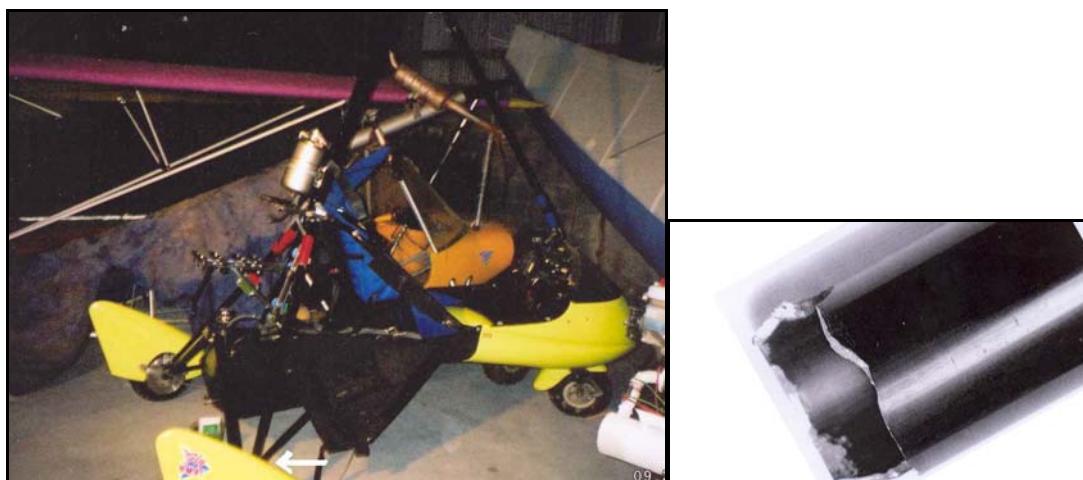
Close examination of the undercarriage revealed that the cause of the failure was due to the draglink pulling out of its anchoring bolt that attaches it to the base tube. This caused the main gear and suspension to bend backwards causing the trike to roll over on its side and the propeller to hit the ground. The suspension arm was also damaged.

- There was evidence of rubbing (polishing/bruising) in and around the holes at both ends of the strut.
- In addition there was rubbing/scoring on the internal surface around the failed end of the strut. Some of this appeared fresh and some appeared older.
- The fracture features throughout were indicative of overload failure. However, areas that were oxidised and rubbed/bruised suggest that failure occurred progressively but that it was initiated by some overloading event.
- There was no indication of any inherent defect in the aluminium associated with the failure.

The draglink detached from the starboard wheel due to overload failure causing the starboard undercarriage to rotate rearwards and causing the propeller to strike the ground.

A trike microlight aircraft similar to EI-CTC. The arrow indicates the location of the starboard drag link. The RH photo shows the fractured end of the drag link.

4.1 The manufacturer should issue a Service Bulletin to all operators to have an examination of the draglink securing holes conducted at regular flying hour/calendar times. **(SR 01 of 2006)**
