## FINAL REPORT

**AAIU Synoptic Report No: 2006-012**  
**AAIU File No: 2005/0030**  
**Published: 24/7/06**

<b>Aircraft Type and Registration:</b>	WESTWIND 2 (1124A), N639AT
<b>No. and Type of Engines:</b>	2 x Garrett TFE 731 SER
<b>Aircraft Serial Number:</b>	308
<b>Year of Manufacture:</b>	1980
<b>Date and Time (UTC):</b>	8 June 2005 @ 13.05 hrs
<b>Location:</b>	Shannon Airport, Co. Clare, Ireland
<b>Type of Flight:</b>	Air Ambulance Flight
<b>Persons on Board:</b>	Crew - Two      Passengers - Five
<b>Injuries:</b>	Crew - Nil      Passengers - Nil
<b>Nature of Damage:</b>	Damage to LH wing de-icing boot and port engine fan blades
<b>Commander's Licence:</b>	US FAA ATPL
<b>Commander's Details:</b>	Male, aged 44years
<b>Commander's Flying Experience:</b>	7,136 hours, of which 1,900 were on type
<b>Information Source:</b>	Station Manager, Shannon Airport AAIU Field Investigation.

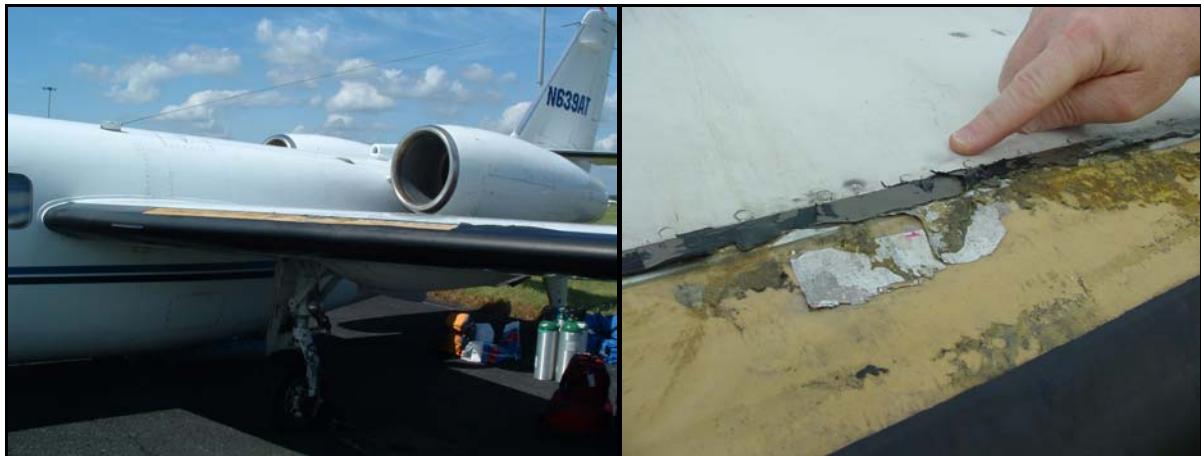
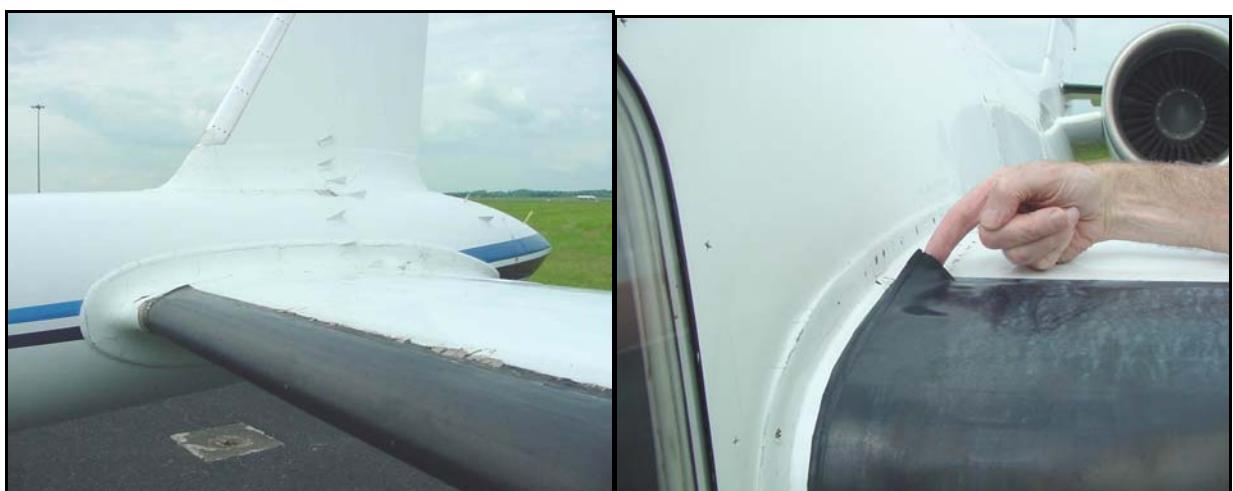
## APPENDIX A

The Investigation inspected the aircraft at Shannon Airport on the day following the incident. A 6 ft 6 in length of the LH wing boot had torn away and was missing (see **Appendix A**). 50% of the No.1 engine fan blades were damaged. The conductive edge sealer was in poor condition and areas of the boot had lifted or bubbled badly. A subsequent boroscope inspection of the engine did not detect any internal damage to the engine. Pieces of silver tape were found stuck to the leading edge of the wing where the portion of boot tore off. The Operator had purchased the aircraft in 2004. At Shannon a boroscopic inspection was conducted on the engine and engine fan blades repaired before the aircraft was flown back to the USA on an FAA ferry permit. The Investigation made a request to the Operator by E-mail that the removed de-icing boot should be returned to the boot manufacturer for testing along with an adhesive test of the starboard de-icing boot. However, neither test took place as the Operator said that he did not receive the request. The boots came off in pieces and were discarded.

No information was provided to the Investigation as to the age of the de-icing boots. As the photos at **Appendix A** show, both port and starboard wing boots were in poor condition. The length of boot which tore away revealed that very little of the adhesive cement had adhered to the wing surface. In addition, silver "high speed" adhesive tape was used to fill the skin contours. The aircraft manufacturer recommends the use of an aircraft structure filler for this purpose.

- (1) Insufficient/poor bonding between the boot material and the surface of the wing leading edge caused portion of the port wing de-icing boot to depart.
- (2) There was evidence that the boots had been poorly maintained in service.

Top LH photo shows length of de-icing boot torn from the aircraft in flight. Top RH photo shows close up of fillers used during installation of de-icing boot. Bottom photos illustrate many areas of lifting and wrinkling of boot material on both port and starboard wings.
