AAIU Synoptic Report No: 2006-014

AAIU File No: 2005/0039

Aircraft Type and Registration:	Enstrom F-28A, G-BBHE
No. and Type of Engines:	1 x Lycoming HIO-360-C1A
Aircraft Serial Number:	153
Year of Manufacture:	1973
Date and Time (UTC):	28 June 2005 @ 10.15 hrs
Location:	Fethard, Co. Tipperary
Type of Flight:	Private
Persons on Board:	Crew - one Passengers - one
Injuries:	Crew - Nil Passengers - Nil
Nature of Damage:	Complete tail rotor section torn away. Main blades destroyed on landing. Undercarriage damaged on landing.
Commander's Licence:	UK PPL(H)
Commander's Details:	Male, aged 62 years
Commander's Flying Experience:	1400 hours of which, 400 were on helicopters.
Information Source:	Aircraft Owner. AAIU Field Investigation.

SYNOPSIS

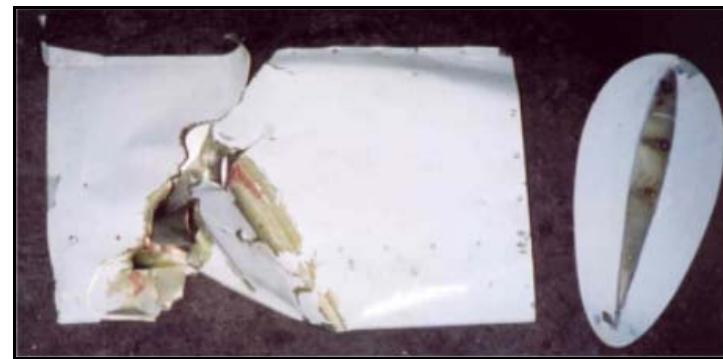
Witnesses on the ground heard the bang and saw pieces falling from the helicopter. Several parts of the tail section including three sections of the R.H. stabilizer (**Appendix A**) were subsequently found in a quarry 0.5 miles before the final landing area. Tail rotor blade strike marks were found on the underneath surface of the larger of the RH stabiliser sections and on the inner top surface of the smaller section. With the exception of the tail rotor drive shaft and the RH section of the stabilizer spar, which were, despite regular searches, never located, the rest of the tail section including airframe and dynamic parts were all located within 20 metres of the helicopter landing area. The cylindrical stinger tube with part of the tail boom attached was found 18 metres to the right of the helicopter. A large dent, 15 inches from the tube end was compatible with a strike from one of the main blades.

Three sections of the R.H. stabilizer were found in a quarry 0.5 miles before the final landing area. The location coincides with that at which the loud bang was heard. A dent in the stabilizer airfoil matches one of the tail rotor blades. The stabilizer departing the helicopter and striking the tail rotor therefore initiated the sequence of events that followed.

Three sections of the RH stabilizer found 0.5 miles from the landing site

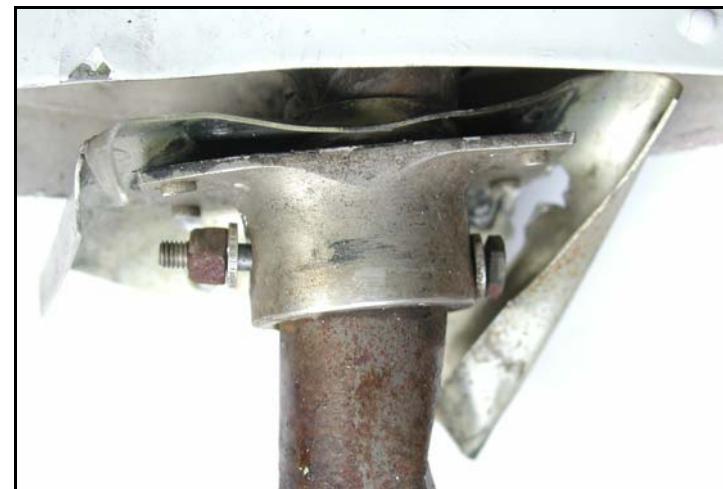
The spar was held in the fuselage fitting by means of a nut, bolt and washers at its LH side. It was observed that the nut was tightened to the end of the threaded portion of the bolt, and it appeared that the bolt was too long for the assembly, (Appendix A). The fitting appears to have been machined to accommodate the washers so that the assembly could be tightened up with the bolt head, the washers and the nut parallel to one another and perpendicular to the longitudinal axis of the bolt. The fitting of the spar on the RH side was a plain fitting with no bolt. A grease mark on the spar indicates that there had been relative movement between the spar and its RH fuselage fitting. The wall thickness of the spar tube was 0.48 inch. Burrs were observed on the insides of both bolt holes. Initiation points for fatigue fracture appear to have been at the inner edges of the bolt holes.

Spar /fuselage attachment bolt, nut and washer.
Note long bolt and space between washer and housing.

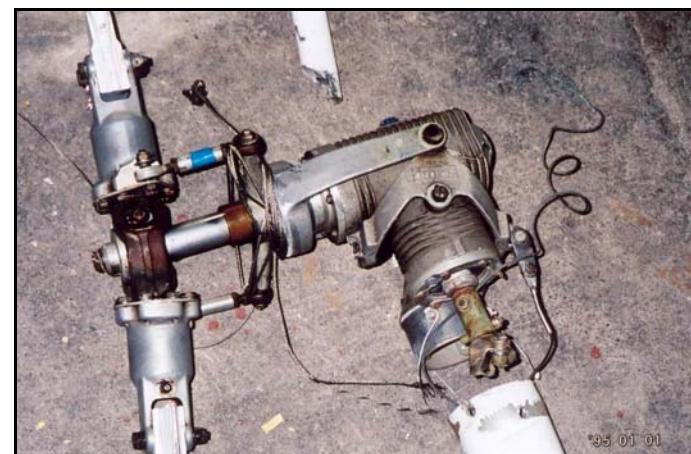
All of the RH tail rotor control cable was found wrapped around the TR gearbox output shaft. It was impossible to rotate the output shaft by hand. It unravelled in two separate lengths of 78 inches and 156 inches. Strands were either broken or damaged at regular intervals. Its anchor point to the pitch change mechanism had broken off. The other end had broken at the thimble Nicropress sleeve (18-2-G), adjoining the cable to the turnbuckle (MS21251-33S), in the lower engine bay. After unravelling, the gearbox shaft was free to rotate by hand. One of the two pitch link retainers had cracked at its root.

Near the impact site, the sonogram frequency for the tail rotor blades becomes indeterminate. At this point it is likely that the RH tail rotor control cable started to wrap itself around the perimeter of the gearbox shaft. With a tail rotor speed of 2520 RPM, it would have taken less than a second for the RH control cable to do this. The wound cable squeezed between the rotating pitch link retainers and the fixed bearing housing assembly. The resulting force was sufficient to break one of these retainers before the gearbox seized and the rotating flexible drive shaft broke away.

Tail rotor gearbox , pitch change mechanism and control cables
as found separated from the tail boom at the helicopter landing site.

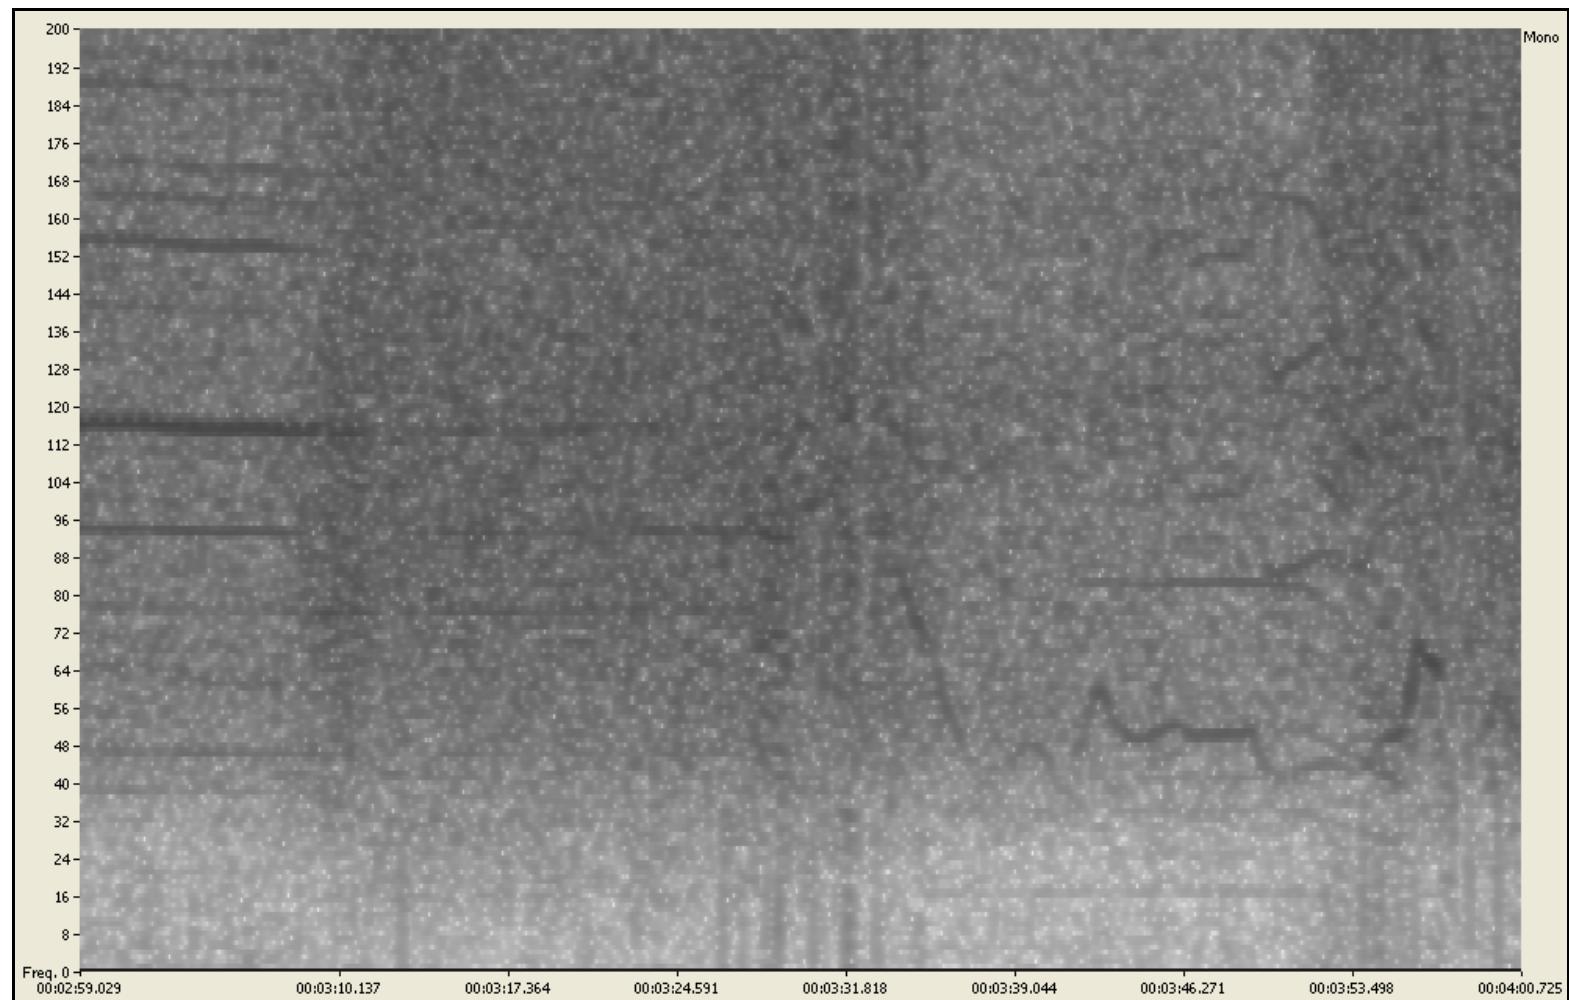
A frequency analysis of the audio output of the video camera carried by the passenger is shown in graphical format at **Appendix B**. The results are not too clear, due in part to the aerodynamic noise when the camera was pushed out into the slipstream. The noise recorded in the cockpit is a complex signal produced by a number of dynamic sources in flight. These sources can be broadly classified as deterministic or stochastic (random) in nature. In engine noise these occur simultaneously. The engine produces pulses at a rate proportional to engine speed. In this four cylinder engine, fuel is ignited and two pulses emanate every crankshaft revolution.

Other sources would include the large engine cooling fan which produces both deterministic and stochastic (turbulent air flow) components. Sound sources, both random and deterministic are shown and this produces the mottled effect. However, the basic engine deterministic noise both before and after TR control failure, can clearly be seen.

In the sonogram, the main rotor blades can be detected at 16.78 c/s prior to the event, corresponding to a speed of 335 Rotor RPM. Following the event, there is a tail rotor blade frequency of 84 c/s, which corresponds to a tail rotor speed of 2520 RPM. This would indicate that there was no disconnect between the main rotor and the tail rotor during autorotation.

Frequency analysis of audio output from video camera onboard aircraft

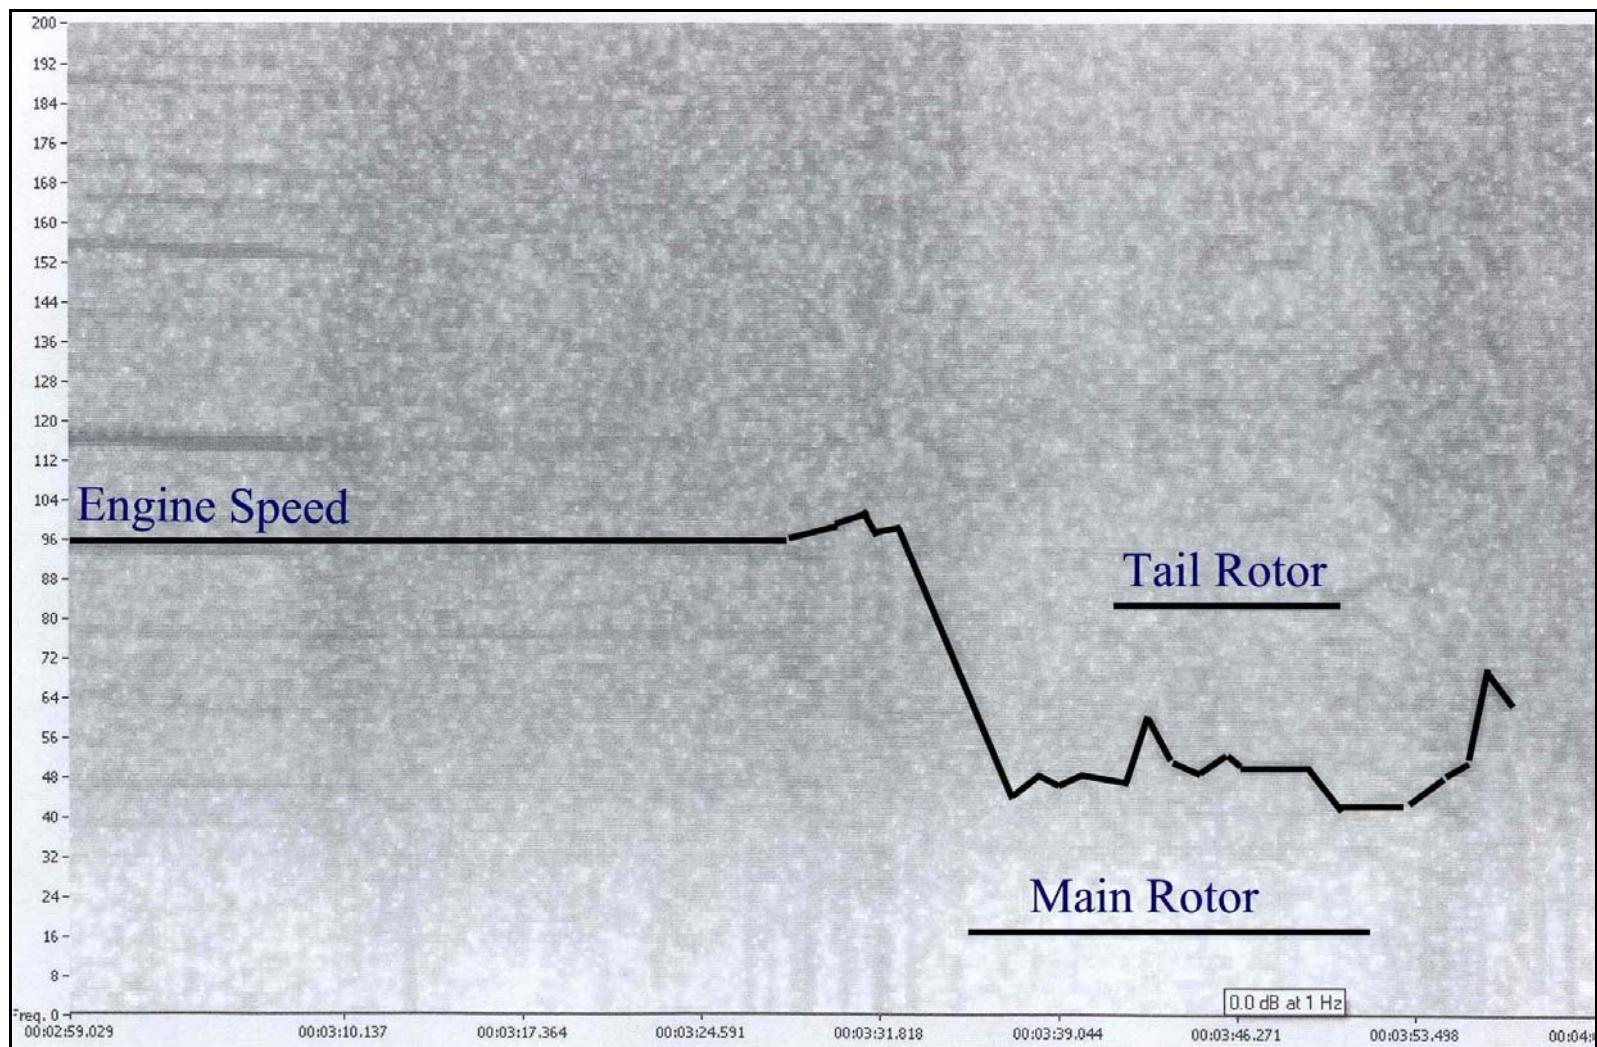
Appendix C demonstrates the most likely sonograms for engine, main rotor blades and tail rotor blades. The pilot said that he maintained engine RPM at about 2950 prior to the event. This corresponds to a frequency of 98.3 c/s, which is difficult to see on the sonogram. Hearing the bang and loss of pedal control were instantaneous so that one or possibly both cables were severed at that point. The pilot took action immediately following the loud bang and on suddenly discovering that tail rotor control was absent. In autorotating on to the chosen field (**Appendix D**) he had to traverse a 10 kv electricity line and a boundary hedge before he made the final landing. The severe drop in engine RPM after the event can be clearly seen. The average engine RPM during autorotation is of the order of 1440 RPM. This rises to 2040 RPM and apparently drops to 1800 RPM at impact. The tail rotor blades continued to rotate at a speed of 2520 RPM. The directional control following the incident was remarkably constant and is an indication that for most of the autorotation sequence the tail rotor blades assumed a nearly neutral pitch condition thus maintaining a certain degree of directional stability. The reduction of engine RPM to near idling speed during autorotation would indicate that engine RPM had little control over main blade speed and tail rotor blade speed as the freewheeling unit had effectively disconnected the engine.

Sonogram of engine, main rotor and tail rotor speed
