## FINAL REPORT

**AAIU Formal Report No: 2006-019**  
**AAIU File No: 2005/0040**  
**Published: 29 Sept 2006**

**Operator:** **Private**  
**Manufacturer:** **Robinson**  
**Model:** **R44 Raven**  
**Nationality:** **Ireland**  
**Registration:** **EI-DOC**  
**Location:** **Nr Derrybrien, Co. Galway**  
**Date/Time (UTC):** **09 July 2005 @ 10.44 hrs**

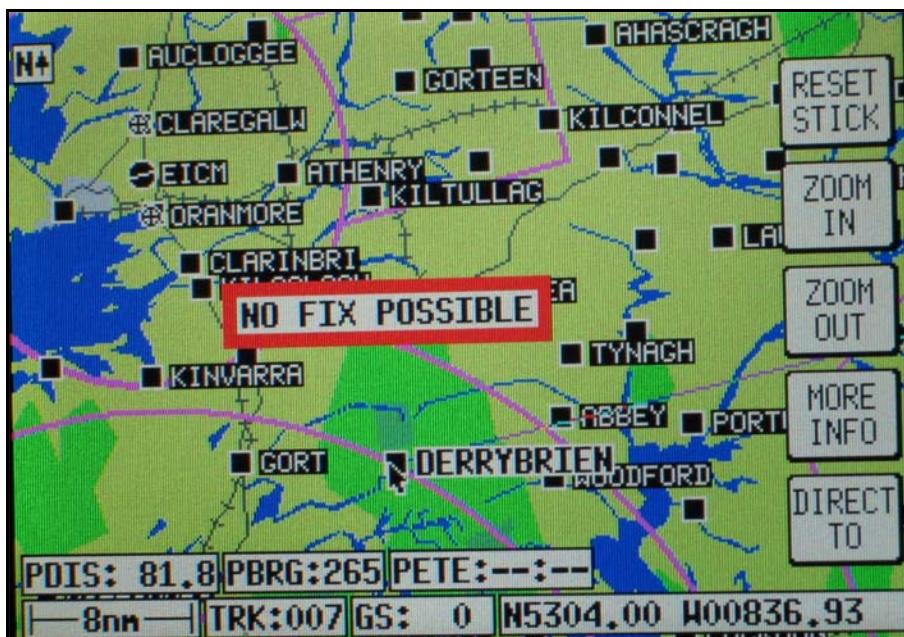
Image 1

This image was taken at an 8nm setting (ref lower left of display). This setting is probably the maximum range setting that the pilot would have used. The high ground in the general Derrybrien area is shown by the light green area surrounding Derrybrien. The summit area is shown by the darker green rectangle immediately north of Derrybrien. The accident site is approximately in the centre of this darker green rectangle. It may be noted that none of the local roads in the area are displayed. The two “rivers” shown (blue) starting near the summit area are, in fact, just mountain streams and are virtually invisible from the air in this area. The pink lines are the boundaries of Air Traffic Control areas.

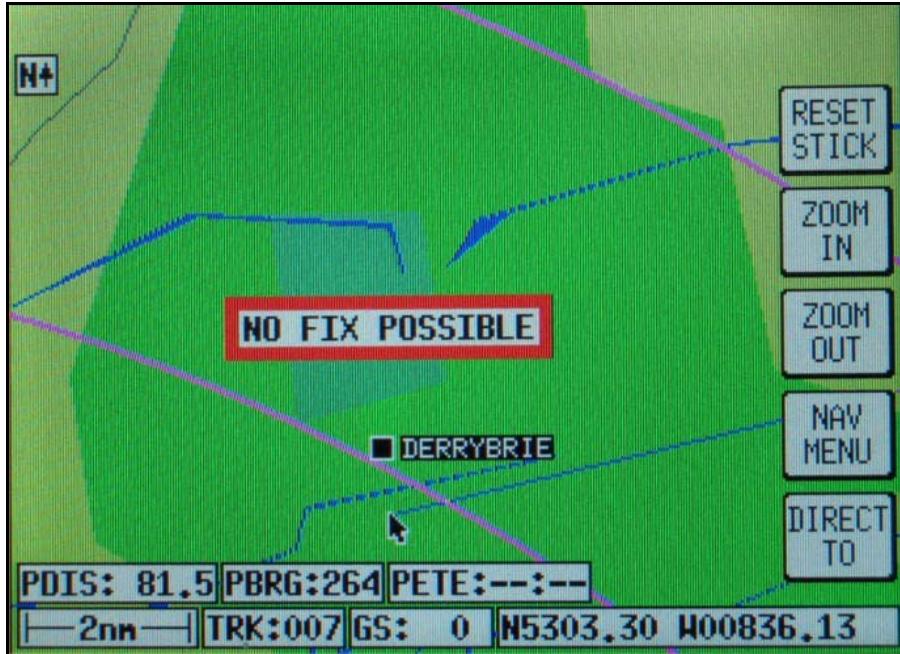
**Image 2**

This image again shows the Derrybrien area, but at a range setting of 2nm. This setting is probably the minimum range setting that the pilot would have used. The accident site is just above the centre of "NO FIX POSSIBLE" message. Again the lack of local terrain features in the display is noticeable.

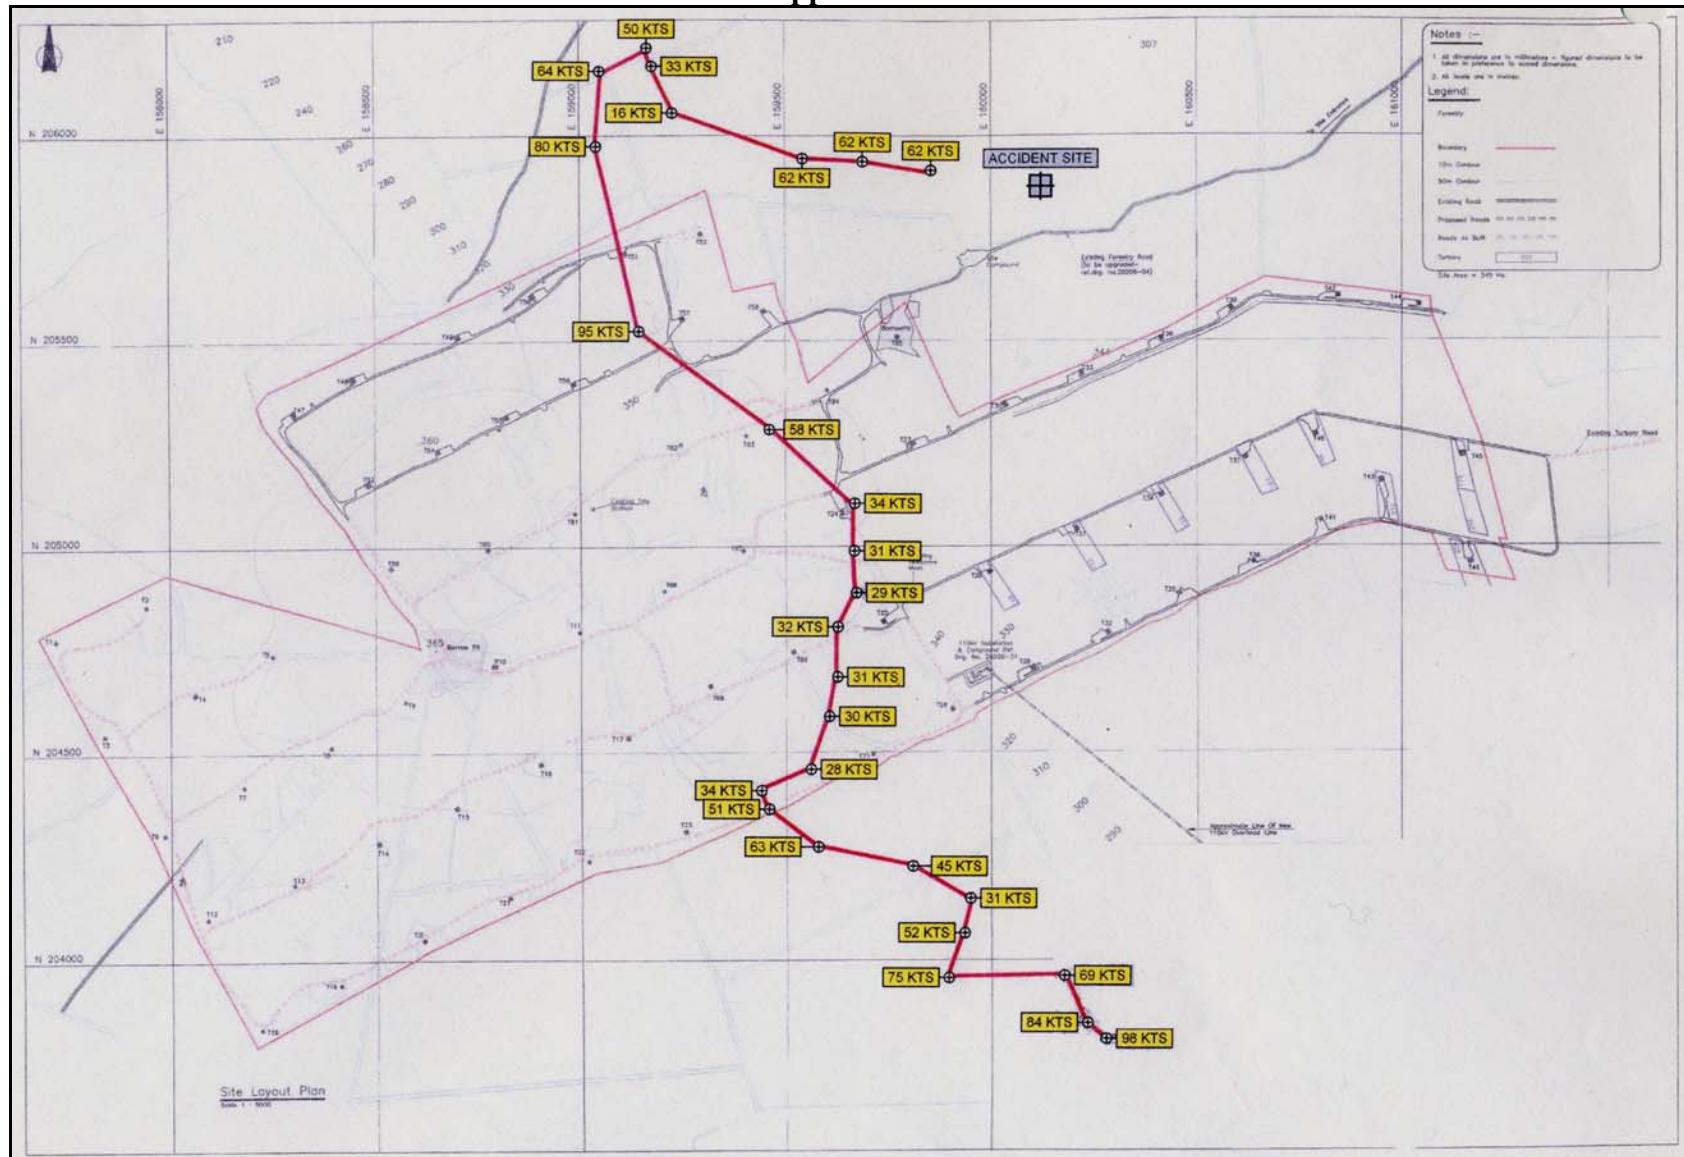
This map shows an overlay of the Shannon radar record onto a site-map of the Derrybrien Wind-Farm project, which includes the accident site. The speeds shown are the instantaneous speeds calculated by the radar at the points in question. While the shape of the plot is reasonably accurate, the plot can't be accurately geo-referenced onto the map, due to the (relatively) poor resolution of the radar. The placement of the plot was achieved by estimating the probable vertical flight path from the last recorder point (at 62 kts ground-speed) to the accident site. Between these two points the radar was unable to detect the helicopter, because it had descended below the crest of the high ground between itself and the radar transmitter. Because of the foregoing, no inference should be drawn as to the proximity of the flight path to any of the turbine towers of the Wind-Farm.

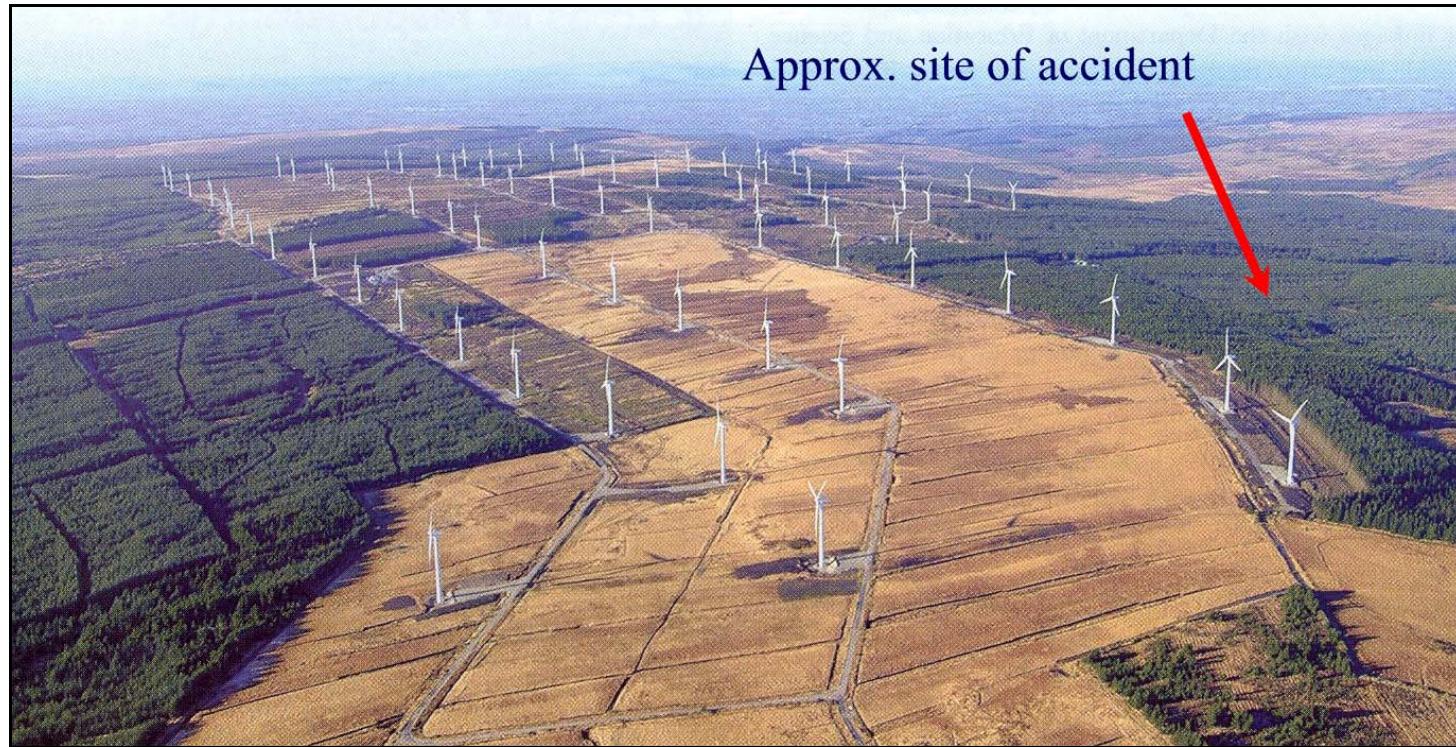
This aerial photo of the Derrybrien Wind Farm was taken some time after the accident, when construction of the farm was complete. The flight path of EI-DOC was from left to right.

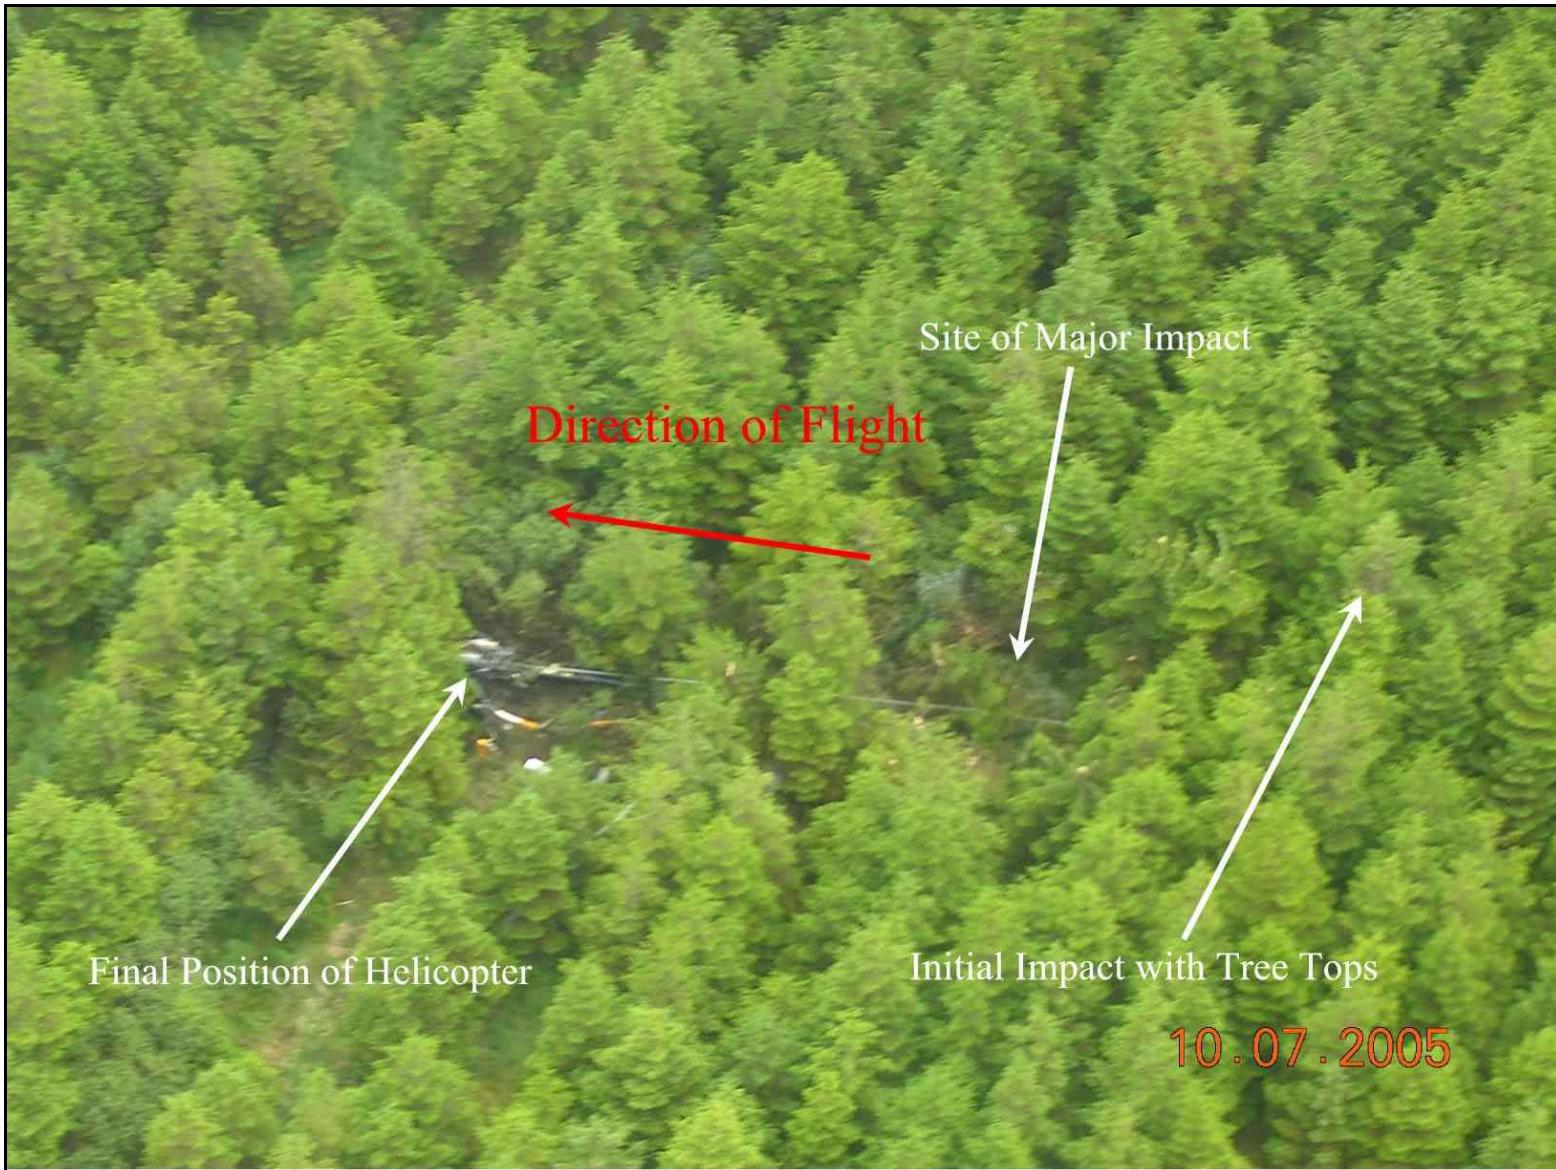
**Aerial Photo of Accident Site**

The helicopter impacted on the northern slopes of the Slieve Aughy Mountains. The crest line of the high ground runs approximately E - W in this area. The helicopter had passed close to the summit, which is 1,174 ft (358 metres) above sea level. This figure does not include the height of the wind turbines located in this area. The helicopter impacted the trees of a dense plantation. At the impact point the terrain is approximately 1,000 ft (305 metres) above sea level, and the taller trees are approx 33 ft (10 metres) high. An aerial view of the accident site is shown in **Appendix D**. The helicopter made initial contact with the trees on a heading of approx 080° at steep angle descent and possibly a high nose down angle. The main rotor blades made progressively heavier contact with the trees, initially with the light tops, but then with the thicker trunks of the trees as it came closer to the ground at this point of major impact. The undercarriage skids separated at this point and the tail rotor assembly departed. Both main rotor blades suffered major damage during this descent through the trees. One main blade spar remained intact, while suffering major distortion. The other blade spar failed approx 0.5 metres from the tip. The separated segment of this blade was not recovered, notwithstanding an extensive air and ground search. The forward momentum of the helicopter carried the fuselage through a tree. It then struck the ground and was brought to a stop as a result of impact with two more trees.

**Note:** the white line streaming back from the helicopter is a survey tape being used by the Investigation.
