## FINAL REPORT

**AAIU Synoptic Report No: 2006-028**

<b>Aircraft Type and Registration:</b>	B737-800, EI-DHX	
<b>No. and Type of Engines:</b>	Two, CFM 56-7	
<b>Aircraft Serial Number:</b>	33585	
<b>Year of Manufacture:</b>	2005	
<b>Date and Time (UTC):</b>	23 March 2006 @ 18.20 hrs	
<b>Location:</b>	Ireland West Airport, Knock, Co. Mayo	
<b>Type of Flight:</b>	Public Transport	
<b>Persons on Board:</b>	Crew - 6	Passengers - 138
<b>Injuries:</b>	Crew - Nil	Passengers - Nil
<b>Nature of Damage:</b>	None	
<b>Commander's Licence:</b>	ATPL	
<b>Commander's Details:</b>	Male, aged 39 years	
<b>Commander's Flying Experience:</b>	7,998 hours (of which 295 were on type) Last 90 days – 261 hours Last 28 days – 62.27 hours Last 24 hours – 5.33 hours	
<b>Information Source:</b>	AAIU Field Investigation

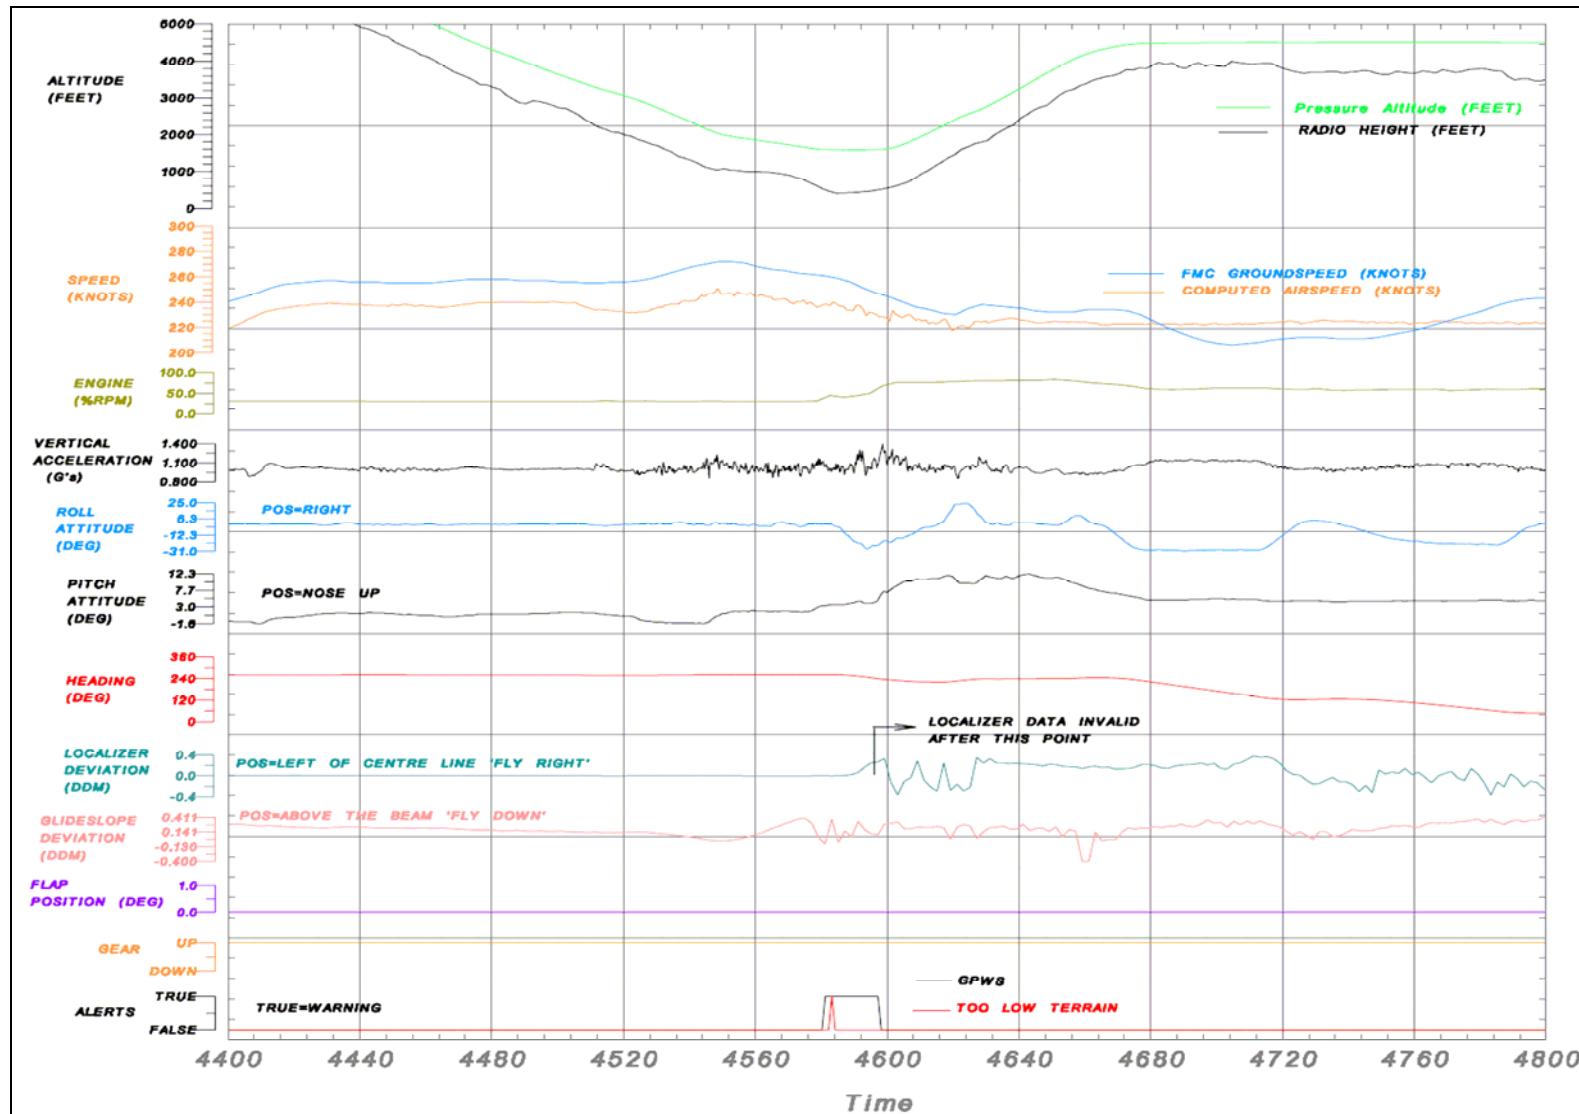
## APPENDIX C

Information derived from the Operational Flight Data Monitoring (OFDM) System (**APPENDIX C**) showed that a high energy first approach was carried out to EIKN which contravened many of the Operators Standard Operating Procedures (SOP's), including the non deployment of flaps, landing gear, speed brakes, too high on glideslope (G/S) and culminating in an Enhanced Ground Proximity Warning System (EGPWS) Mode 4A alert, as the aircraft turned port in a Go-around (G/A) non-procedural manoeuvre. The System had triggered a, "*too low terrain*" alert. Mode 4A is active during the cruise and approach with gear and flaps up. It also provides alerting for protection against an unintentional gear up landing.
