FINAL REPORT

AAIU Synoptic Report No: 2006-029

Aircraft Type and Registration:	ATR 42-300, EI-BYO
No. and Type of Engines:	2 x Pratt & Whitney PW100-120
Aircraft Serial Number:	161
Year of Manufacture:	1989
Date and Time (UTC):	5 August 2005 @ 13.28hrs
Location:	Enroute to Cork Airport
Type of Flight:	Public Transport
Persons on Board:	Crew - 3 Passengers - 45
Injuries:	Crew - Nil Passengers - Nil
Nature of Damage:	No Damage to Aircraft
Commander's Licence:	JAA ATPL
Commander's Details:	Male, aged 31 years
Commander's Flying Experience:	5,000 of which 570 were on type.
Information Source:	Operator and Irish Aviation Authority.

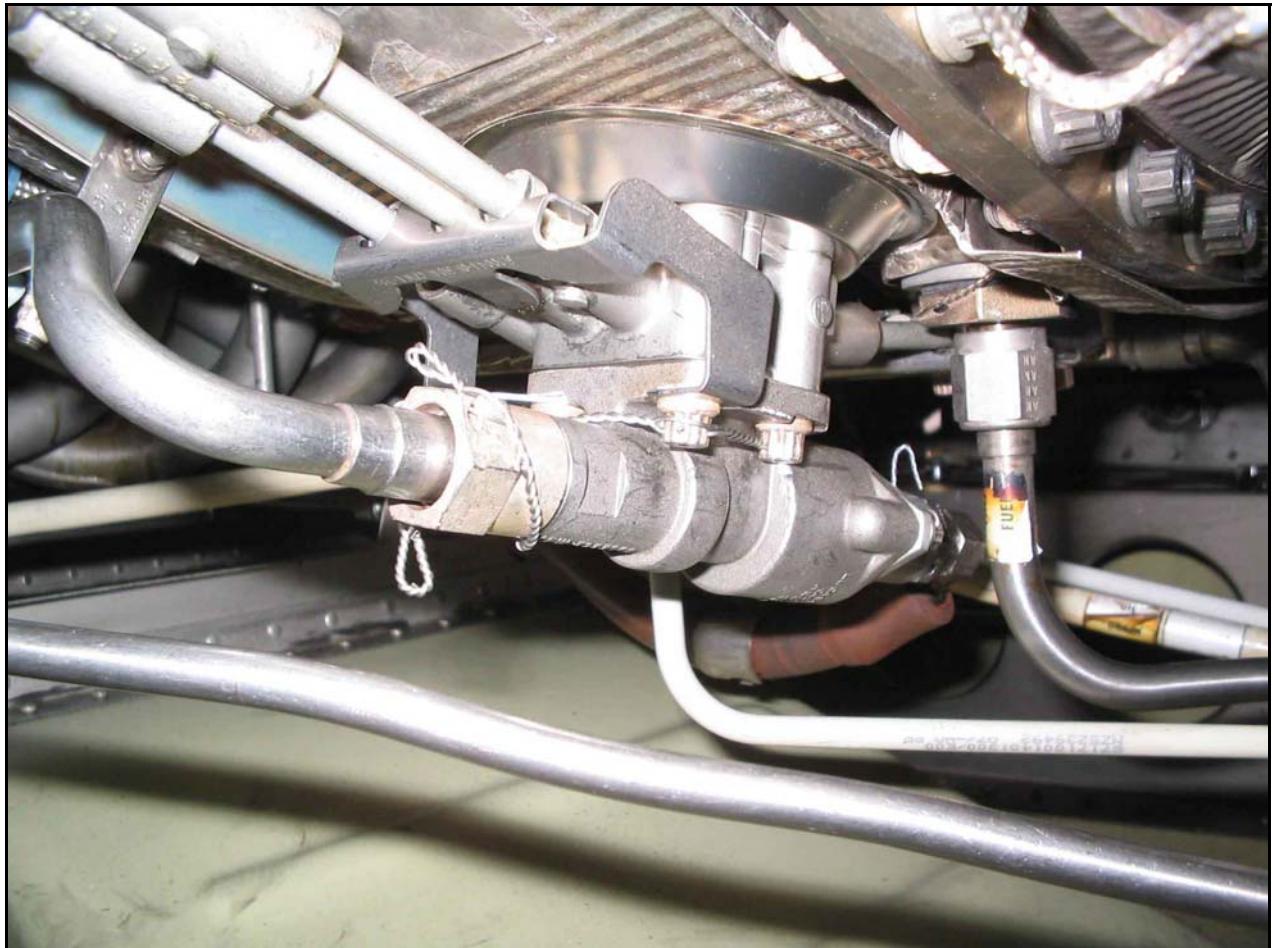
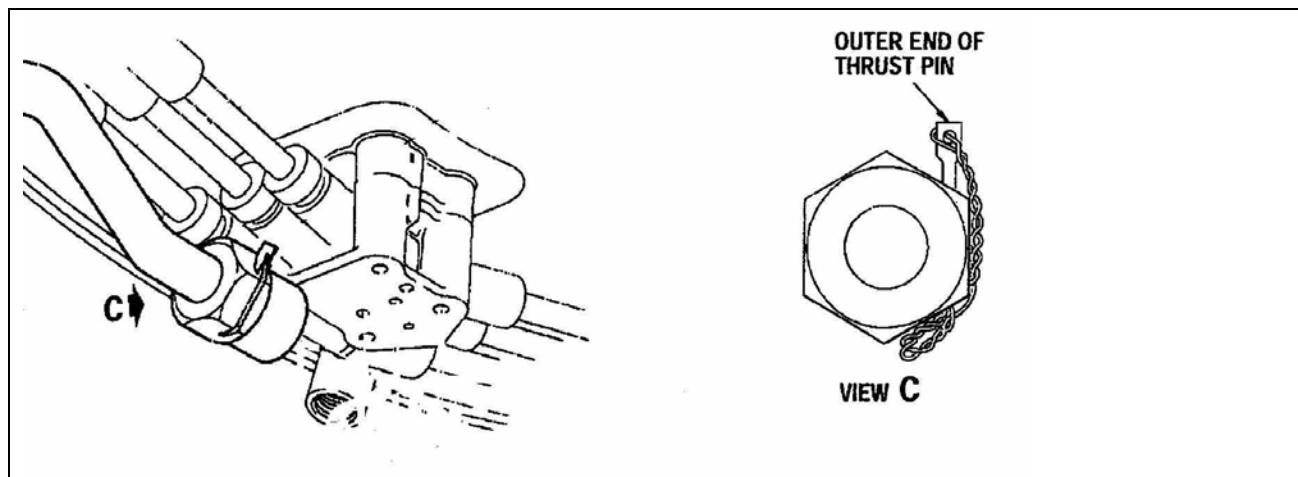
APPENDIX A

The leak was traced to a nut on the fuel flow divider union. The nut was discovered to be incorrectly wire locked and had backed off the divider. The union was re-torqued in accordance with the Maintenance Manual (MM) and leak tested. An engine run was carried out which was satisfactory. The nut was then wire locked correctly.

Appendix A shows a photograph and drawing of the fuel flow divider assembly installation. The Maintenance Manual requires that items to be wirelocked together are the tube coupling nut to its thrust pin, and the coupling nut to the adjacent dump valve bolts.

The method of wire-locking used did not prevent the nut from backing off due to normal engine vibration. This allowed the nut to loosen with a consequent leakage of fuel on to the engine nacelle. The fuel flow to the engine was progressively less and a reduction in available power followed. Had the flight time been longer the engine could have suffered complete fuel starvation, necessitating a descent and approach with only No.2 engine operating. On landing, the Captain took the correct action in pulling the No.1 fire handle and calling the Fire Services. Operator actions, in issuing the Engineering Notice and the QA Notice, following the event were adequate. The preliminary amendment of the manufacturers CIR manual was also timely. The Investigation does not, therefore, intend to make any Safety Recommendations.

1. A nut on the fuel flow divider was incorrectly wire-locked and allowed the nut to back off, thereby causing the fuel leakage.

The tube coupling nut is wirelocked to adjacent bolts on the dump valve in such a way that tension in the wire prevents the nut from backing off. The wire locking of the thrust pin to the coupling nut keeps the thrust pin in place.

In August 2005, days after this incident, the Operator issued Engineering Notice No. 28/2005 instructing it's technical personnel that the instructions detailed in the engine manufacturers Maintenance Manual should be followed during the removal/installation of the flow divider delivery tube nut. The Operator also found that an incorrect thrust pin configuration may be found due to an error in the engine shop Cleaning Inspection and Repair Manual (CIR). An Operators Quality Assurance Notice (ENO705) was issued on 10 August 2005 requiring that a duplicate inspection be carried out anytime part of the fuel system downstream of the fuel booster pumps is disturbed.
