FINAL REPORT

AAIU Synoptic Report No: 2007-003

Aircraft Type and Registration:	Schweizer 300, EI-DDI	
No. and Type of Engines:	1 x Lycoming HIO-360-GIA	
Aircraft Serial Number:	0156	
Year of Manufacture:	2003	
Date and Time (UTC):	12 March 2006 @ 12.40 hrs	
Location:	Weston Airport	
Type of Flight:	Training	
Persons on Board	Crew - One	Passengers - One
Injuries:	Crew - Nil	Passengers - Nil
Nature of Damage:	No apparent damage to helicopter	
Commander's Licence:	UK CPL(H)	
Commander's Details:	Male, aged 44 years	
Commander's Flying Experience:	3,900 hours of which 1,200 were on type	
Information Source:	Pilot of EI-DDI

SYNOPSIS

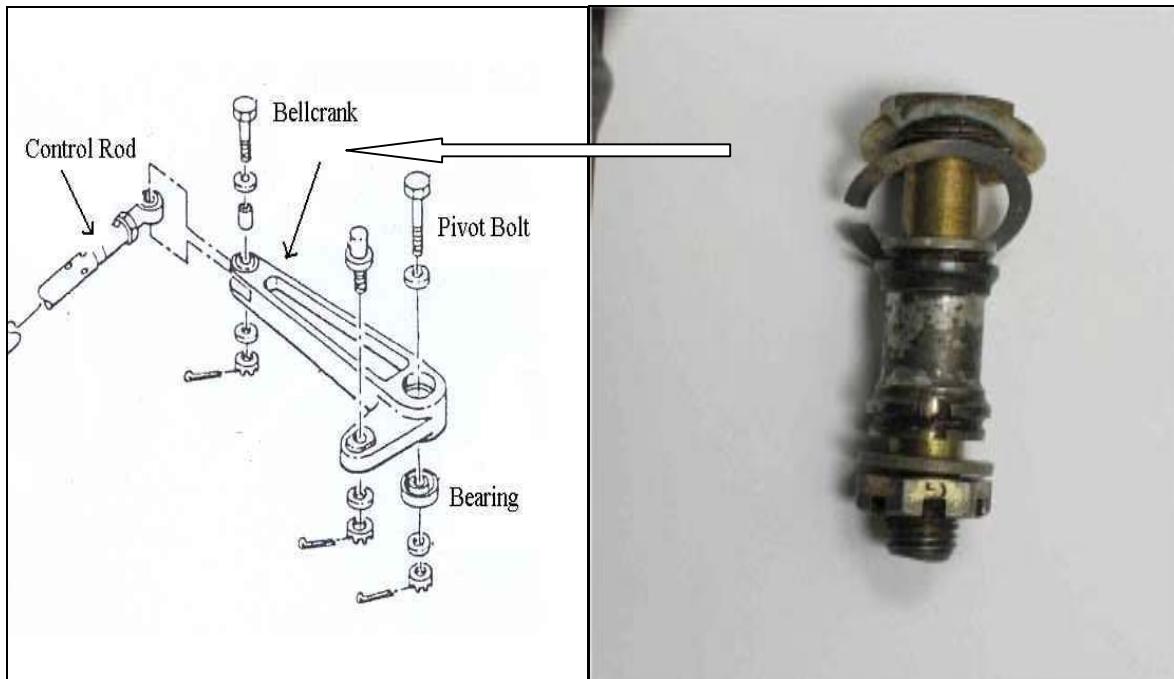
Appendix A

Examination of the tail rotor blade pitch change mechanism showed that the double row ball bearing installed in the bellcrank had disintegrated. This allowed the bellcrank to slip through the pivot bolt including its washer and nut and separate from the tail rotor gearbox. Some corrosion was also evident on the bearing inner surface. The local servicing contractor indicated that the bolt and its bearing had not been changed since aircraft construction and that their orientation when removed from EI-DDI was correct. The bolt, nut, washers and inner face in the sequence shown in **Appendix A** were forwarded to the manufacturer for examination. Their conclusions were as follows:

“Analysis revealed that corrosion likely caused the bearing breakage. Reduction in the diameter of the bearing balls due to corrosion probably contributed to the separation. Without an identification of component location and orientation, a positive root cause cannot readily be determined.”

The loss of tail rotor control was due to the deterioration of the tail rotor swashplate bellcrank attachment bearing.

The bolt NAS6205-26D as removed from EI-DDI.

As a result of the above Preliminary Report, the Manufacturers of EI-DDI on 4 October 2006 issued a Mandatory Service Bulletin C1B-019 (see **Appendix B**), which introduced a large safety washer (Part No. AN970-5) to the bellcrank bolt assembly. This new washer will prevent the bellcrank from slipping down through the pivot bolt, should the bearing disintegrate. Compliance is at the next removal of the bellcrank assembly at 600 hrs or 12 months from the issue date, whichever comes first.

1. The manufacturer should modify the bell-crank assembly in order to prevent the bell-crank disconnecting from its fixed mounting in the event of bearing failure. [\(SR 03 of 2007\)](#)

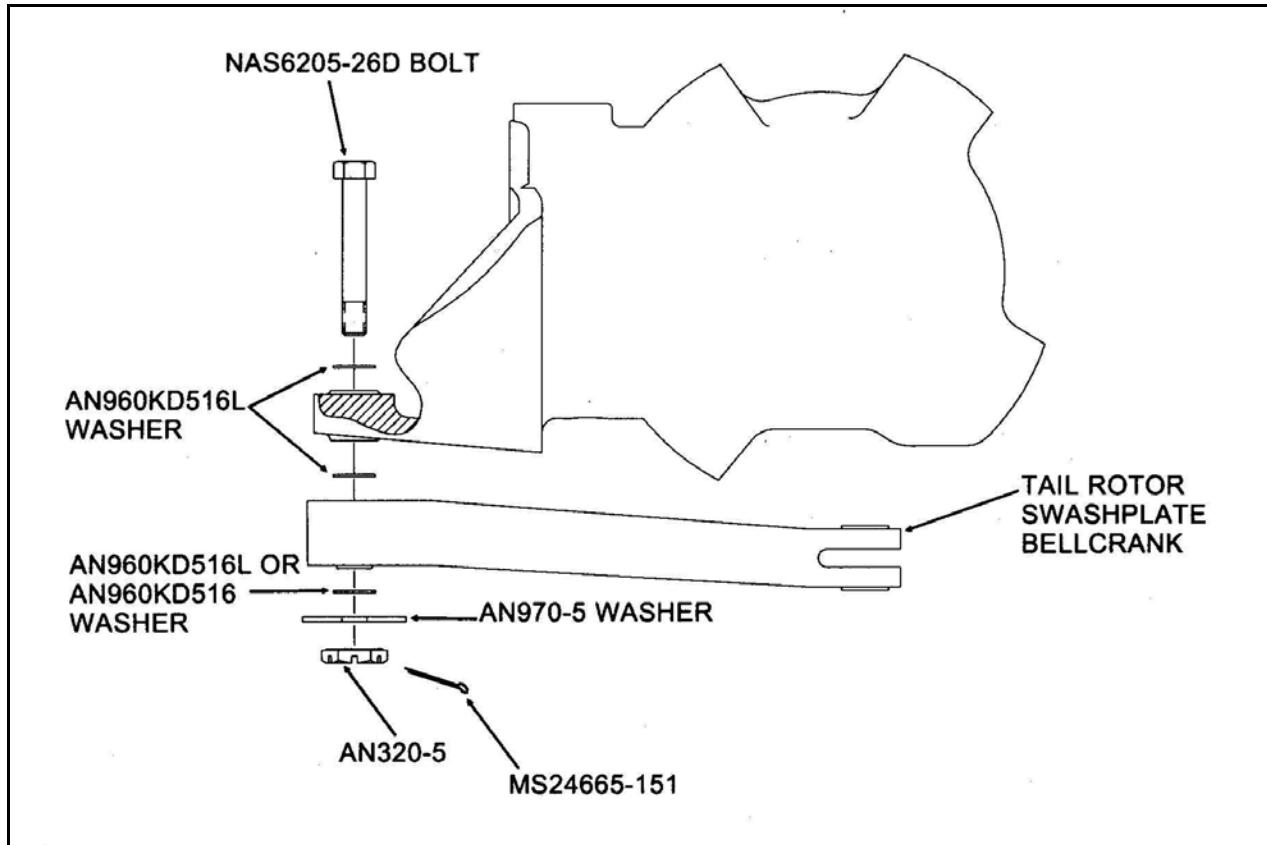
- A report has been received of loss of tail rotor control due to deterioration of a tail rotor swashplate bellcrank attachment bearing. This allowed a downward displacement of the bellcrank to a point that the bellcrank pivot pin disengaged the tail rotor swashplate pivot bearing. Installation of a large area AN970-5 washer as a safety washer will prevent a bellcrank displacement that can cause pivot pin disengagement. 269C-1 Model Helicopters serial number 0261 and subsequent have been delivered with the large area washer installed.
- Failure to comply with this Service Bulletin may lead to loss of control of the helicopter and subsequently cause serious injury, death and/or property damage.

- Inspect attachment bearing in tail rotor swashplate bellcrank assembly for security and condition in accordance with Basic HMI Section 9.
- Remove tail rotor swashplate bellcrank assembly from tail rotor transmission mount and discard NAS6205-25D bolt. Install bellcrank using NAS6205-26D bolt, AN970-5 large area washer, AN320-5 nut and MS 24665-151 cotter pin. Use AN960KD516L or AN960KD516 washers as required to shim for clearance between bellcrank and transmission mount and AN970-5 washer as shown in Figure C1B-019-1.
