Air Accident Investigation Unit Ireland

**INCIDENT REPORT
Boeing 737-8AS, EI-ENB
Kerry Airport (EIKY), Co. Kerry, Ireland
21 December 2010**

AAIU Report No: 2012-004

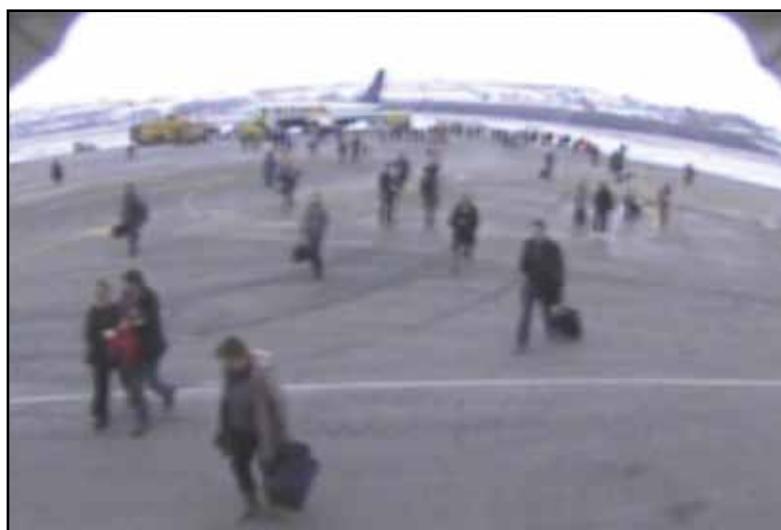
Airport security cameras recorded that the first Fire Service appliance arrived at the aircraft 22 seconds after the aircraft came to a halt. One minute and five seconds later the port doors opened, the slides inflated and passengers immediately began to leave the aircraft. The security cameras (**Photo No. 1**) recorded that a significant number of the passengers carried hand baggage as they walked towards the airport terminal building.

Photo No. 1: Passengers after emergency evacuation.

Passengers who take carry-on baggage off the aircraft during an emergency evacuation impede the evacuation because it restricts the evacuation flow rate, which is critical especially in the event of a fire or the suspicion of one. Furthermore, aircraft emergency slides are not designed to accommodate hand baggage and can therefore be damaged. There is also a significant risk that a passenger with hand baggage can lose balance while descending the slide and consequently suffer injury on contact with the ground. In addition, it delays the evacuee clearing away from the slide after descent. Finally, it negates the certification process that governs aircraft design and safe evacuation procedures.

The Investigation believes that the only practical option for cabin crew is to repeatedly and vigorously order passengers not to remove carry-on baggage during the evacuation.
