Air Accident Investigation Unit Ireland

**FACTUAL REPORT
SERIOUS INCIDENT TO
Powerchute Kestrel (Microlight), G-MWFI
Dunmore, Co. Galway
05 August 2012**

AAIU Report No: 2013-001**State File No: IRL00912086****Report Format: Factual Report****Published: 14/01/2013**

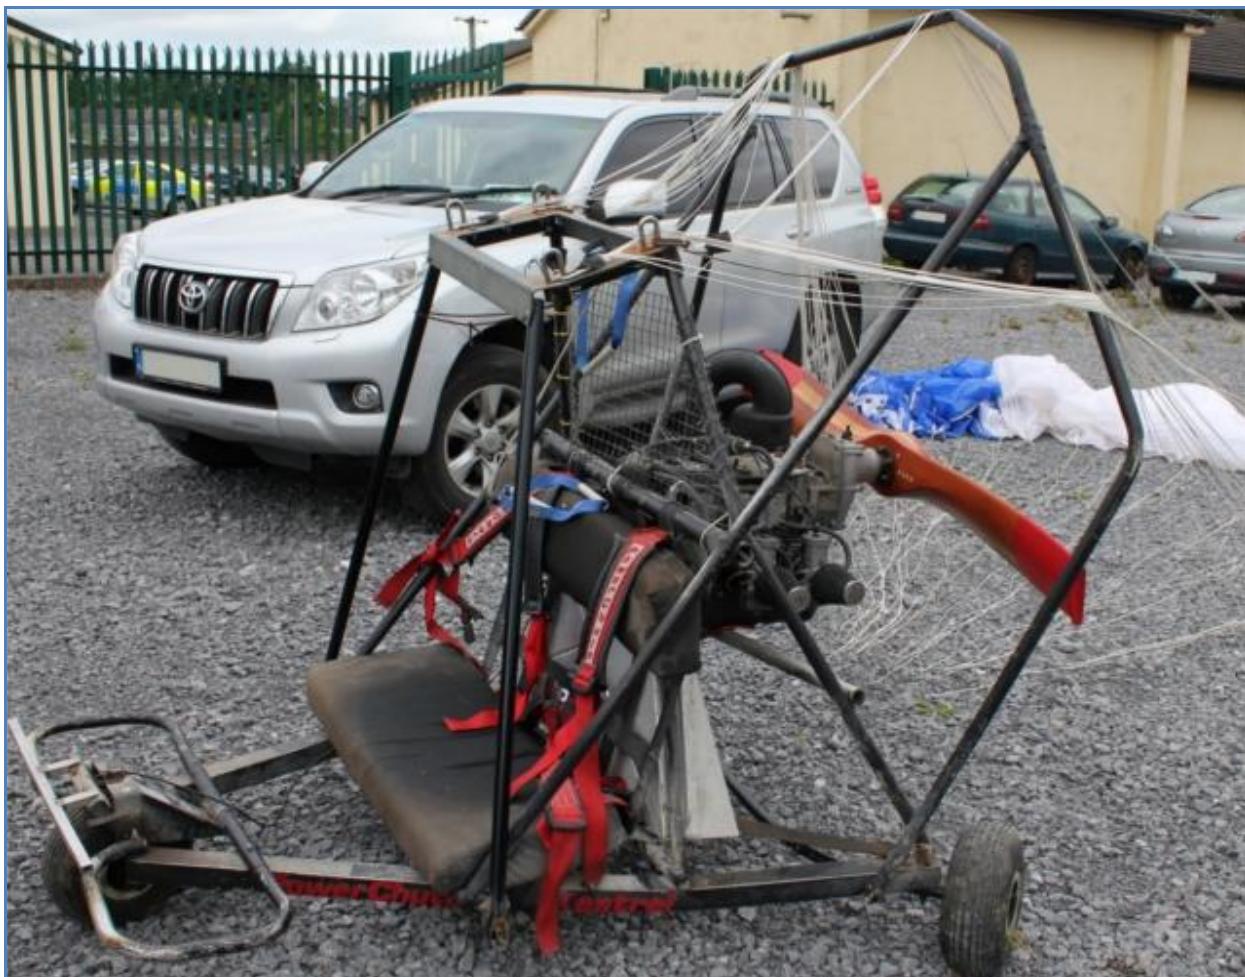
Photo No. 1: Paramotor G-MWFI

Evidence of a wire strike was found on the side of the aircraft. The left wheel trans-axle was bent aft (**Photo No. 1**), probably due to ground impact.
