# Air Accident Investigation Unit Ireland

ACCIDENT TO  
Pegasus Quantum 15-912, G-BZOD  
Near Ballyduggan, Co. Tipperary  
9 August 2011

## FINAL REPORT

**AAIU Report No: 2013-003**  
**State File No: IRL00911075**  
**Report Format: Synoptic Report**  
**Published: 21/02/2013**

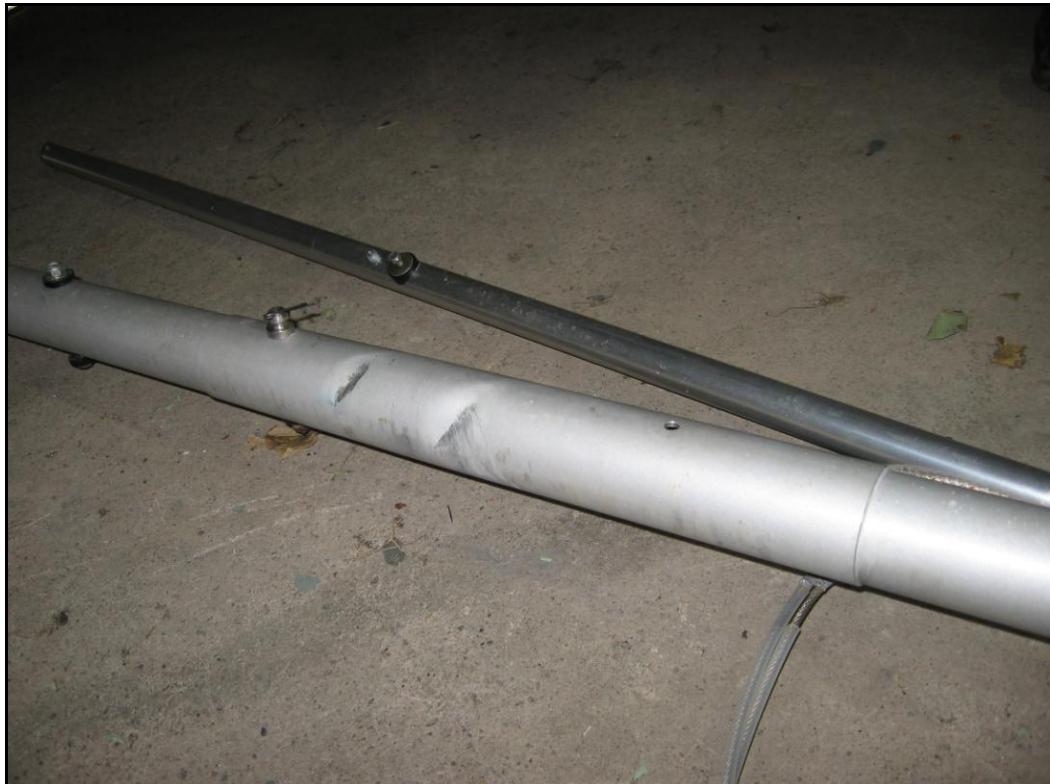
The trike front strut failed in bending and tension with marks on the front strut protection sleeve indicating it struck the control frame at the right hand corner, i.e the trike unit fell into the right hand side of the sail. There were two characteristic blade strike marks on the starboard side of the wing keel above the propeller (**Photo No. 1**) and blue Dacron keel pocket fibres embedded in one damaged propeller blade (**Photo No. 2**). This indicates that the front strut had failed and the trike unit continued to swing back into the sail while the engine was running at low power.

**Photo No. 1:** Propeller blade strike marks on the keel

On this occasion it is likely that when the aircraft inverted, the front strut failed due to the trike inertia opposing the wing pitching moment. This is supported by the evidence of the propeller strikes on the keel. The tumble entry was only just strong enough to invert the aircraft and allow the trike unit to fall into the right hand sail (failing the leading edge) but not so strong as to start a typical, fully established, tumbling autorotation in pitch. Subsequently, with asymmetric lift due to the failed right leading edge, the aircraft entered an autorotation in yaw which continued until ground impact. This autorotation in yaw reduced the rate of vertical descent sufficiently to make the accident survivable.

10. The aircraft entered a partial tumble manoeuvre.
11. The opposing forces between wing and trike caused the trike front strut to fail.
12. Due to the front strut failure the propeller struck the wing keel.

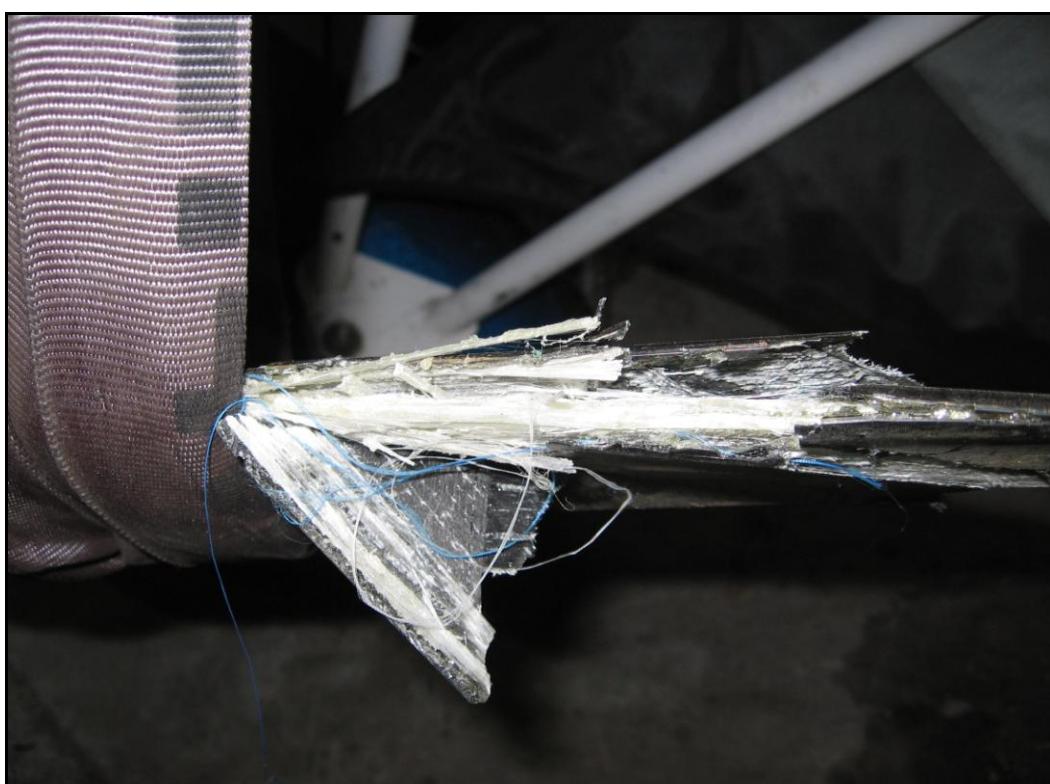
**Photo No. 2:** Blue Dacron from keel pocket embedded in propeller blade

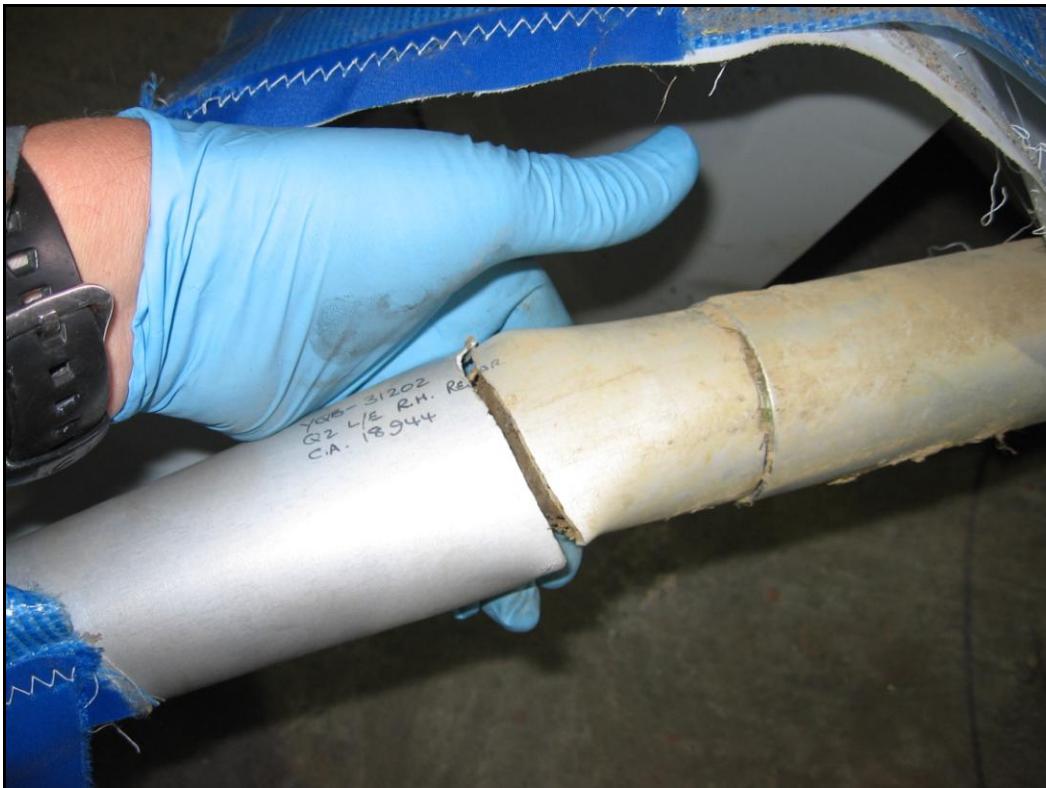
The right hand leading edge failed in negative bending outboard of the crossboom to leading edge junction sleeving (**Photo No. 3**). There were clods of soil embedded in the inboard part of this fracture whereas the outboard part of the leading edge was clean.

**Photo No. 3:** Starboard (RH) wing leading edge failure outboard of crossboom, showing inboard part muddy and outboard part clean

13. The tumble entry was only just strong enough to invert the aircraft, and allowed the trike unit to fall into the right hand sail (failing the leading edge).
