Air Accident Investigation Unit Ireland

ACCIDENT
COMCO - IKARUS, C42 FB Microlight, EI-ETU
Carrickbrack Airfield, Letterkenny
Co. Donegal, Ireland.
27 December 2012

FINAL REPORT

AAIU Report No: 2013-006

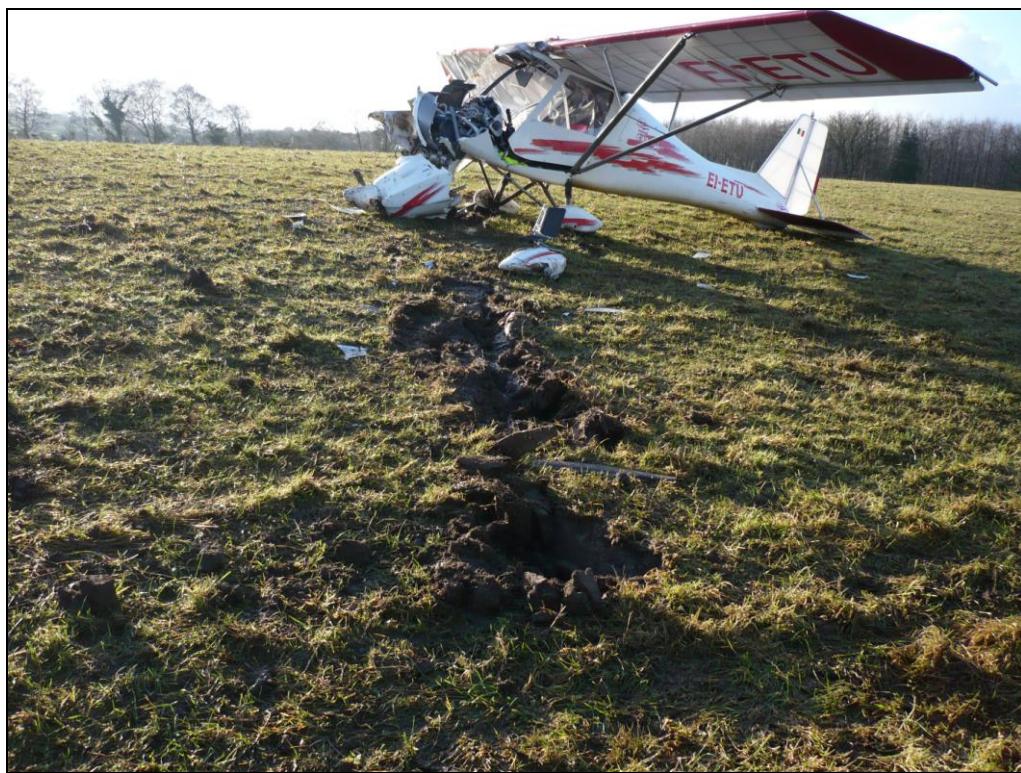
Following a longer than expected take-off run over wet/soft grassland, the aircraft became airborne and had insufficient height to clear a line of trees at the airfield boundary hedgerow. The right-hand wing-tip struck a holly tree and the aircraft subsequently impacted heavily into the adjacent field. Both occupants escaped without injury, but the aircraft was substantially damaged. There was no fire.

The aircraft was extensively damaged (**See Photo No. 1**). However, both pilots were wearing four-point harnesses and evacuated the aircraft uninjured.

An examination of the airfield identified that the ground conditions were of wet/soft grassland. Tyre rutting was evident in the ground along the take-off run and the point of take-off was approximately 63 meters from the boundary hedgerow.

The Pilot stated that there were no technical issues with the aircraft. Earlier in the month, the 3-blade propeller was found to be out of balance and a qualified engineer balanced and re-set the blades. The aircraft had run more smoothly and faster since, but the Pilot considered that he may have underestimated the effect of the new propeller adjustment on the take-off and climb out. This, combined with the ground conditions, led to the late take-off.

Photo No. 1: Impact point and final resting position of EI-ETU

No.	It is Recommended that:	Recommendation Ref.
1.	GASCI should consider the development and dissemination of safety information for the general aviation community specific to highlighting the potential risks associated with operating to and from airstrips.	IRLD2013009
