# Air Accident Investigation Unit Ireland

## SYNOPTIC REPORT

ACCIDENT  
Tandem Parachute Jump  
Near Clonbullogue Airfield (EI CL),  
Co Offaly, Ireland  
18 August 2012

**AAIU Report No: 2013-007**  
**State File No: IRL00912090**  
**Report Format: Synoptic Report**  
**Published: 8 May 2013**

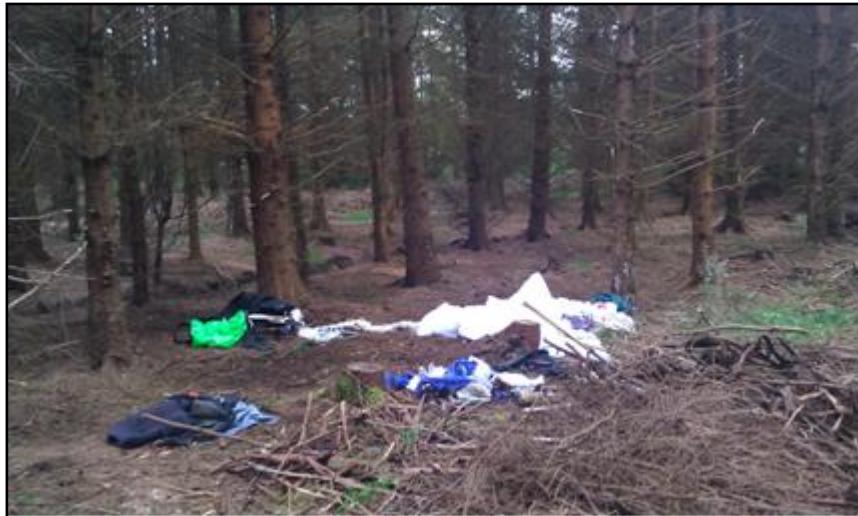
Jumping commenced at approximately 17.04 hrs from 10,000 ft with the TM and TP first to leave EI-IAN, followed by the other jumpers from EI-IAN and EI-CDP. All jumpers exited the two aircraft safely. A number of witnesses then observed one of the tandems in a spiral rotation, followed by a release of the left side riser (see Section 1.2) of the main canopy. Both the main canopy and the reserve canopy went to a condition of partial inflation. The canopies remained in that condition until impact within a forest clearing (**Photo No. 1**) where both individuals suffered serious impact injuries.

**Photo No. 1:** Impact site

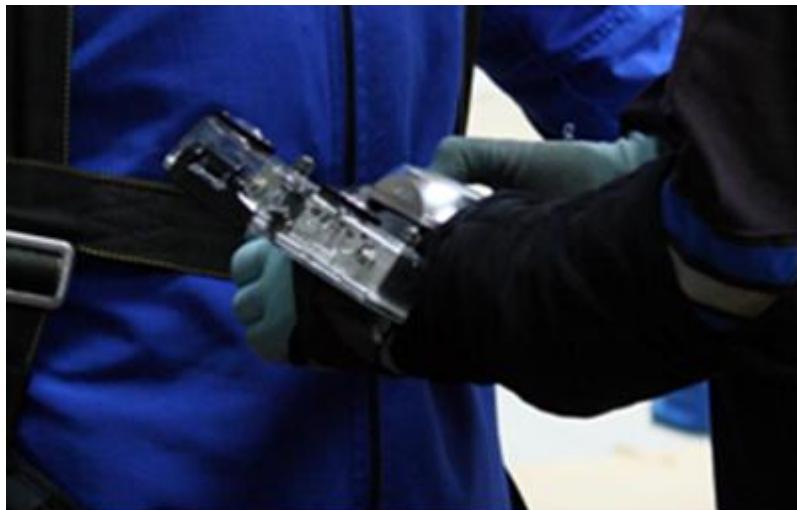
It was noted that the TM had a large wrist mounted double camera bracket and altimeter container on his left arm (**Photo No: 2**). However, no cameras were attached for the accident jump.

**Photo No. 2:** Camera and Altimeter Container Bracket

The TM was observed to have a large wrist mounted double camera bracket and altimeter container on his left arm yet no cameras were attached for the jump. Apart from the altimeter itself (which can be singularly strapped to the arm) the empty camera container served no purpose. The Investigation is of the opinion that specific to tandem jumps, such a bracket could impede arm movements of a tandem master, it could snag in critical elements of the harness equipment or it could cause injury to a tandem passenger.

16. Redundant ancillary equipment in the form of a double camera bracket was in use by the tandem master during tandem operations. Such equipment could cause injury to the TP, impede access to critical items or accidentally activate emergency equipment.

The Investigation found that the General Advisory Memorandum (GAM) and the documents developed from such guidance by the PAI and IPC do not address the issue of the carriage of redundant ancillary equipment during tandem operations and a Safety Recommendation has been made to that effect.

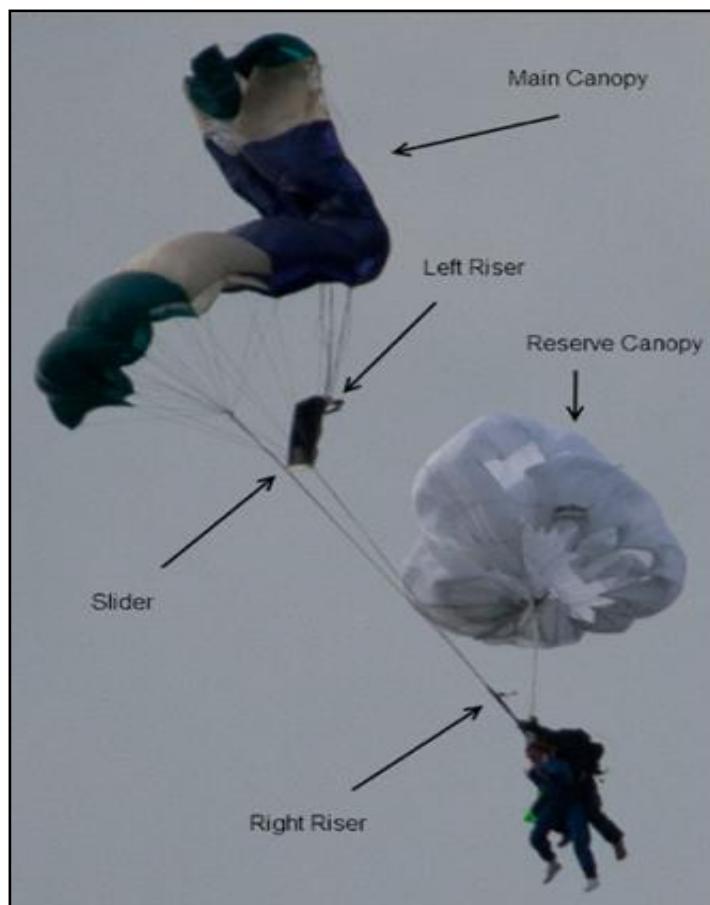
The main chute slider was seen to be held half way up the remaining right hand line group and the left hand riser becoming entangled with the slider. The main canopy remained partially inflated. A further 16 sec later the reserve chute was seen to emerge from the free-bag, followed by the free-bag and bridle becoming entangled with the reserve slider at the top of the lines of the reserve canopy. The remaining reserve chute lines appeared twisted and the reserve canopy was only partially inflated. The reserve pilot-chute was seen at the riser end of that line group. Both partially inflated canopies remained in this configuration until impact (**Photo No. 3**).

**Photo No. 3:** Configuration of Main and Reserve canopies prior to impact.

10. The release of the left hand side riser stopped the spiral rotation, however its release caused it to engage with the main chute slider and lock itself off halfway up the remaining line group.

11. Both the main and reserve canopies went to a condition of partial inflation and this configuration remained in the descent until the tandem pair impacted heavily into a forest clearing.
