Air Accident Investigation Unit Ireland

ACCIDENT
Fairchild Aircraft Corporation
SA 227-BC Metro III, EC-ITP
Cork Airport, Ireland
10 February 2011

AAIU Report No: 2014-001
State File No: IRL00911013
Report Format: Formal Report
Published: 28 January 2014

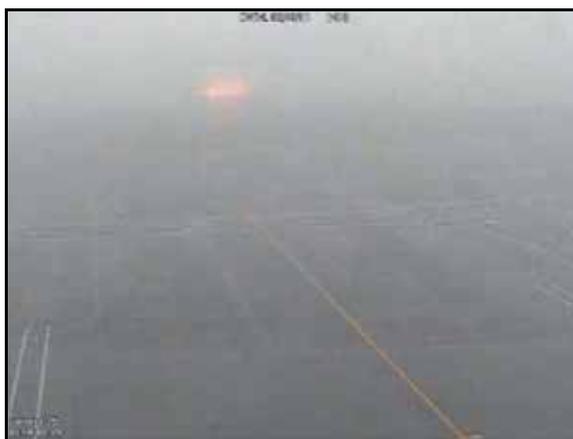
Photo No. 2: Initial flash fire

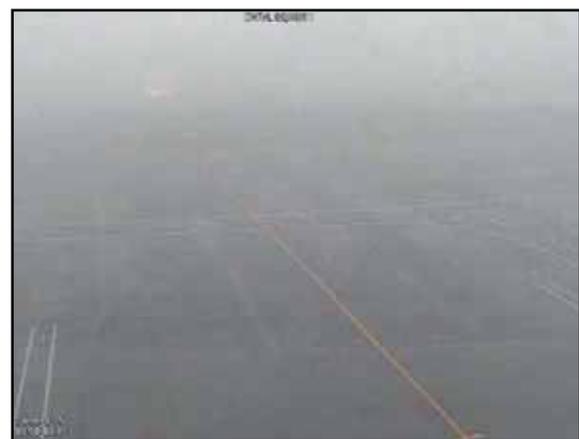
Photo No. 3: Second flash fire

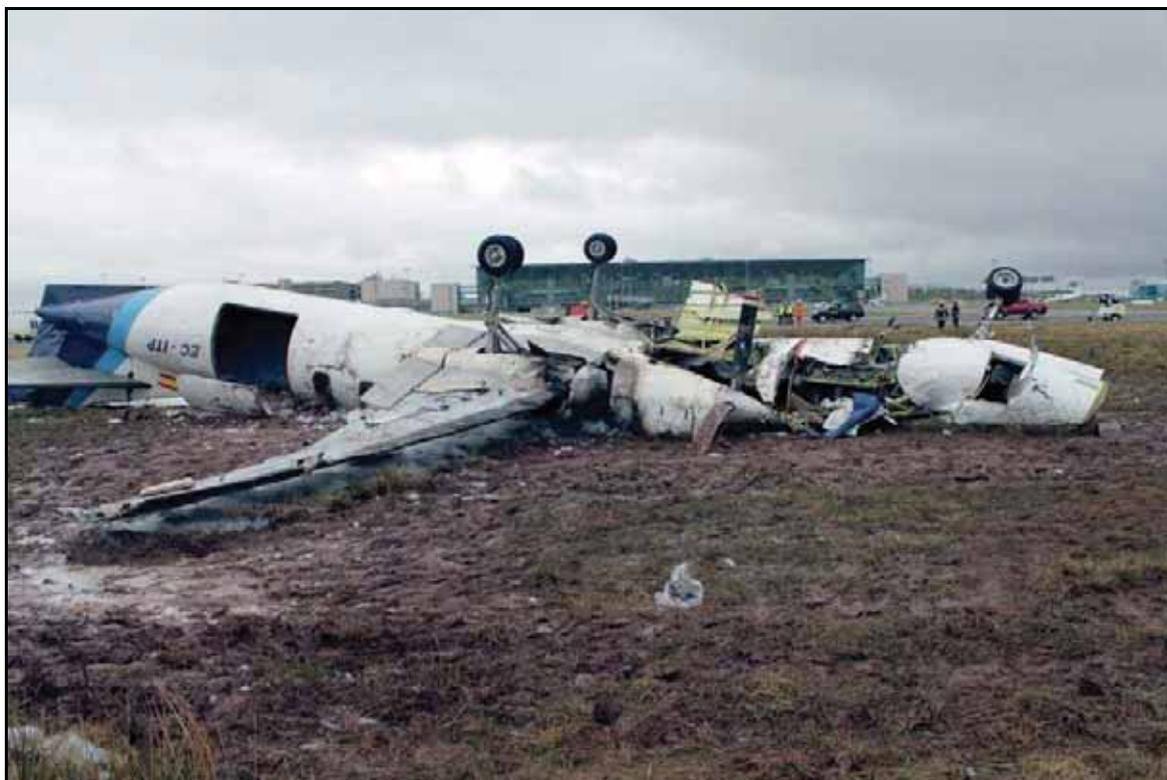
The aircraft wreckage was found in an inverted position, 189 m from the initial contact point and 72 m to the right of the runway centreline. All three landing gear legs were extended and undamaged. The forward fuselage was severely crushed; fire and impact damage occurred to both engines (**Photo No. 4**).

Photo No. 4: Final resting position of EC-ITP

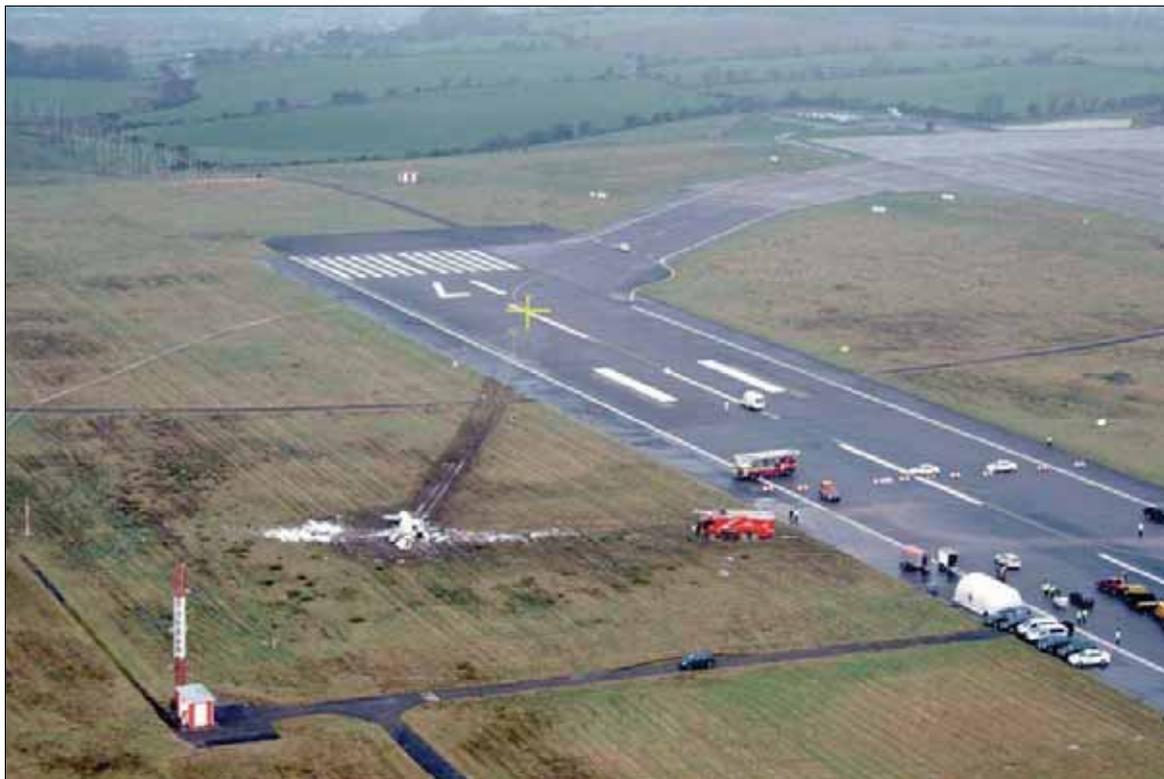
Photo No. 5: Point of initial wingtip contact (identified by the yellow reference mark), debris trail and final position of wreckage

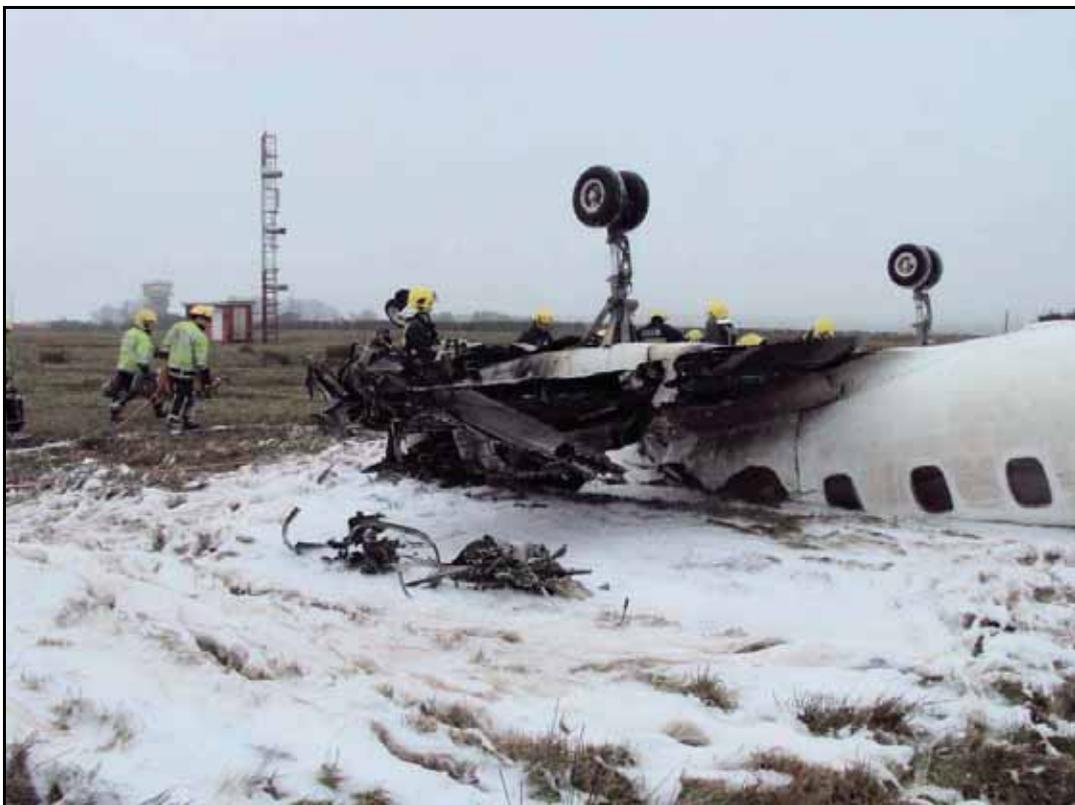
The portion of right wing and flap that remained attached to the fuselage ended several feet outboard of the right engine nacelle. Damage to the right wing had three distinct visible areas; the outboard section, the mid-section and the leading edge. The remnants of the wing attached to the nacelle had extensive fire damage (**Photo No. 6**). The structure had broken downwards at the outer end of the fractured wing.

Photo No. 6: Damage to right wing

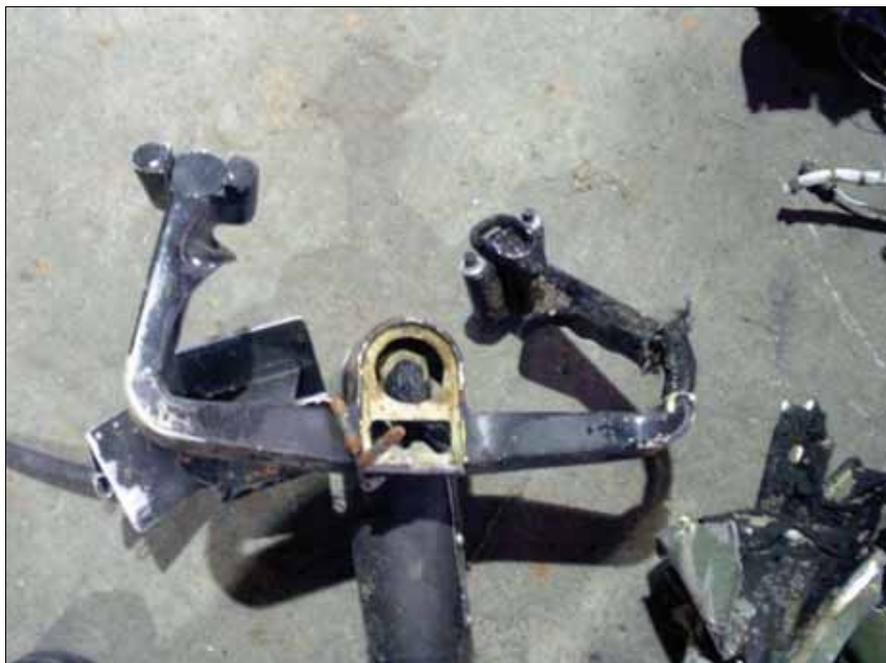
Photo No. 7: Co-pilot control wheel showing fracture of right-hand control grip

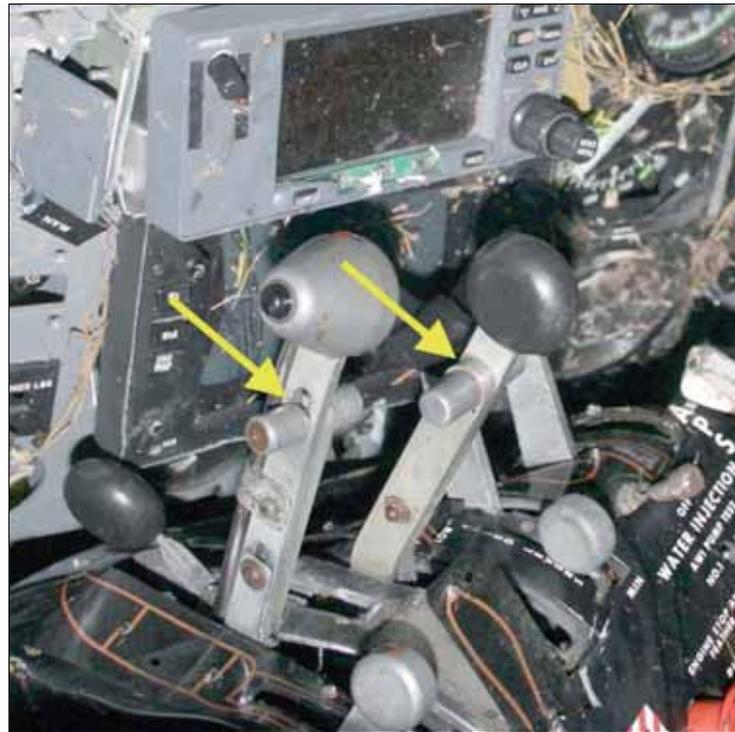
The engine control quadrant and control linkages were damaged by impact. As a result of this damage, the power levers and speed (RPM) levers were restricted in movement. The left Beta latch lever was found in the normal (down) position. The right Beta latch lever was found in the raised position (**Photo No. 8**). Both power levers were bent to the right. When the levers were straightened with minimal pressure, both mechanisms functioned correctly.

Photo No. 8: Left and Right Beta Latch lever positions

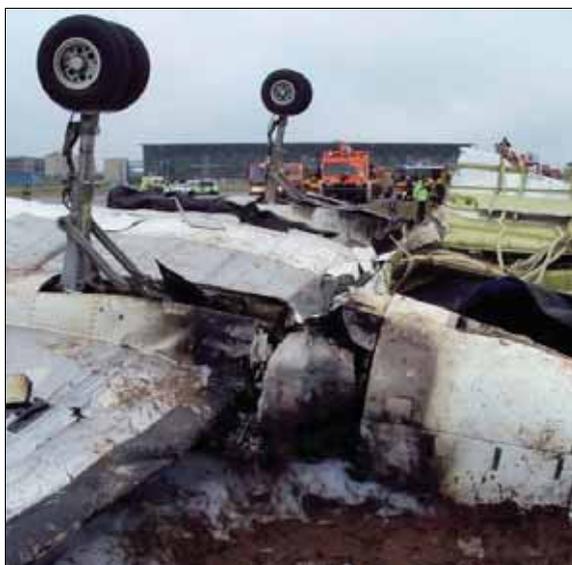
Photo No. 9: Left Engine Fire damage

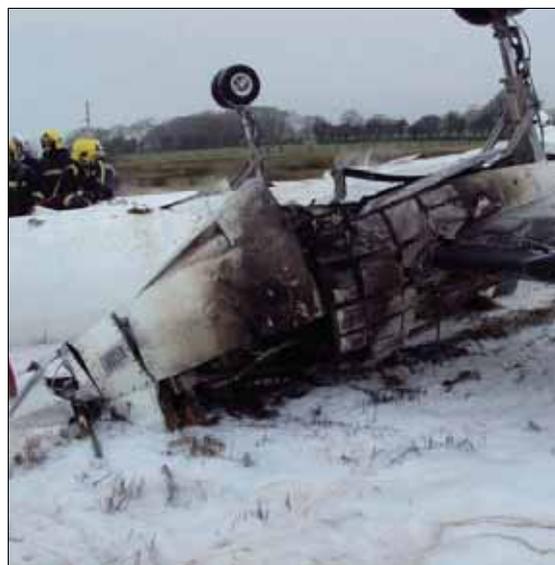
Photo No. 10: Right Engine Fire damage

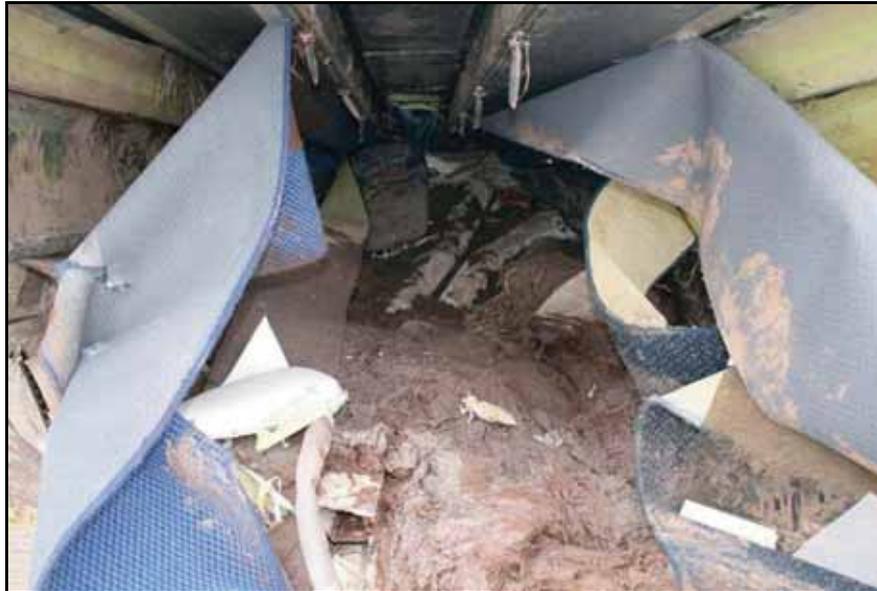
The cockpit and forward cabin were severely crushed in the impact, thus greatly reducing the volume of survival space. Furthermore, the opening in the upper fuselage allowed large amounts of soil to enter the forward cabin as the aircraft transited the grass area (**Photo No. 11**).

Photo No. 11: Forward view of inverted passenger cabin following rescue operation

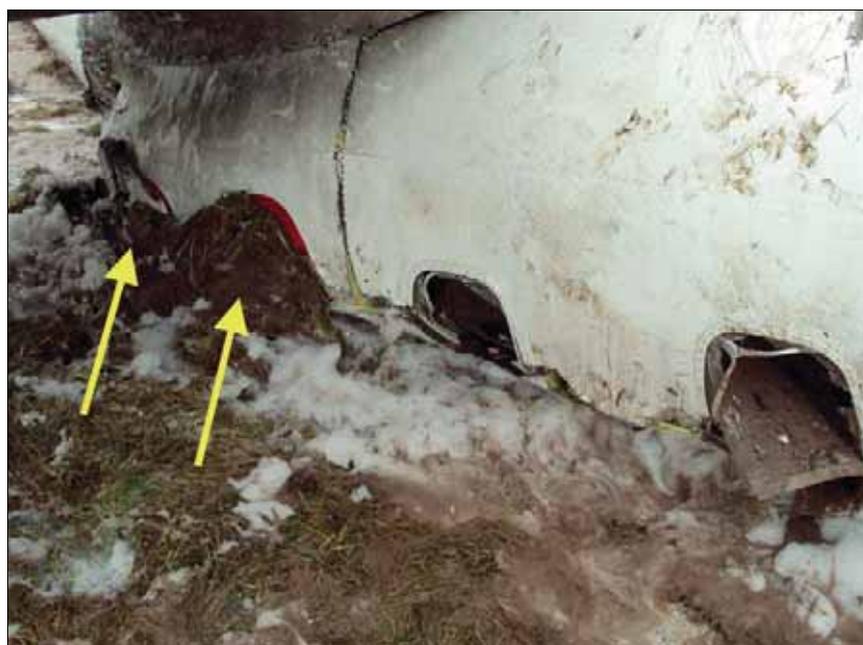
The AFS could not gain entry into the aircraft by normal means as the passenger door at the front left of the fuselage was severely crushed and could not be opened. The three emergency exits in the cabin were unusable due to crushing and were also blocked with soil from inside the cabin (**Photo No. 12**).

Photo No. 12: Starboard Emergency Exits

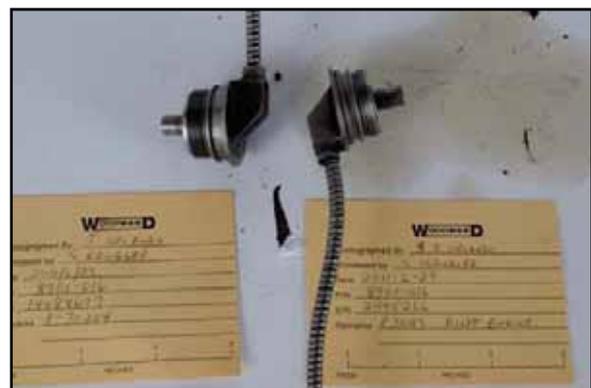
Photo No. 2:

According to the component manufacturer, the P_{T2}/T_{T2} Sensor was produced in August 1999 and was not returned to the manufacturer for any subsequent maintenance. The P_{T2}/T_{T2} sensor bellows displacement was measured using measuring tool WT-51467 # 1 (**Photo No. 1**). The height of the bellows was measured from the inside of the outer flange to the center of the bellows stem measured was 0.947 inches at a room temperature of approximately 75°F (specification is 1.023 ± 0.002 inches at 75°F). This is consistent with the sensor reading a lower temperature value than actual. The height of the bellows being considerably shorter than required would be consistent with a breach within the system (**Photo No. 2**).

Bellows height comparison

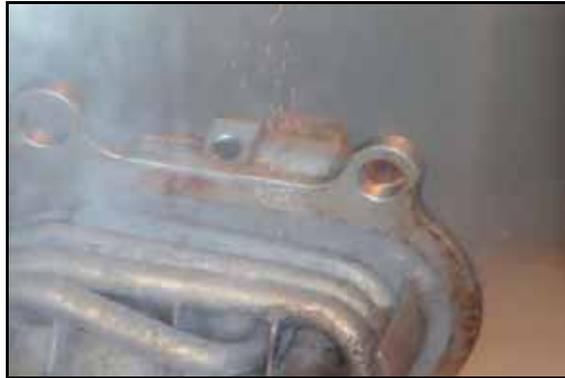
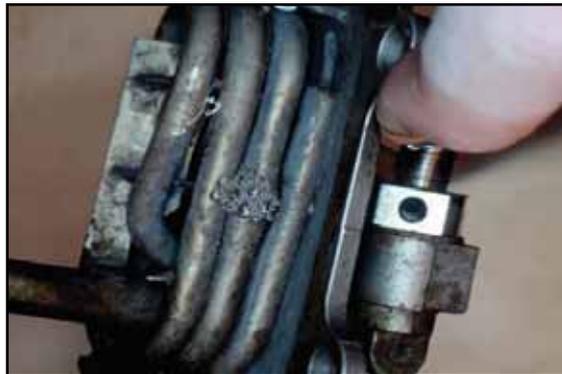
No leak (bubbles) was noted coming from the bellows but a streak of bubbles was noted coming from the sensing tube (**Photo No. 4 & Photo No. 5**). The sensing tube was marked where the bubbles appeared to have been coming from (**Photo No. 6**). Additional examination will be needed to determine the exact location and cause of the breach.

Photo No. 4: Sensing tube leak

Photo No. 5: Sensing tube leak

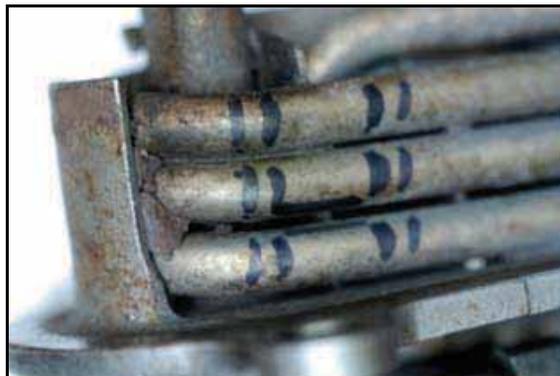
Photo No. 6: Possible sensing tube breach location

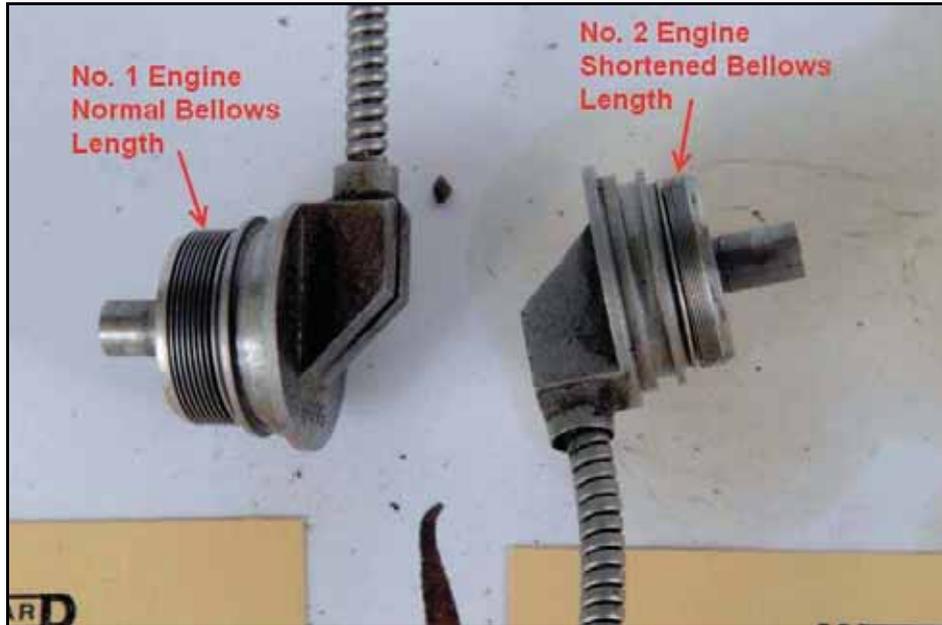
The length of the No. 2 engine bellows being considerably shorter than specified is consistent with a breach or leak within the system.

Photo No. 1: P_{T_2}/T_{T_2} sensor bellows from No. 1 and No. 2 Engines
