# Air Accident Investigation Unit Ireland

## SYNOPTIC REPORT

**Boeing 737-8AS, EI-DWF  
Near Perugia, Italy  
18 July 2013**

AAIU Report No: 2014-010

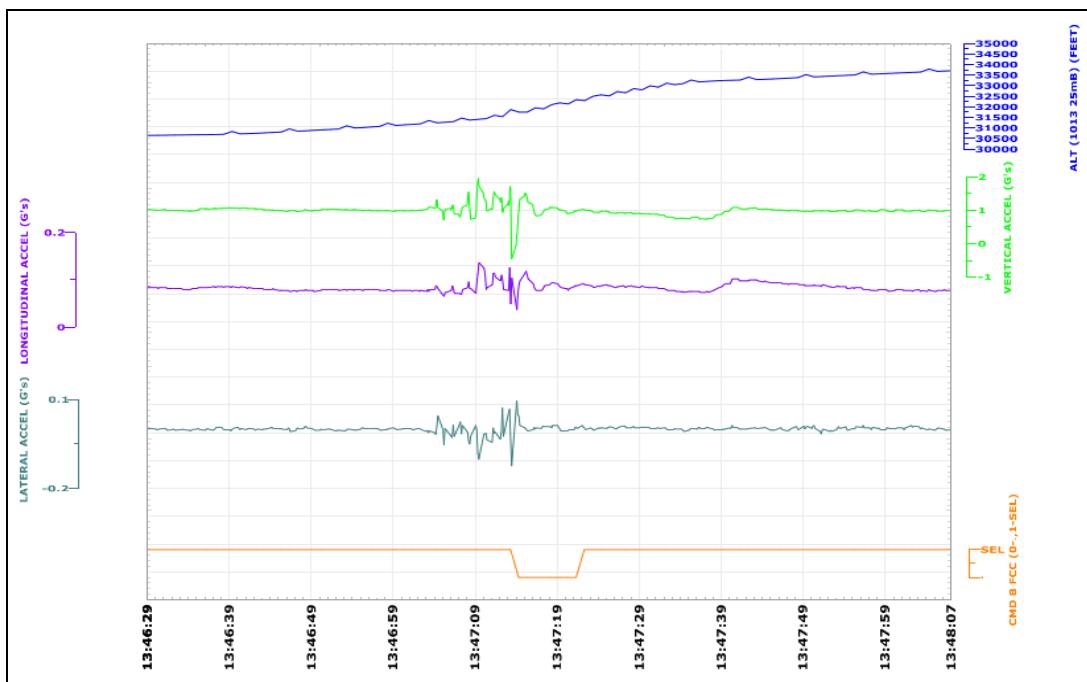
**Figure No. 2:** Graphical representation of Flight Data extract

The Operator provided the Investigation with Flight Data obtained from the aircraft's Quick Access Recorder (QAR). **Figure No. 2** includes a graphical representation of the following parameters: Altitude (blue), vertical acceleration (green), longitudinal acceleration (magenta), lateral acceleration (grey) and autopilot (orange).

It can be seen from the vertical acceleration parameter in **Figure No. 2** that the severe turbulence was encountered suddenly at 13.47:05 hrs at an altitude of approximately 31,000 ft (FL 310). After approximately four seconds, a maximum positive acceleration of 1.95 g was recorded. Five seconds later, the maximum negative value of -0.46 g occurred, quickly followed by a positive acceleration of 1.52 g. Four seconds after this, the turbulence had effectively ceased. Lateral and longitudinal disturbance coincided with the vertical acceleration. The autopilot disengagement is shown by the step in the orange line. The data indicates that no significant turbulence preceded the event.

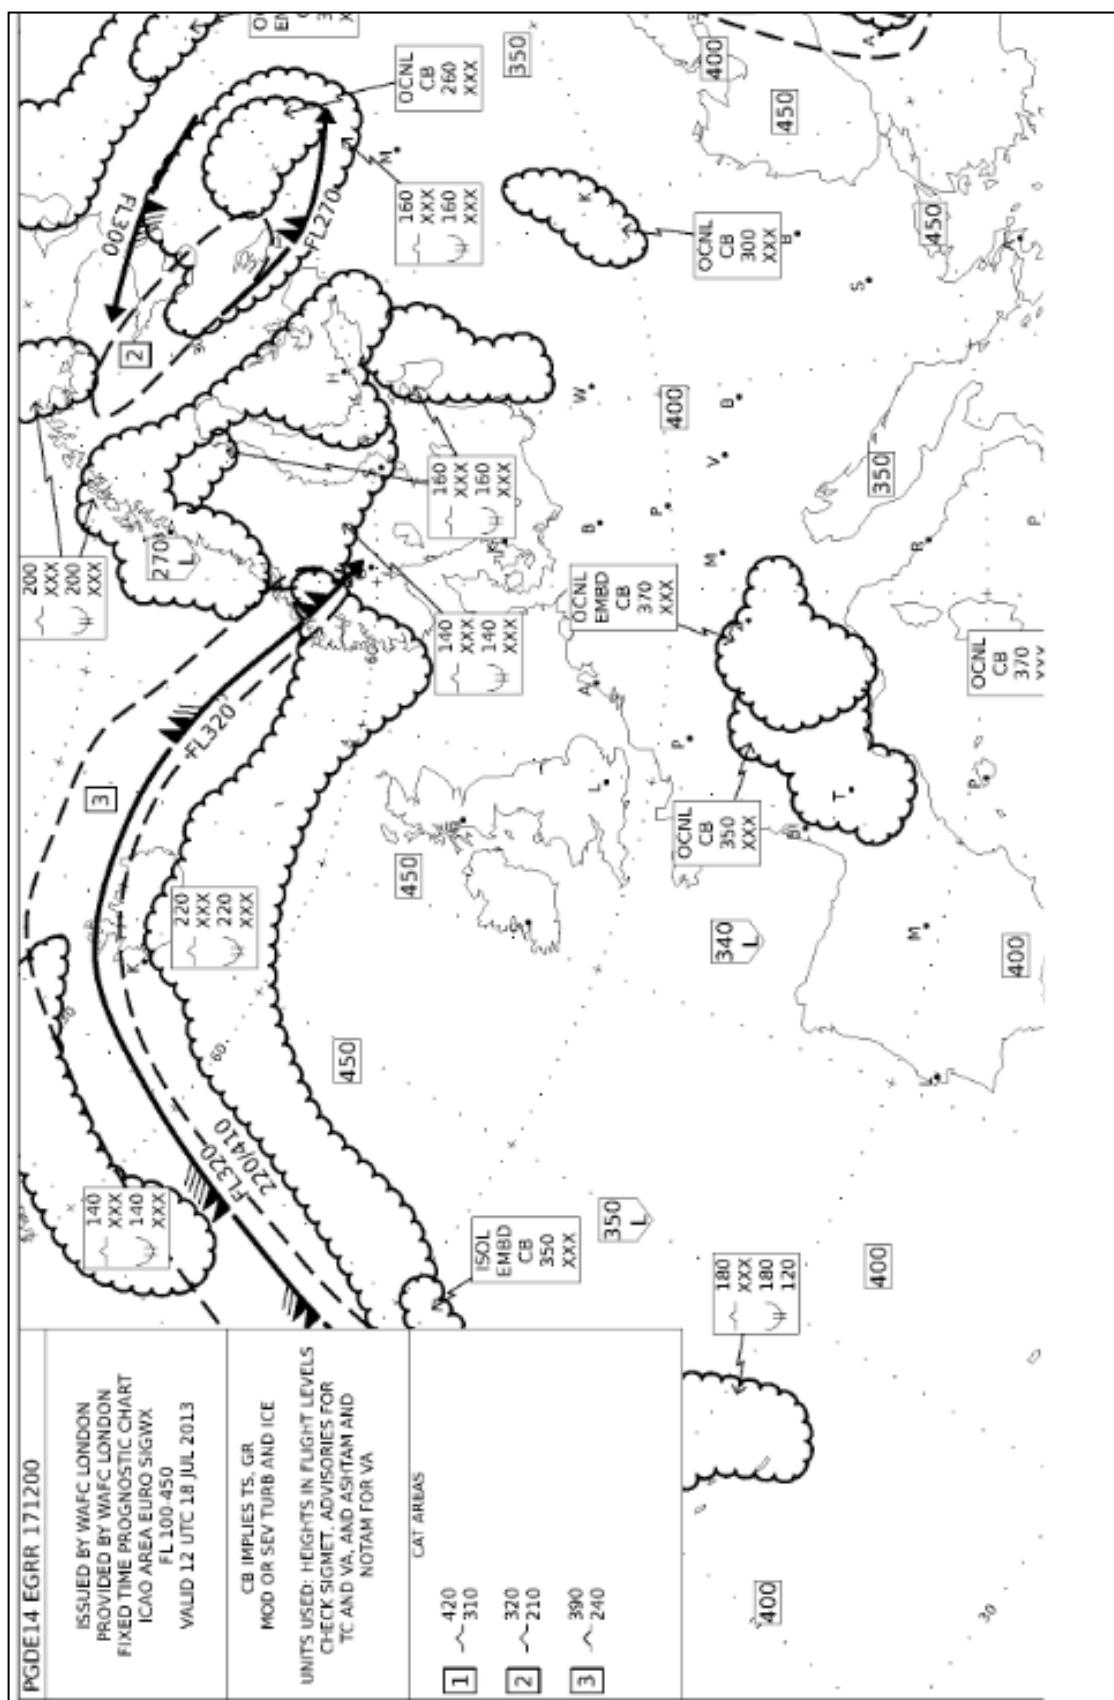
Figure No. 3: Prognostic Chart for 12.00 hrs issued to the Flight Crew.

The meteorological data provided to the Flight Crew by the Operator, as part of the briefing pack for the flight, included prognostic weather charts for 12.00 hrs and 18.00 hrs, (Appendix A). Neither chart indicated any Cb activity over the Italian peninsula. On the chart for 12.00 hrs, occasional embedded Cbs were forecast over northern Italy for FL370. The forecast for 18.00 hrs indicated that these would expand in northerly, easterly and westerly directions and would be present at FL340. The charts note that the presence of Cb implies thunderstorms, hail, moderate or severe turbulence and ice.

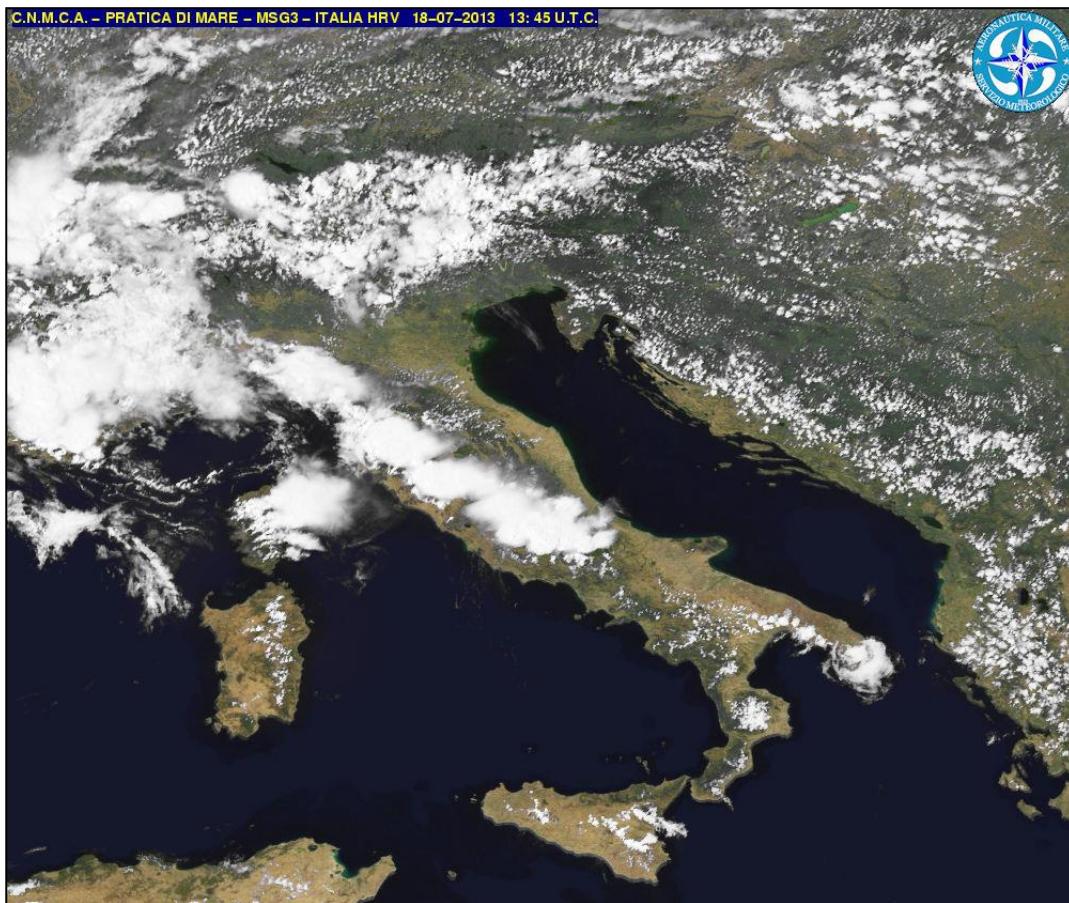
**Figure No. 6:** High Resolution Visible image of actual weather conditions at 13.45 hrs

The ANSV was requested to obtain details of the actual weather conditions that existed in the area at the time of the event. They provided a High Resolution Visible (HRV) satellite image showing the cloud activity over Italy at the time of the occurrence. The SIGMET<sup>16</sup> and AIRMET<sup>17</sup> messages that were issued on the day of the occurrence were also provided.
