# Air Accident Investigation Unit Ireland

## SYNOPTIC REPORT

ACCIDENT  
**Beechcraft Duchess 76, EI-BUN**  
**Weston Airport, Co. Kildare**  
**20 September 2013**

AAIU Report No: 2015-001

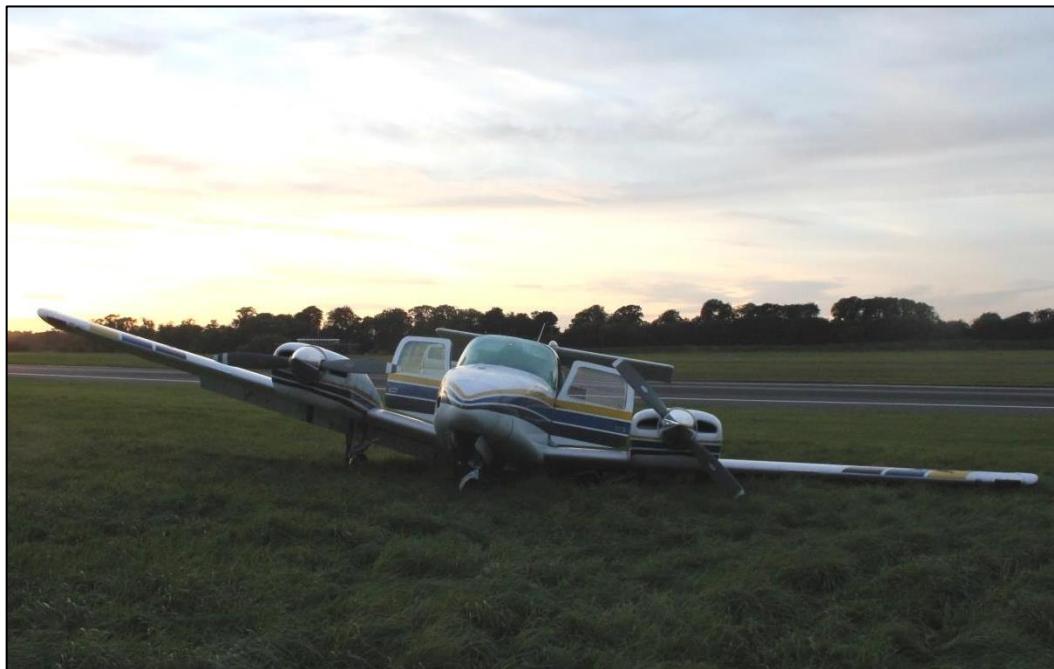
During the landing roll at EIWT following a series of circuits, the left hand main landing gear on the twin-engined training aircraft collapsed. This caused the aircraft to veer to the left and depart the side of the runway before coming to rest in the grass adjacent to the runway. The aircraft sustained substantial damage. The two occupants were uninjured.

**Photo No. 1:** Final resting position of EI-BUN in the grass adjacent to RWY 25.

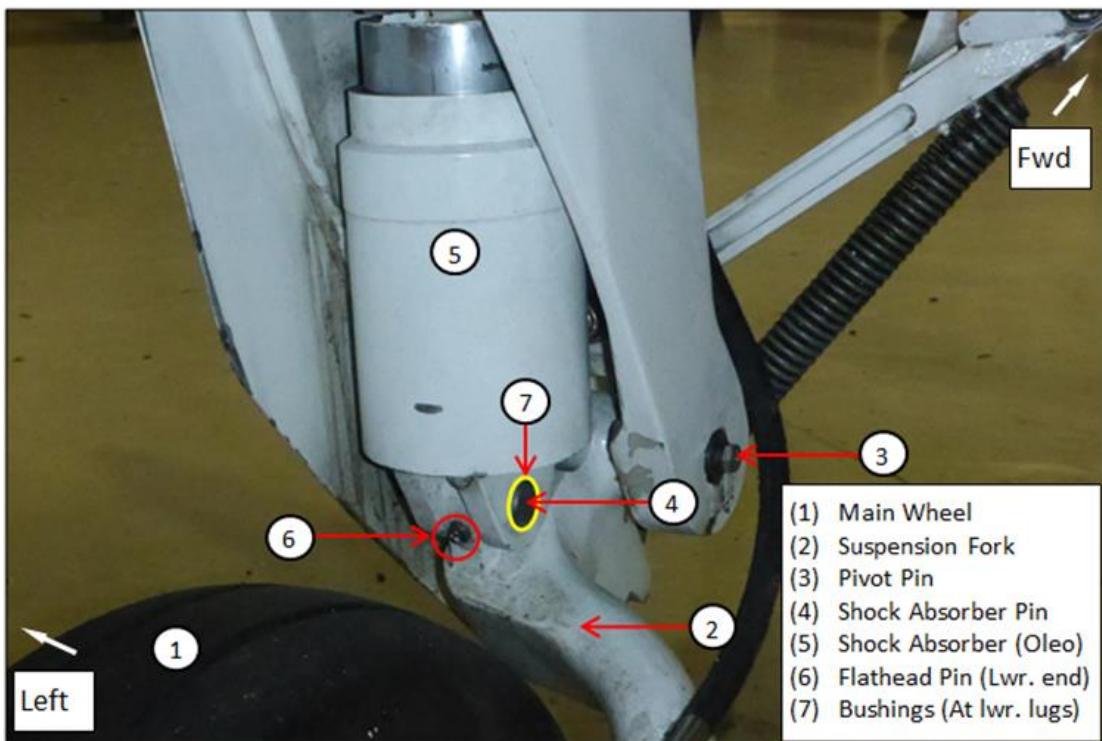
In the case of each main landing gear (**Photo No. 2**), a main wheel (Item No. 1) is fitted to a suspension fork (Item No. 2) which is free to pivot at a pivot pin (Item No. 3). A shock absorber pin (Item No. 4) connects the suspension fork to two lugs which are part of the lower end of the shock absorber (Item No. 5). The shock absorber pin is secured to the suspension fork by a flathead pin (Item No. 6) which is retained by a split pin. The flathead pin prevents movement between the shock absorber pin and the suspension fork.

However, the compression and extension of the shock absorber during normal operation causes some back and forth rotational movement of the shock absorber about the fixed shock absorber pin. Bushings are installed in the lower lugs of the shock absorber to facilitate this movement (Item No. 7 – highlighted in yellow, two per shock absorber).

The Investigation noted that during visual inspection of the landing gear, it is possible to see the lower end of the flathead pin, including the retention split pin (**Section 1.5.2, Photo No. 2**). The upper end of the pin, including the “flathead”, is not readily visible.

As indicated in **Section 1.5.2, Photo No. 2**, the lower end of each flathead pin, including the retention split pin can be readily inspected when the aircraft is in its normal configuration. However, it may be difficult to notice when the lower end of a flathead pin along with its retention split pin is missing. Hence, the L/H shock absorber pin may not have been securely retained for a period of time. This is evidenced by the failure of the flathead pin in the R/H main landing gear which did not lead to an immediate migration of its shock absorber pin. It is further evidenced by the circumferential wear marks on the section of the L/H shock absorber pin that mated with the suspension fork (**Section 1.7.2, Photo No. 8**, Area No 2), which indicate that relative movement may have been occurring here for a period of time. Such movement could only occur if the shock absorber pin was not being retained in the suspension fork by the flathead pin.

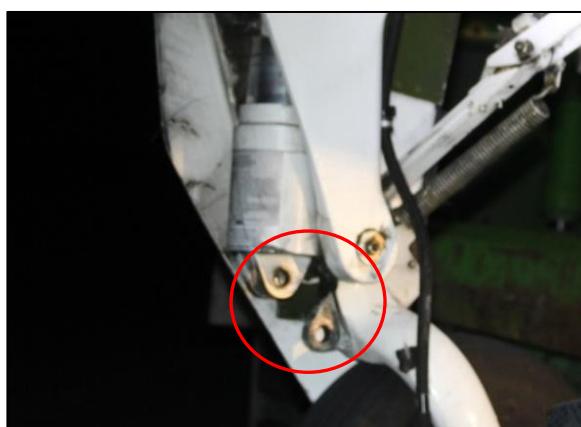
When the aircraft was examined by the Investigation following the occurrence, it was found that the flathead pin had failed in the L/H main landing gear suspension fork, which in turn allowed the shock absorber pin to migrate, resulting in the collapse of the landing gear.

**Photo No. 3** below was taken during the aircraft recovery operation and shows the L/H main landing gear with the shock absorber pin missing (circled area).

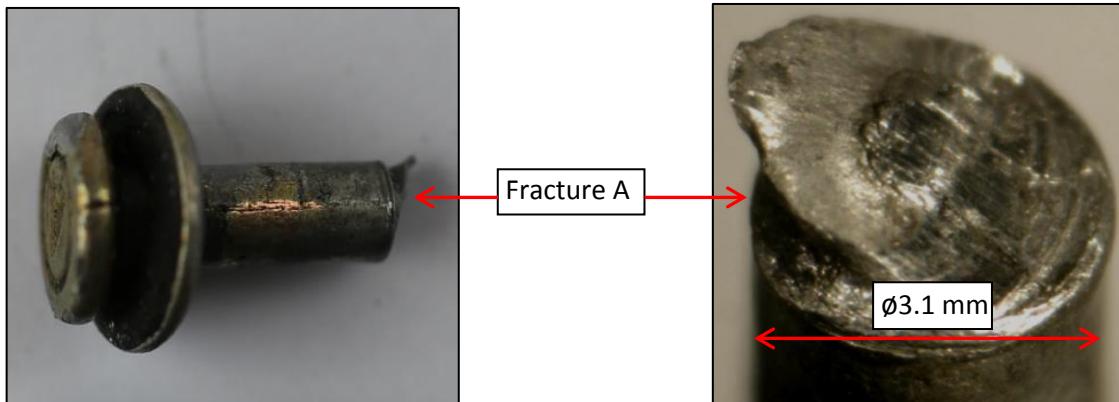
The 8.5 mm long section of the flathead pin removed from the L/H main landing gear suspension fork is shown in **Photo No. 4**. A close-up of the fracture face, identified as Fracture A, is shown in **Photo No. 5**, which is taken from the metallurgist's report.

**Photo No. 4:** 8.5 mm section of the flathead pin from L/H Main Landing Gear.

**Photo No. 5:** Close-up of Fracture A.

The metallurgist's report stated that: "*The fracture features of Fracture A were those of shear failure, whilst those of Fractures B and C were typical of reversed bending fatigue<sup>5</sup> failure. Neither of the Fractures B or C mated with Fracture A. [...] A piece of the LHS [left hand side] retaining pin is missing from Fracture A to Fracture B or C*".

9. Shearing and reverse bending loads resulted in the fatigue failure of the flathead pin which normally secures the L/H main landing gear shock absorber pin.

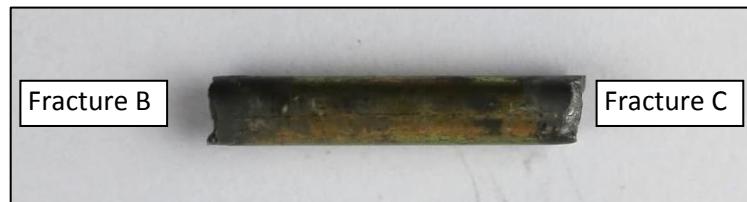
The 16 mm long section removed from the L/H shock absorber pin is shown in **Photo No. 6**. The fracture faces on this section are identified as Fracture B and Fracture C.

**Photo No. 6:** 16 mm long section of flathead pin removed from migrated L/H shock absorber pin.

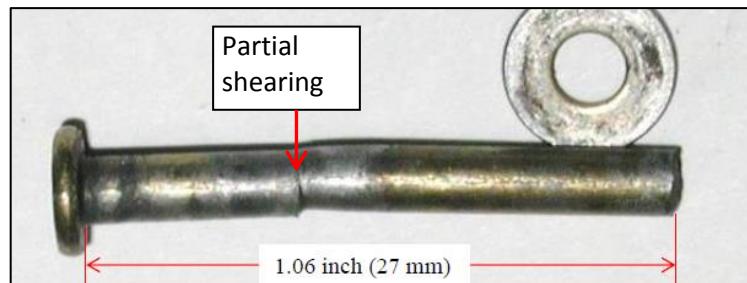
The flathead pin from the R/H main landing gear suspension fork is shown in **Photo No. 7** below, which was also taken from the metallurgist's report. In relation to this pin, the report stated that: "*At a distance 10 mm below the flathead, the pin had suffered partial shearing and at 27 mm below the flathead, the pin was fractured. The fracture features were similar to Fractures B and C in the LHS pin, resulting from reversed bending fatigue*".

**Photo No. 7:** Flathead Pin from R/H Main Landing Gear.

10. The flathead pin fitted to the R/H main landing gear was also damaged as a result of shearing and bending loads, but remained sufficiently intact to prevent the migration of the associated shock absorber pin.

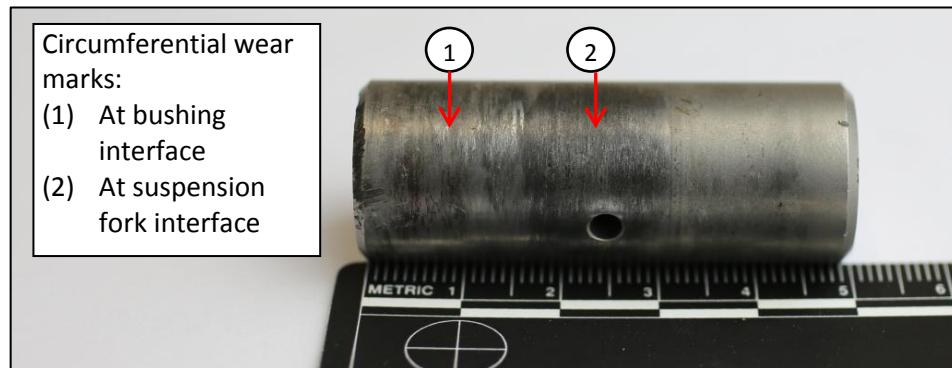
The shock absorber pin was also examined by the metallurgist. It was noted that there were circumferential wear marks on the surface (**Photo No. 8**). In addition, a number of other scratches and marks were found, but the metallurgist considered that they had been caused after the pin migrated. The circumferential wear marks on the pin were in the area which mated with one of the bushings on the lower lugs of the shock absorber (Area No. 1) and also in the area that mated with the suspension fork (Area No. 2).

The Investigation measured the outside diameter of the pin and found it to be 0.749 inches.

**Photo No. 8:** Wear marks on the L/H main landing gear shock absorber pin.

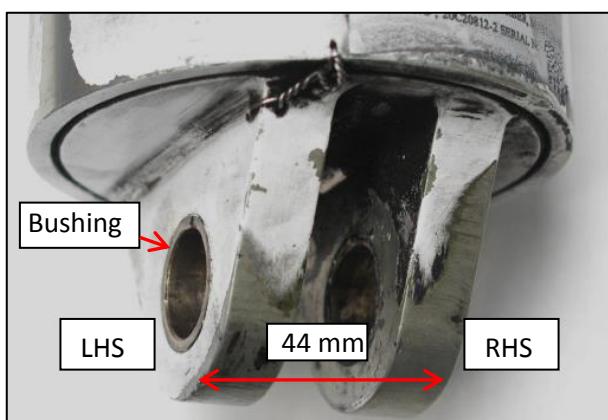
*"There [were] circumferential score marks in both bushings and both had two distinct, deep, lateral (left to right) score marks. The spacing of these marks was similar in both bushings. There was a circumferential track in the LHS bushing and areas that appeared to be a mix of more random scoring/indentation [...]. The cause of the two lateral score marks in each bushing is not known. Some of the damage to the bushings has probably occurred after the fracture of the small retaining pin. However, the similar spacing of the lateral score marks in both bushings is not consistent with damage by the broken retaining pin. It therefore appears that the bushings were scored at some time prior to failure of the small retaining pin. Damage to the bushings and lack of lubrication most probably led to poor rotational movement between the landing gear pin [shock absorber pin] and the bushings which in turn led to fatigue loading of the small retaining pin" (Photos No. 9 and No. 10). It was also noted that "there were remnants of grease in both bushings but this was very dry".*

**Photo No. 9:** Lower lugs of L/H shock absorber with bushings installed.

The plain, brass-like bushings found fitted to the lower lugs of the left hand main landing gear shock absorber on EI-BUN did not contain a PTFE lining, nor were they equipped with lubrication retention grooves/pockets. The internal diameter of one of the bushings was measured to be 0.7519 inches (average value).

The incorrect, non-lubricated aluminium bronze bushings fitted to EI-BUN resulted in increased friction between the bushings and the shock absorber pin, in a similar manner to severely worn PTFE-lined bushings. This increased friction is evidenced by the circumferential score marks on the bushings and on the shock absorber pin.

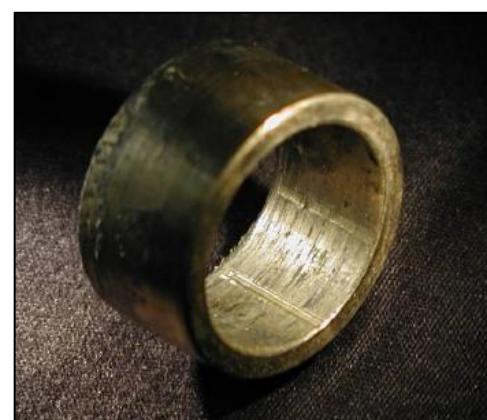
**Photo No. 10:** Scoring on RHS bushing (with bushing removed).

The lateral score marks on the bushings may also have contributed to the increased friction, which resulted in rotational forces being exerted on the shock absorber pin and consequently led to fatigue failure due to shearing and reversed bending loads being placed on the flathead pins.
