Air Accident Investigation Unit Ireland

SYNOPTIC REPORT

ACCIDENT
Beechcraft Duchess 76, EI-BUN
Weston Aerodrome (EIWT)
22 May 2014

AAIU Report No: 2015 - 003

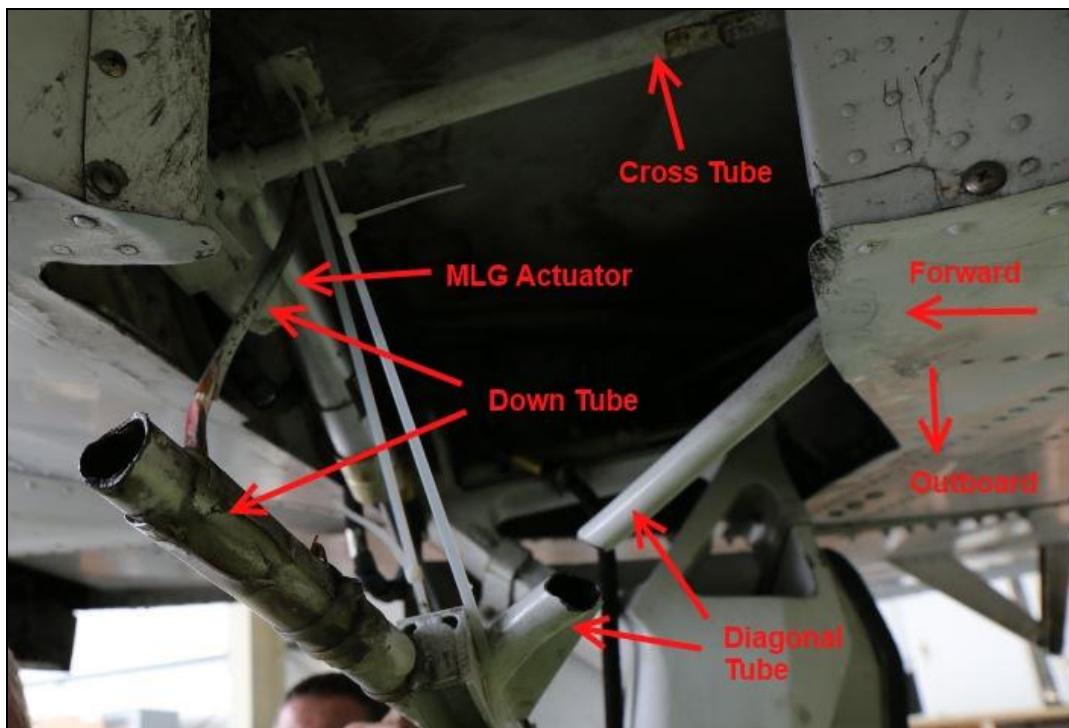
During the accident sequence, the rotating right-hand (R/H) propeller made contact with the runway surface, resulting in damage to both propeller blades. Damage was also caused to the R/H flap assembly, the R/H aileron and the under-surface of the rear part of the aircraft fuselage. During recovery of the aircraft, it became evident that the R/H main landing gear (MLG) side brace, known as the A-frame assembly, had failed. The down tube and the diagonal tube of the A-frame were both fractured, **Photo No. 1**. The part number (P/N) of the R/H A-frame was difficult to discern as the final two digits were very faint. However, correspondence with the aircraft Manufacturer confirmed that the P/N was 105-810023-76.

Photo No. 1: Fractured Side Brace (A-frame) Tubes

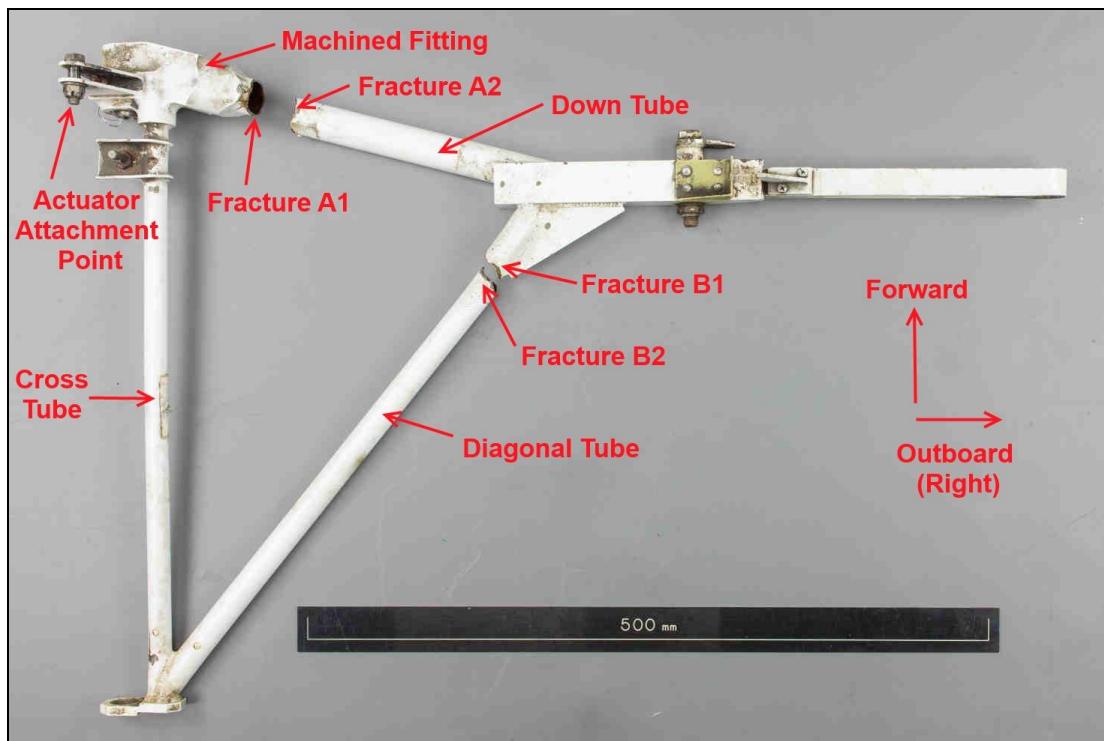
Photo No. 2 shows a top view of the component as shipped. The fracture surfaces are identified as A1 and A2 for the down tube and B1 and B2 for the diagonal tube.

Photo No. 2: A-Frame as Shipped for Metallurgical Analysis

Examination of the diagonal tube fracture surfaces shows this tube to have fractured by ductile overload. This was most probably a secondary failure due to transfer of the loads to a smaller diameter tube after failure of the down tube.”

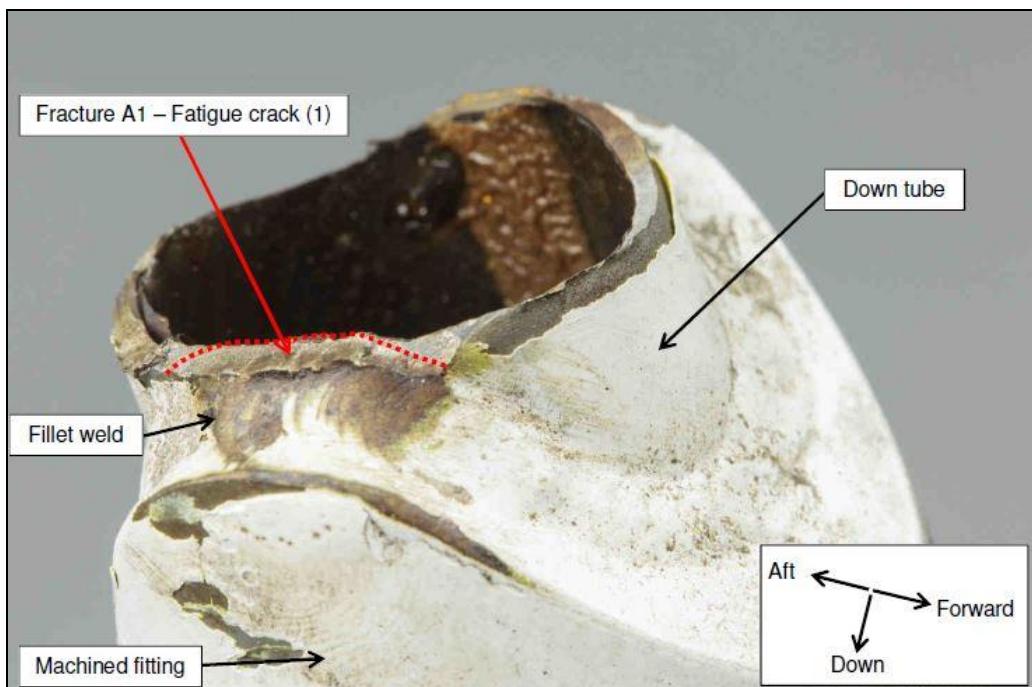
Photo No. 3 shows the location of the fatigue crack on the upper part of the down tube fracture, identified as fracture A1. The fatigue crack (fatigue crack (1)) is located adjacent to the toe of the fillet weld on the downward face of the machined fitting. The fatigue crack at this location had propagated completely through the wall thickness of the down tube. The second area of fatigue cracking located on the opposite side of the upper part of the down tube had also propagated through the wall thickness of the down tube.

Photo No. 3: Fatigue Crack (1) on the Upper Part of the Down Tube Fracture A1

"The two areas of fatigue cracking exhibit features consistent with multiple origin fatigue cracking, with the individual fatigue cracks merging together during propagation of the cracks. The fatigue cracks have initiated on the external surface of the down tube, adjacent to the fillet weld toe. This location of the structure has the largest change in stiffness, but also exhibits the highest hardness and lowest ductility associated with the heat affected zone (HAZ) microstructure of the weld."

"Both of the fatigue cracks have propagated through the wall thickness. Once these cracks had grown to a critical size the remainder of the down tube has fractured in overload. The macro appearance of overload failure regions of the down tube suggest that the tube has finally fractured from the upper surface of the tube, with the fracture progressing around the tube to the lower fatigue crack."

"The external surface of the downward facing side of the tube in the location of fatigue crack (1) shows evidence of mechanical scoring / wear. The substrate steel is exposed in this location and the surrounding paint layers show "feathering" consistent with abrasion. The exposed steel substrate shows evidence of corrosion and the polished microsections of the fracture location show corrosion pitting of both the weld and down tube surfaces. Corrosion pitting can initiate fatigue cracks, however, no evidence of corrosion pitting was observed at the origin of the fatigue cracks examined."

A localised change in wall thickness was observed in the down tube adjacent to fatigue crack (1). This change in wall thickness appears as a “bulge” with the length of the feature similar to that of the fatigue crack width. The even deformation of the microstructure in both sides of the “bulge” suggests deformation from compression loading in this location. The bulge also coincides with the region of lowest hardness in the outer area of the HAZ close to the weld.

It is therefore surmised that the down tube has failed by the formation and propagation of two multiple-origin fatigue cracks due to reverse bending loading of the structure. Once these cracks had grown to a critical size the remainder of the down tube has fractured in overload from the upper surface of the tube, with the overload fracture progressing around the tube to the lower fatigue crack. The loads applied to the tube during final overload have resulted in localised compression loading at the location of the lower fatigue crack which has formed the bulge of material in the region of the softer HAZ.

It is recommended that the Federal Aviation Administration should consider mandating repetitive visual and non-destructive inspections of Beechcraft Duchess 76 A-frames P/Ns 105-810023-75 and 105-810023-76.

It is recommended that Textron Aviation should consider amending the Beechcraft Duchess 76 Maintenance Manual to include specific reference to mandatory repetitive visual and non-destructive inspections of A-frames P/Ns 105-810023-75 and 105-810023-76.
