Air Accident Investigation Unit Ireland

SYNOPTIC REPORT
SERIOUS INCIDENT
Avions de Transport Régional
ATR 72-212A, EI-REL
Near Cork Airport (EICK)
2 January 2014

AAIU Report No: 2015 - 007

Aircraft Type and Registration: ATR 72-212A, EI-REL

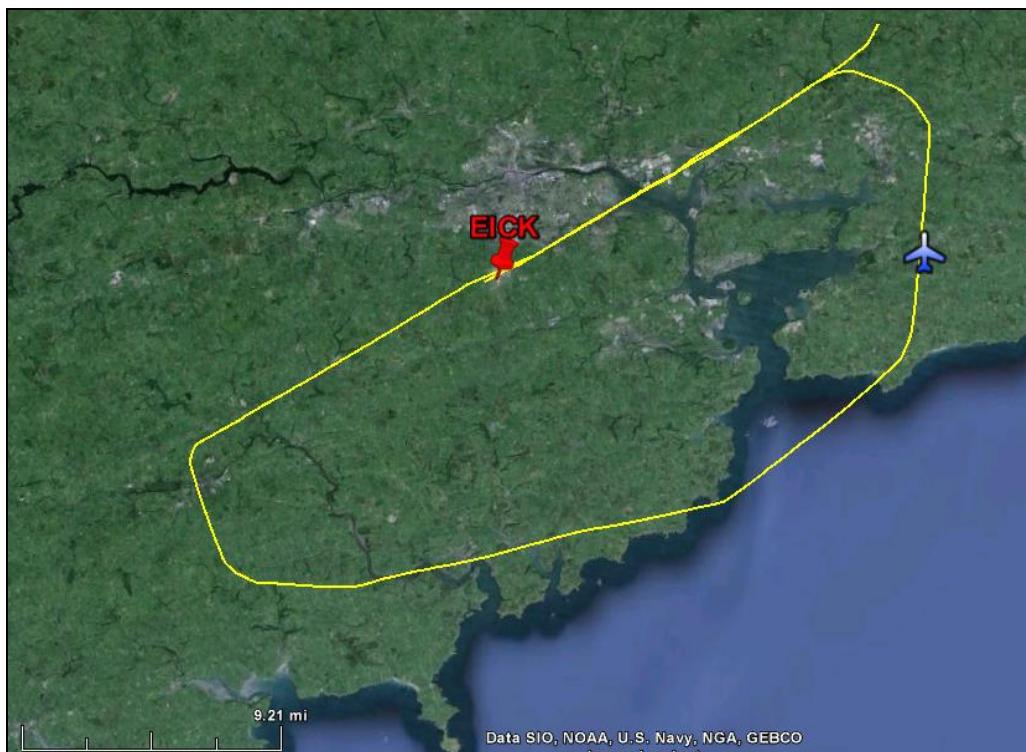
After the go-around, El-REL followed ATC instructions to maintain the runway heading and to climb to 3,000 feet. At 22.34:24 hrs, the Flight Crew informed ATC that they intended to make a second approach to RWY 25. ATC acknowledged this and instructed El-REL to turn left onto a heading of 180°. Thereafter, ATC provided vectors to El-REL which brought the aircraft onto an easterly track to the south of EICK, close to the coast and at times over the sea, **Figure No. 1**.

Figure No. 1: Track of EI-REL between First and Second Approaches.

The Flight Crew were faced with a very rare but significant issue when the forward visibility through their windscreens was obscured due to sea salt accretion on the windscreens, while attempting a night landing at EICK during a winter storm. Their first approach to RWY 25 had resulted in a go-around which was entirely due to a significant increase in indicated airspeed on finals. At that time, there was no issue with forward visibility. The aircraft was then positioned back onto finals by radar vectors issued by ATC, while two other aircraft made approaches to EICK. The track followed was initially to the southwest on the runway heading, followed by left turns under radar control, which brought EI-REL back to the east of the airport along a ground track which was south of EICK, close to the coast and at times over the sea at an altitude of 3,000 ft.

It is likely that the aircraft windscreens began picking up the sea salt contamination while flying along this track, although its presence at that stage is unlikely to have been of particular significance to the Flight Crew, in the absence of strong external light sources.

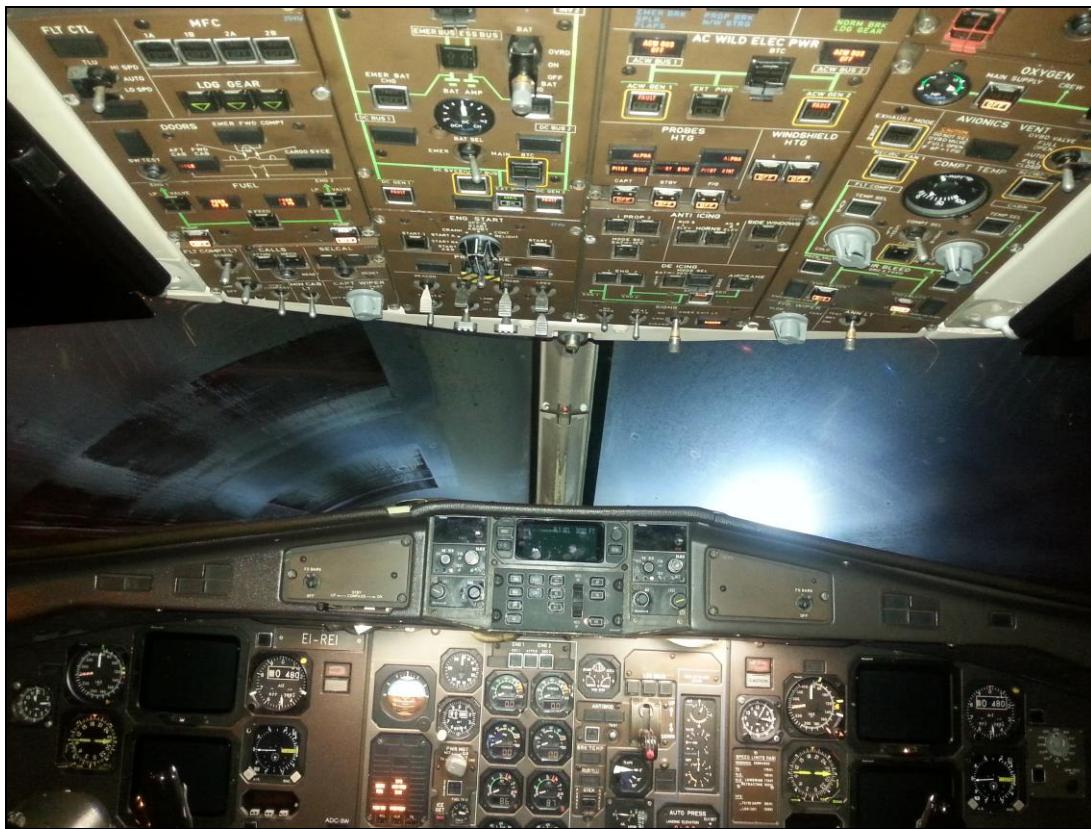
He said that the accretion seemed to be a fast and invisible process. Although the aircraft was VMC, due to the level of turbulence and the type of approach (VOR) being carried out, the Flight Crew's focus was on their instruments rather than on the outside. He felt that the salt accretion occurred during a few minutes, turning the windscreens condition from clear to a blur. The Flight Crew tried to clear the windscreens using both wipers, but to "*absolutely no effect*". The Operator provided photographs of the contamination on EI-REI taken after it had parked, one of which is reproduced as **Photo No. 1**.

The Commander of EI-REL told the Investigation that the salt accretion on her aircraft was thicker than that shown on the photograph of EI-REI.

Photo No. 1: Contamination on Windscreens of EI-REI which landed at EICK shortly before EI-REL.

Another ATR 72 landed shortly before EI-REL's second go-around. It also suffered salt contamination on its front windscreens, although to a lesser extent than EI-REL. The other aircraft had not flown at low level over the sea. It is noteworthy that the Flight Crew of EI-REL and the commander of the other ATR 72 both stated that the windscreen wipers were ineffective in clearing the salt residue. The Commander of EI-REL also stated that she believed that the windscreen heat had exacerbated the issue by drying out the salt and enabling a thick layer to form.

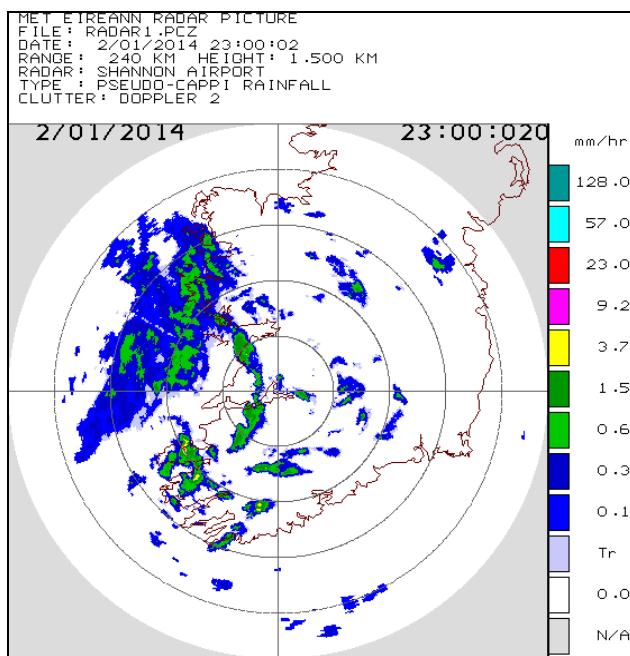
Met Éireann reported that the METAR¹¹ for EICK at 23.00 hrs suggested NIL weather. However, potential for showers did exist at the time in the vicinity. The Report continued, "*It should be noted that RADAR imagery taken at 23.00 hrs shows the EICK area to be echo free - implying that any showers that may have existed in the region of Cork Airport were very light.*"

This radar imagery is reproduced in **Figure No. 2**.

Figure No. 2: Radar Imagery at 23.00 hrs.

10. Although there was a very strong, unstable, showery flow with embedded trough lines at the time of the event, weather radar imagery showed that the area around EICK was echo free, i.e. any showers that may have existed in the area of Cork Airport were very light.
