Air Accident Investigation Unit Ireland

FACTUAL REPORT

ACCIDENT
Tecnam P2002-JF, EI-JPK
Coonagh, Co. Limerick
14 February 2015

AAIU Report No: 2015 - 008

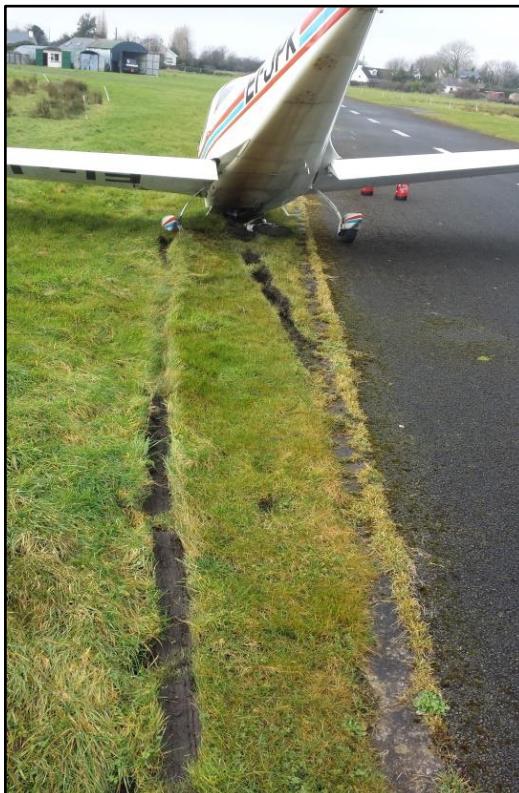
Prior to the occurrence, the Pilot had completed approximately 50 minutes flying, which included two uneventful landings on Runway (RWY) 28. The weather was good with near calm conditions. The Pilot decided to do a third and final circuit to land in order to bring the flight time to a full hour. He reported that he performed a standard approach to RWY 28, flared and touched down within the first third of the runway. After lowering the nose wheel, the pilot applied normal hand-lever braking to slow the aircraft down. Following approximately 100 metres (m) of ground roll, the Pilot felt that there was something wrong with the nose wheel and thought that "*the tyre might be punctured*". He continued to slow the aircraft down by using the hand-lever brake. The aircraft started to veer slowly to the left of the runway centreline. The Pilot attempted to correct the drift with the nose wheel steering, however the steering was unresponsive. In addition, there was no rudder authority to assist as the aircraft was travelling at too low a ground speed at that stage. The aircraft's left main wheel and nose wheel encroached into the soft grass verge on the left side of the runway at a point approximately 280 m along the runway (**Photo No. 1**).

Photo No. 1: Left main wheel and nose wheel tracks adjacent to runway.

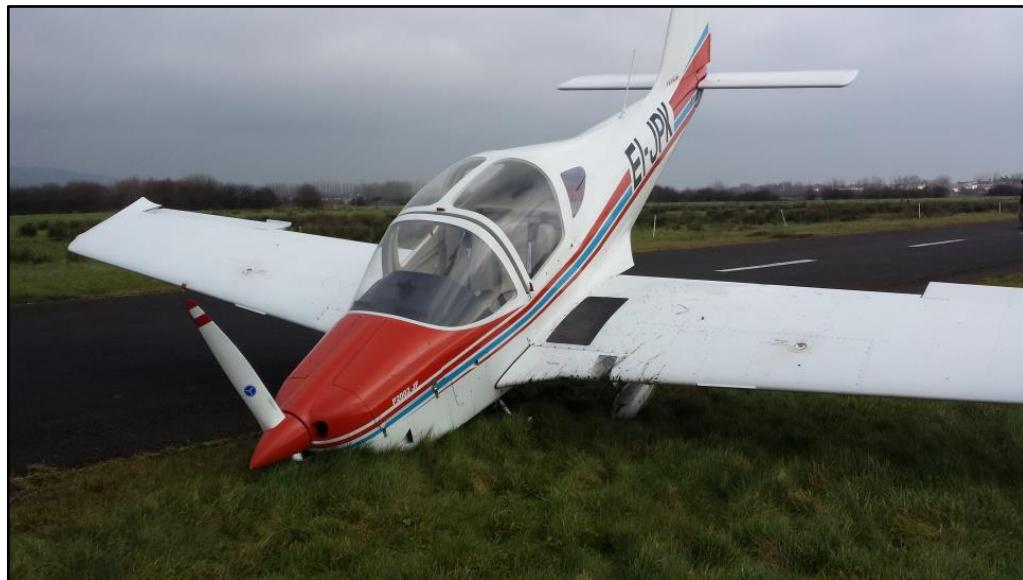
The aircraft's nose wheel dug into the soft ground, collapsed and separated. As the aircraft pitched nose down, the rotating propeller made contact with the soft ground and one blade detached. The aircraft's nose came to rest on the engine cowling (**Photo No. 2**).

Photo No. 2: Final resting position of EI-JPK.

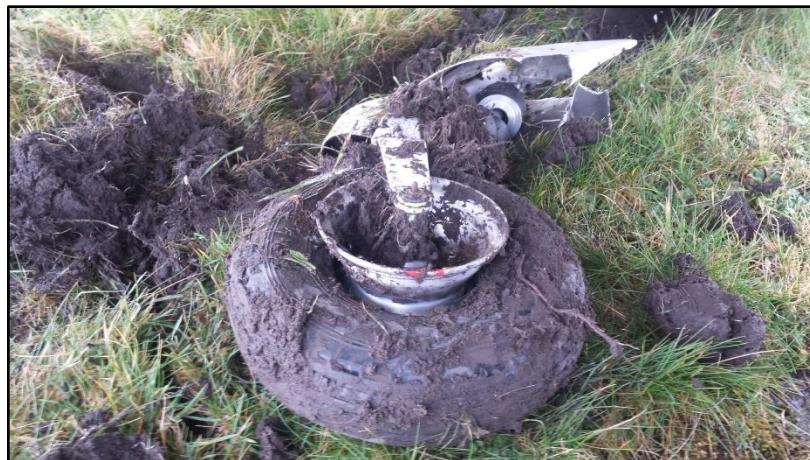
An examination of the separated nose wheel determined that the tyre and tread were in good condition, but the tyre had deflated and the bead had slipped inward on the wheel rim (**Photo No. 3**).

Photo No. 3: Separated nose wheel and deflated tyre.

The Pilot confirmed that the aircraft's three tyres were serviceable during his pre-flight inspection and as two circuits had been successfully completed, it is likely that the nose wheel tyre deflated sometime during the latter stages of the flight or during the final landing/rollout manoeuvre. A loss of tyre pressure will affect the overall form and rigidity of the tyre itself and when a nose wheel deflates it can present difficulties in maintaining directional control. This is particularly relevant when the aircraft does not have differential braking, as was the case with the subject aircraft.

While the aircraft was travelling at a relatively low speed during the rollout, there was still sufficient momentum for the aircraft to veer off the centreline. The loss of effectiveness of the nose wheel steering, the lack of available rudder authority and the narrowness of the runway all contributed to the runway excursion.
