Air Accident Investigation Unit Ireland

SYNOPTIC REPORT

INCIDENT
Avions de Transport Régional
ATR 72-202, EI-FXG
Shannon Airport
26 February 2014

AAIU Report No: 2015-009

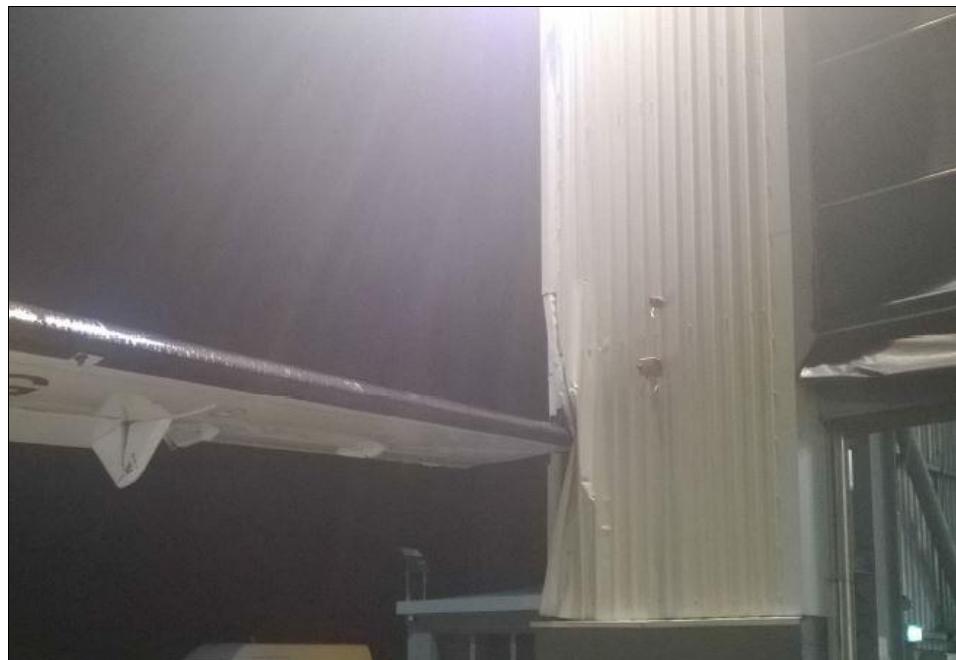
On opening the front cargo door, it became apparent to the Commander that the left wing-tip had struck the corner of the hangar (**Photo No. 1**). The Co-pilot was instructed to complete the normal shutdown checklist. The Flight Crew pulled the CVR⁷ circuit breaker and completed the Technical Log.

Photo No. 1: Left wing-tip impact with hangar cladding

The outboard leading edge of the left wing and the navigation light lens cover were the only parts of the aircraft to make contact with the hangar. The leading edge of wing rib No. 31 (the outermost rib) was slightly distorted at three locations. A section of the upper flange was distorted less than 2 mm and two sections of the lower flange were distorted by less than 3 mm. HFEC NDT⁹ was carried out on this component and no cracks were detected.

Collision with a building structure due to insufficient wing-tip clearance for safe manoeuvring in an area that was unsuitable for that aircraft type.

No sealant was disturbed on the leading edge prior to removal and there was no damage to the leading edge boot apart from a small cut. There were no marks or scratches on the aileron to suggest that contact had been made. The aileron inspection panels were removed and the aileron inspected for damage; none was found. Aileron travel checks were carried out and no faults were found. The navigation light lens and wing de-icing boot were replaced. The Aircraft Manufacturer allowed the replacement of the wing-rib to be deferred until the next C-check.

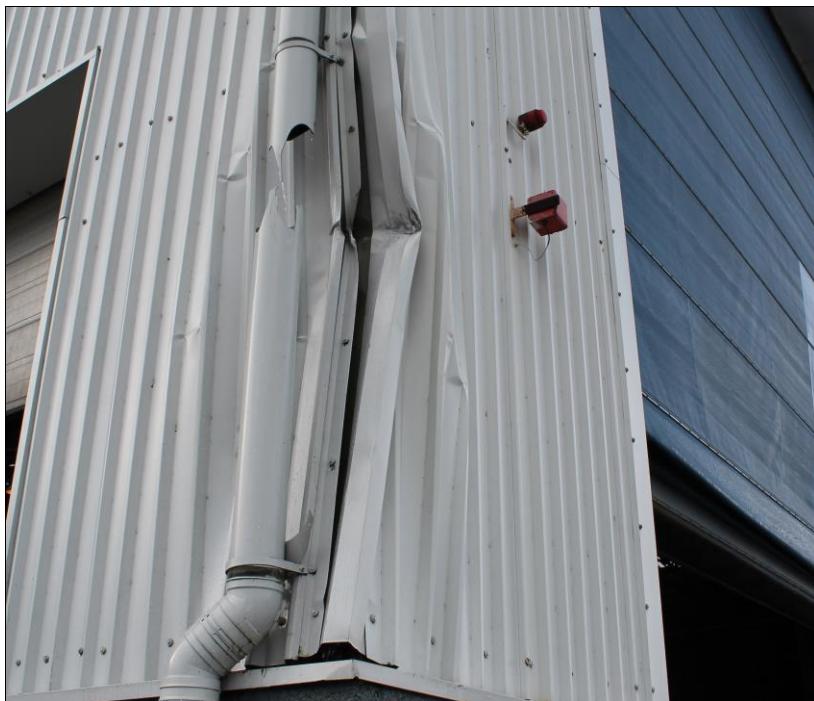
Two metal cladding panels covering the hangar structure and a section of corner angle cladding were damaged by contact with the wing-tip, a section of plastic drainpipe was also damaged (**Photo No. 2**). The internal steel structure of the hangar was undamaged.

Photo No. 2: Damage to hangar

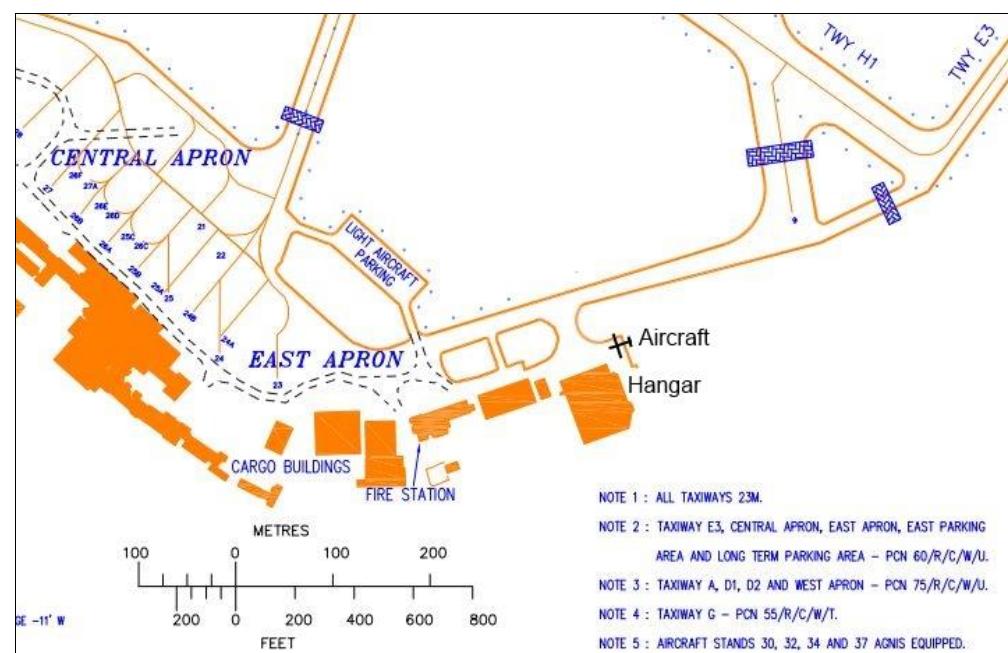
The hangar in question is situated adjacent to a de-designated taxiway (formerly Taxiway E1) between the East Apron and Taxiway E3 (**Figure No. 1**). Responsibility for aircraft towing in these areas rests with the handling company involved. The paved area in front of the hangar (termed a support stand) was designed as temporary parking for aircraft using the hangar. It was not intended for use as a permanent parking area for loading and unloading aircraft.

Figure No. 1: Position of aircraft and the East Apron hangar
(based on IAI Chart AD 2.24-2)

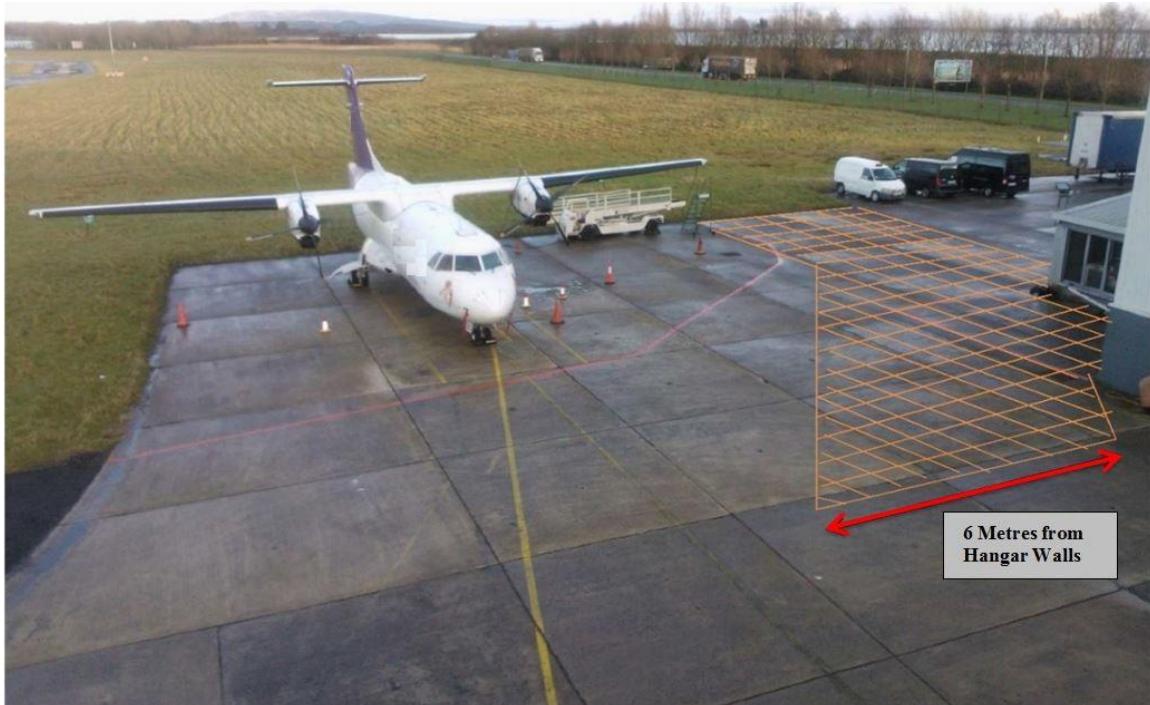
A yellow lead-out line was marked from the position of the nose wheel such that it provided a clearance of approximately 6 metres between the left wing-tip of the aircraft and the hangar. The lead-out line was set at an angle from the parked aircraft position thus requiring an immediate right turn to be carried out upon taxi in order to follow the line and be assured of the wing-tip clearance (**Photo No. 3**).

Photo No. 3: Example of an ATR 42 parked on the East Apron support stand (*File Photo*)

As the wingspan of the ATR 72 is 2.48 metres greater than that of an ATR 42 (**Photo No. 3**), the left wingtip of EI-FXG extended into the hatched area. A photograph taken by the Handling Company prior to the departure of EI-FXG showed the left main landing gear well forward and left of the ramp markings applicable to the ATR 42, as a result, the nose of the aircraft extended well beyond the red line (protected area).
