# Air Accident Investigation Unit Ireland

**FACTUAL REPORT**  
**INCIDENT**  
**BAE Systems Avro 146-RJ85, EI-RJH**  
**Near Dublin Airport**  
**22 May 2014**

**AAIU Report No: 2015 - 016**

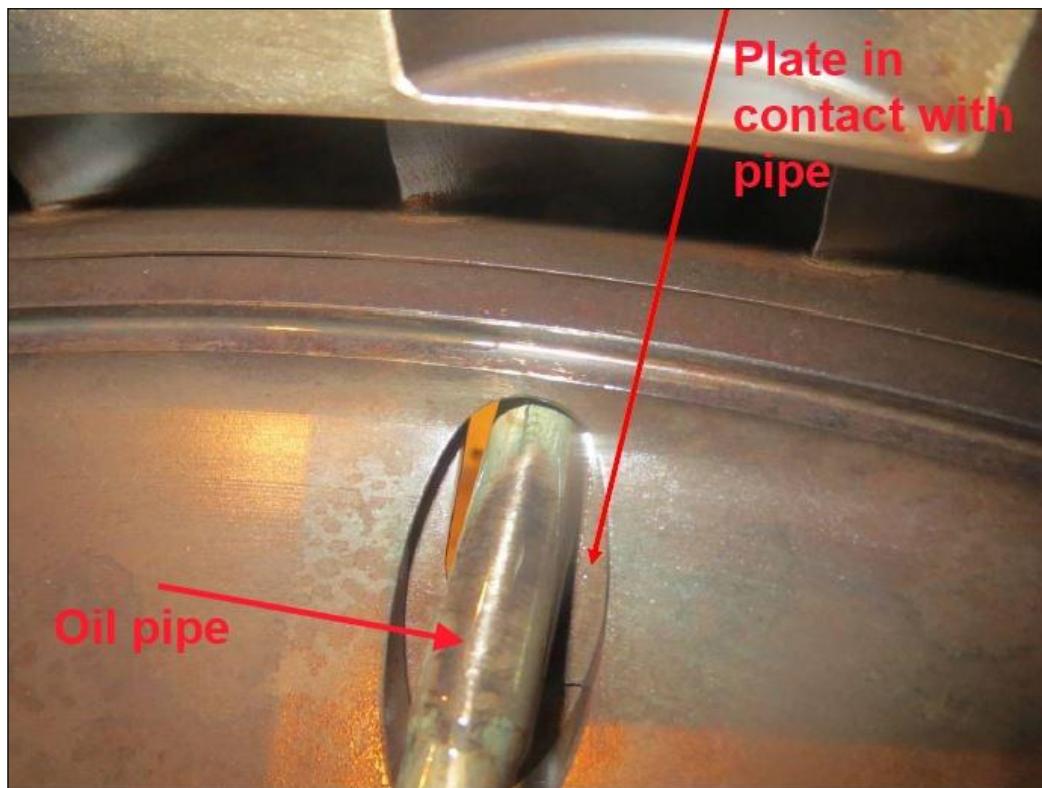
The maintenance facility reported that initial disassembly revealed the engine to be in the expected condition relative to its achieved in service life. The combustor/turbine (CT) module was removed to access the high-pressure turbine (HPT). Upon disassembly of the HPT there was evidence of a leak on the diffuser<sup>8</sup>. The plate that is welded around the oil inlet pipe to the No. 2 bearing housing was found to have fractured and had located itself under the remaining plate and was contacting the inlet pipe (**Photo No. 1**).

**Photo No. 1:** Fractured plate and adjacent oil pipe.

Upon pressure testing of the diffuser and No. 2 bearing housing it was evident that the leak was from the oil inlet pipe.

Bleed air, taken from this section of the engine, is used to supply the air conditioning packs. Thus, it is probable that the bleed air supplied to the air conditioning packs was contaminated by oil leaking from the pipe, which in turn led to the smoke and fumes entering the cockpit and cabin.
