# Air Accident Investigation Unit Ireland

**SYNOPTIC REPORT**

**SERIOUS INCIDENT  
DHC 6-300, C-GSGF**

**Weston Airport, Co. Kildare**

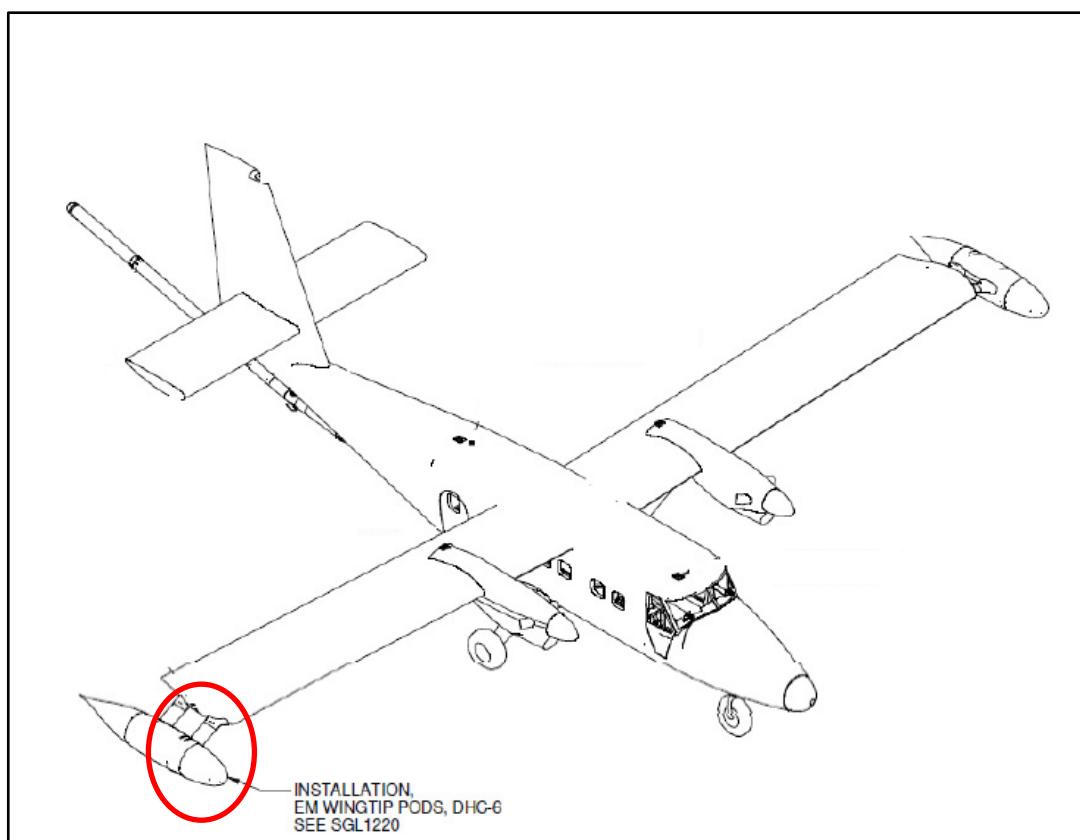
The aircraft had been fitted with a Geophysical Survey Installation in accordance with a Transport Canada approved Supplemental Type Certificate (STC) No. O-LSA11-155. This STC includes an Airplane Flight Manual Supplement (AFMS) No. SGL1298, Rev. A, dated 4 September 2014. This STC involves the installation of, *inter alia*, a wingtip mounted, EM pod containing sensor equipment and wiring (**Figure No. 1**).

**Figure No. 1:** Aircraft schematic showing the EM pod installation, nose cone circled in red.

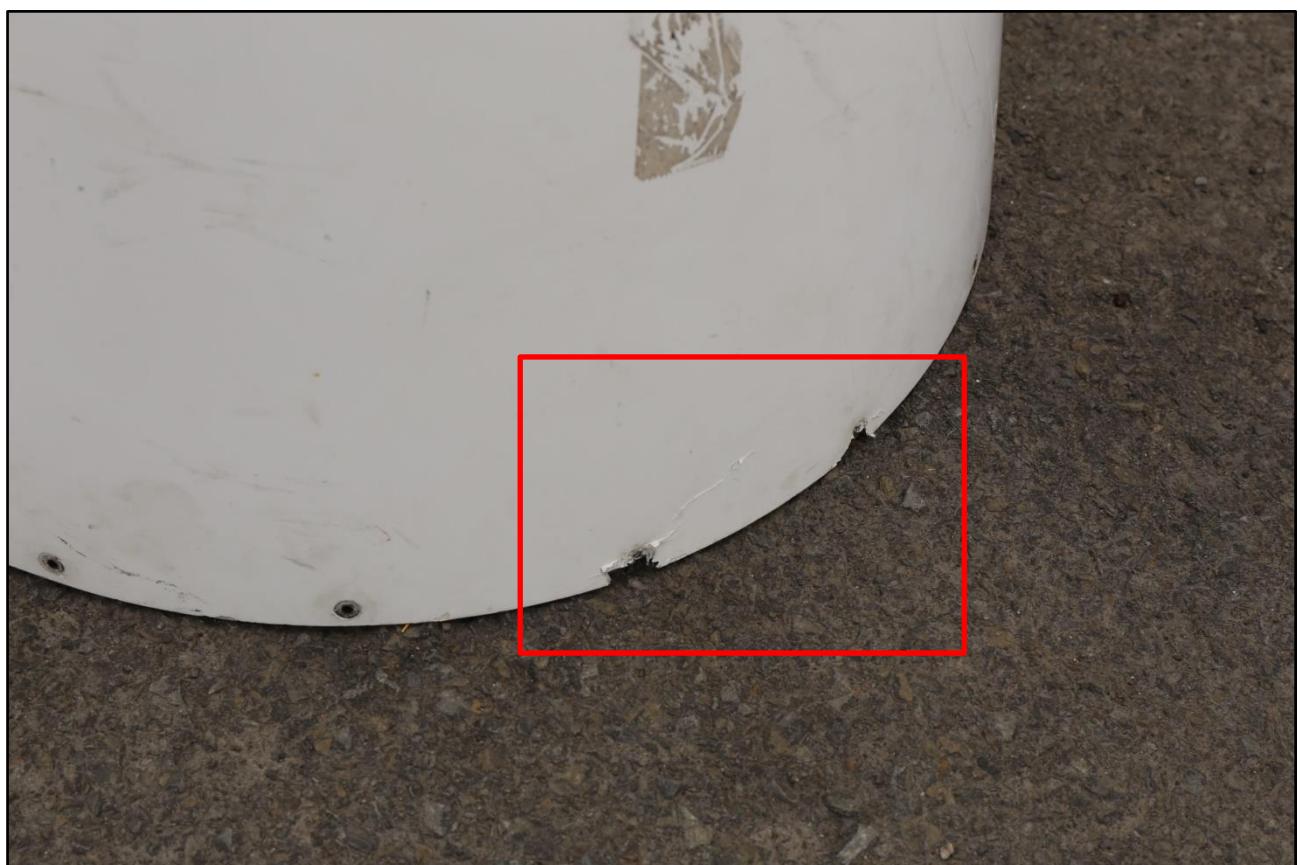
Following the event, the nose cone which had been retrieved at EIWT was inspected and it was noted that two of the retaining screw holes had been torn through (**Photo No. 1**).

**Photo No. 1:** Nose cone with two retaining screw holes torn through.

7. Only two of the nose cone retaining screws were re-installed and the nose cone material failed at these two points.
8. None of the personnel who carried out a walkaround inspection noted that the screws were missing from the right hand EM pod nose cone.

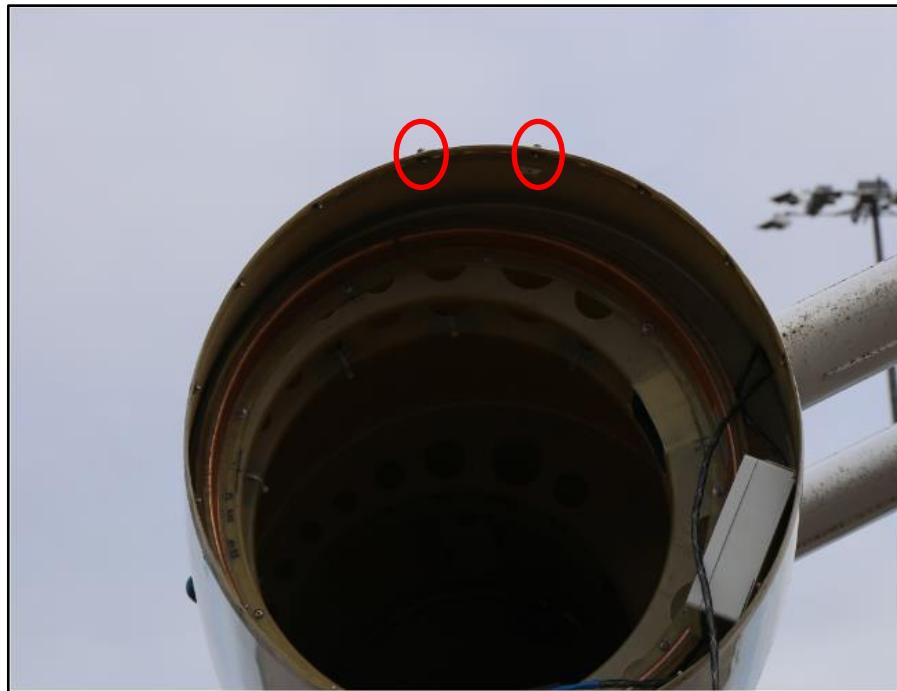
The Investigation noted the presence on the matching surface of the aircraft pod of two retaining screws and the torn out material. The Investigation further noted that the two screws which were installed were positioned at the twelve-o-clock position/top of the EM pod (**Photo No. 2**), and as such could not be seen from the ground when the nose cone was installed.

**Photo No. 2:** Two top screws installed on EM Pod.

The AFM Supplement requires personnel to *"check that all visible attaching fasteners are installed and secure"*. However the Investigation notes that the two screws which were installed, at the top of the nose cone, would not be visible from the ground. With none of the *"visible"* screws installed, someone viewing the nose cone from the ground would not have noticed any difference between adjacent holes on the nose cone even though fourteen screws were missing.

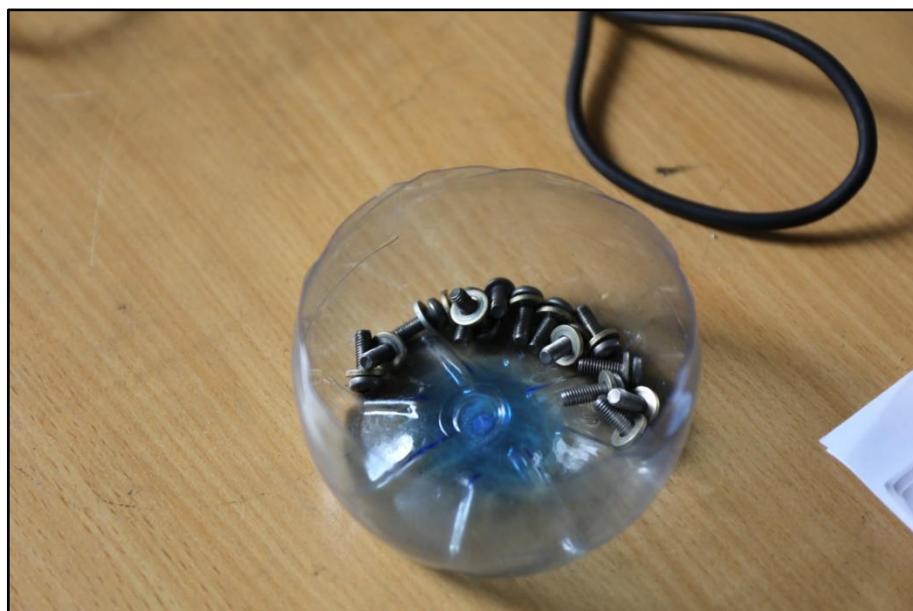
It was reported that during the EM Pod maintenance, while the nose cone was being re-installed, a fault was detected with its sensor system. Re-installation of the nose cone was halted pending identification of the cause of the fault and consequently only the top two nose cone retaining screws were re-installed. Troubleshooting subsequently traced the origin of the sensor problem to a location inboard of the pod and the fault was rectified. The Inspection was then completed but the 14 remaining nose cone retaining screws were not re-installed.

The missing screws were located in a container at the Operator's maintenance facility (**Photo No. 3**).

**Photo No. 3:** Missing nose cone retaining screws as located at the Operator's premises at EIWT.

Since the event the Operator's Policy Manual has been updated to include a documented policy mandating the use of flagging tape and also of cloth bags to hold hardware that are attached to the parent component to aid as a visual cue.

The Operator issued a maintenance memorandum requiring all attaching hardware to be painted the same colour as its background. The Operator believes that this will provide an enhanced visual cue in the event of required hardware not being installed.
