Air Accident Investigation Unit Ireland

SYNOPTIC REPORT

SERIOUS INCIDENT
Boeing 757-224, N41140
80 NM Southwest of Dublin, Ireland
20 October 2013

AAIU Report No: 2016-007

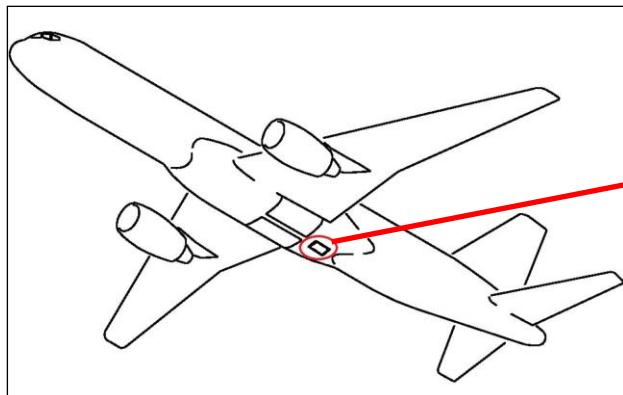
- The door frame of the centre hydraulic system servicing bay and adjacent structure (**Figures No. 1 and No. 2**).
- The centre hydraulic system servicing bay door and hold-open rod.
- The electrical connector on the filter module pressure transmitter.
- The reservoir drain valve, quantity transmitter and associated electrical connector.
- The hydraulic service panel light.
- The wiring loom P-Clip at the rear of the hydraulic service bay.
- Some wing to body fairings had popped open.

Figure No. 1: Location of the centre hydraulic system servicing bay

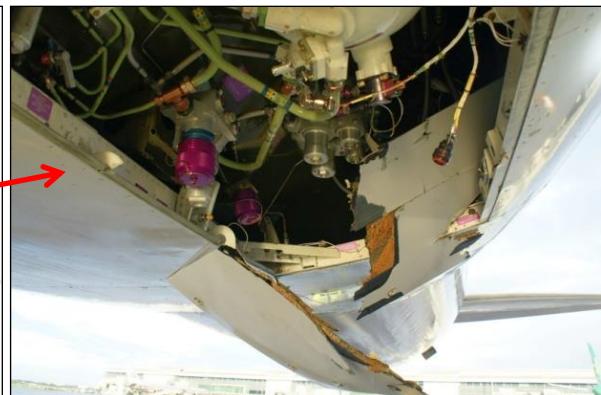
Figure No. 2: Photograph of Damage to Service Bay and Associated Structure

FDR data shows that the hydraulic quantity decreased sometime after 19,685 seconds. At this time the aircraft was undergoing the second pitch down manoeuvre, after which the aircraft underwent a rapid change in normal load factor from -0.22 g to + 1.62 g, as the airspeed increased through the Vmo of 350 kts. The computed airspeed remained above 350 kts for the next 50 seconds, peaking at 380 kts. It was likely that the centre hydraulic access panel became detached during this period, causing the damage that resulted in loss of centre hydraulic system fluid and pressure.

Following the occurrence, maintenance personnel performed a functional test of the Air Data System and no defects were found. The aircraft's pitot-static system was tested and no leaks or heating systems faults were identified. The damaged centre hydraulic system components and servicing bay door were replaced and a temporary repair was carried out to the wing to body fairings. The aircraft then operated on a ferry flight to KEWR, USA, where permanent repairs were carried out.
