# Air Accident Investigation Unit Ireland

## FACTUAL REPORT

#### Enstrom 280FX, N280CH

#### Near Carlingford, Co. Louth, Ireland

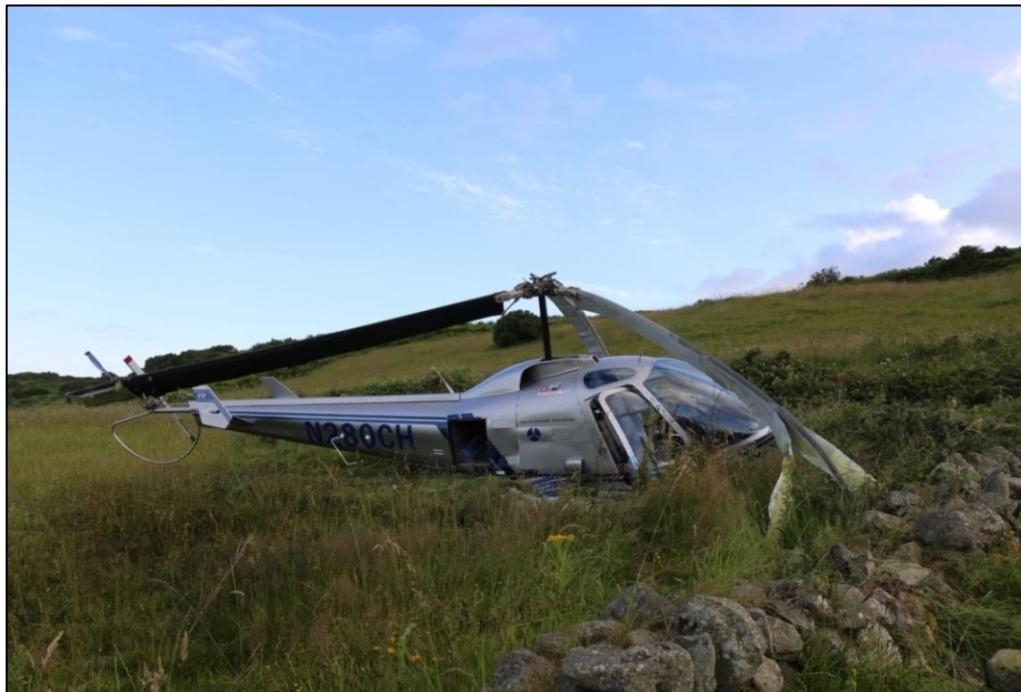
The helicopter impacted with sloping, uneven ground and came to rest on a heading of 310° magnetic, approximately 140 metres (m) to the south east of the departure site and pointing back towards it (**Photo No. 1**). The helicopter was substantially damaged as a result of the impact. The Pilot informed the Investigation that he was the sole occupant, that he had no problem in exiting the helicopter and that apart from a sore elbow, he was uninjured. The Pilot also stated that the helicopter had no technical defects prior to the accident. He reported that no flight plan was filed.

During the impact sequence, the rotating main rotor struck the uneven ground, resulting in severe damage to the blades. Damage was also sustained to the helicopter's right hand landing skid with associated damage to the right hand side of the fuselage.

**Photo No. 1:** Final resting position of N280CH (The flight commenced from a landing site located uphill and approximately 140 metres to the right).
