Air Accident Investigation Unit Ireland

SYNOPTIC REPORT

SERIOUS INCIDENT
Boeing 737-8AS, EI-EFB
Near Stansted, United Kingdom
18 September 2014

AAIU Report No: 2016-013

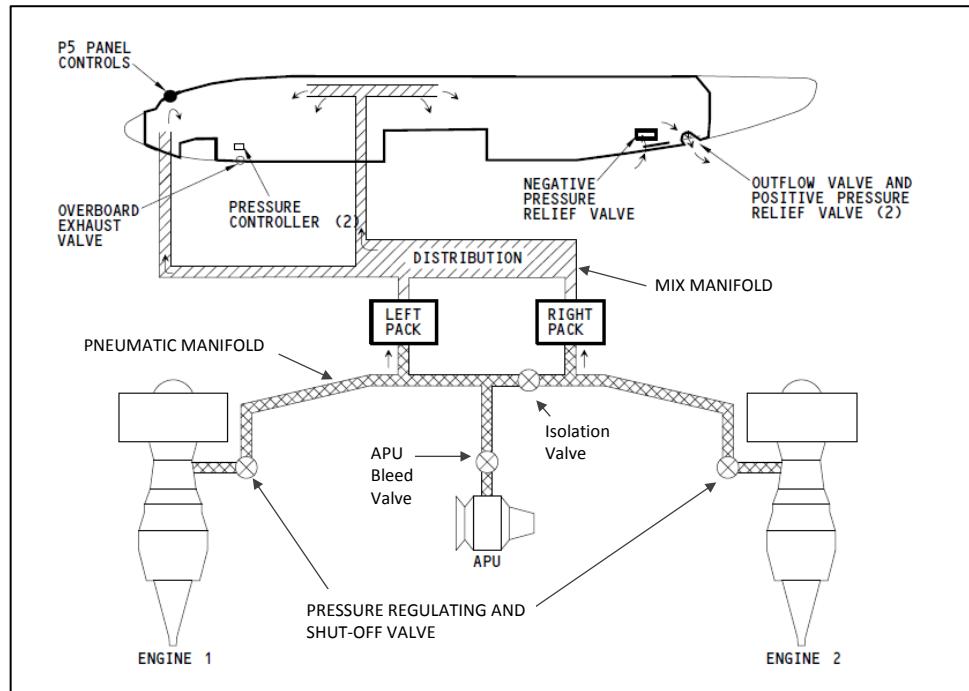
Figure No. 1: Schematic Diagram of Air Conditioning System
 (Adapted from *Boeing 737-600/700/800/ 900 Aircraft Maintenance Manual*)

Two Pressure Regulating and Shut-Off Valves (PRSOVs) regulate the bleed air pressure in the pneumatic manifold. An isolation valve, when closed, isolates the pneumatic manifold into a left and right system. The APU is the primary source of bleed air when the aircraft is on the ground and is a backup source of bleed air in flight. Bleed air from the APU is controlled by the APU bleed valve and is supplied to the system on the left side of the isolation valve. Therefore, the bleed air flow from the APU is biased towards the left pack. **Figure No. 1** refers.

APU bleed air enters the pneumatic manifold at a point to the left of the bleed isolation valve. Therefore, the flow is biased towards the left pack, which supplies conditioned air to the cockpit. This may have resulted in the left hand air conditioning system being more affected by contamination than the right hand system and may explain why the majority of the reports were for unusual smells in the cockpit and not the aircraft cabin.
