# Air Accident Investigation Unit Ireland

## SYNOPTIC REPORT

### INCIDENT Boeing 737-8AS, EI-FIH Porto, Portugal

5 September 2015

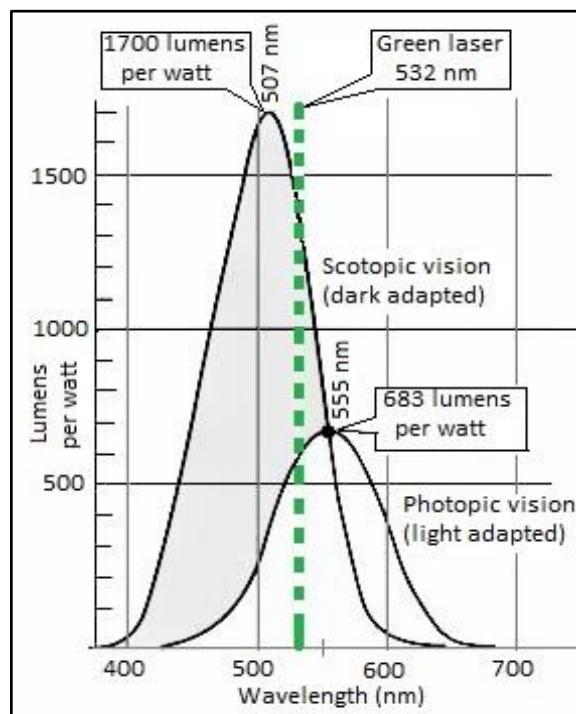
**Graph No. 1:** Sensitivity of Human Eye when Dark and Light Adapted

In the US, reports indicate that laser attacks by handheld lasers are primarily green in colour, (91%), as opposed to red (6.3%), which was more common a few years ago. FAA flight simulator studies have shown the adverse visual effects from laser exposure are especially debilitating when the eyes are adapted to the low-light level of a cockpit at night (dark-adapted). This is significant because the wavelength of most green lasers, 532 nanometres (nm), is close to the eye's peak sensitivity when dark-adapted. A green laser may appear as much as 35 times brighter than a red laser of equal power output. **Graph No. 1** (adapted from the FAA document) shows the sensitivity of the human eye when dark-adapted and light-adapted. The dotted green line represents the frequency of the majority of green lasers, i.e. 532 nm, which lies close to the peak dark-adapted frequency.

Data indicates that the majority (91%) of laser attacks on aircraft are from green lasers, and that the attacks occur during night operations, when the aircraft are approaching an airport. In general, during night approaches, flight crew will have the cockpit lighting off, or dimmed, to allow the eye to become dark adapted, thus maximising the acquisition of visual cues from the airport and runway environment. The operating frequency of green lasers is in the region of 532 nm, and consequently will have a significant effect on a dark-adapted human eye.

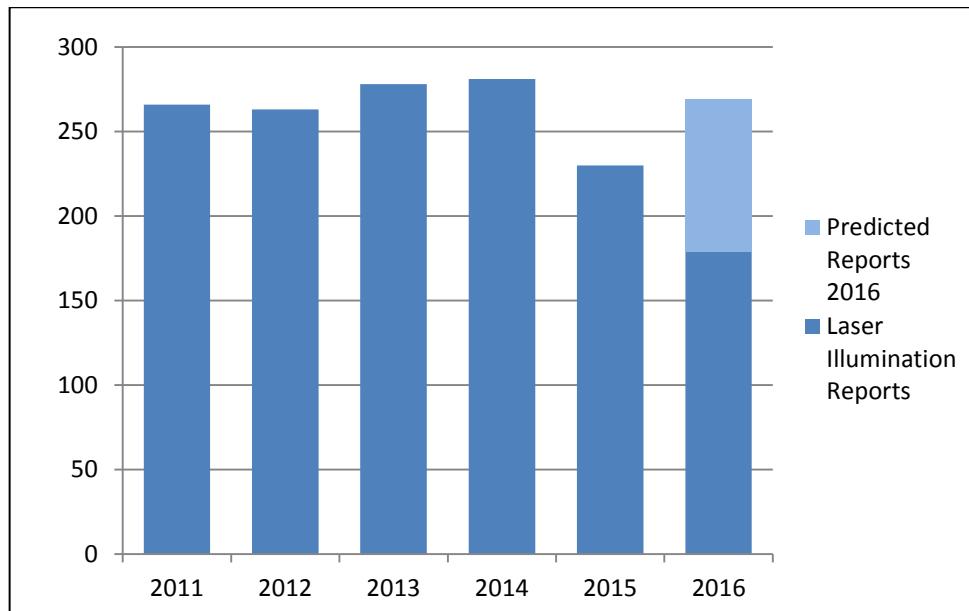
**Graph No. 2: Reported Laser Illuminations**

Statistical data for laser attacks on Irish registered aircraft are gathered by the IAA through Mandatory Occurrence Reports via the Safety Occurrence Tracking System. **Graph No. 2** shows data for reported laser illuminations to Irish registered aircraft operated by the seven largest Air Operator Certificate (AOC) holders in the State, from 2011 to 2016<sup>15</sup>.

<sup>15</sup> Data up to and including 31 August 2016 is shown in dark blue. Projected numbers (based on average of previous years) for remainder of 2016 are shown in light blue.

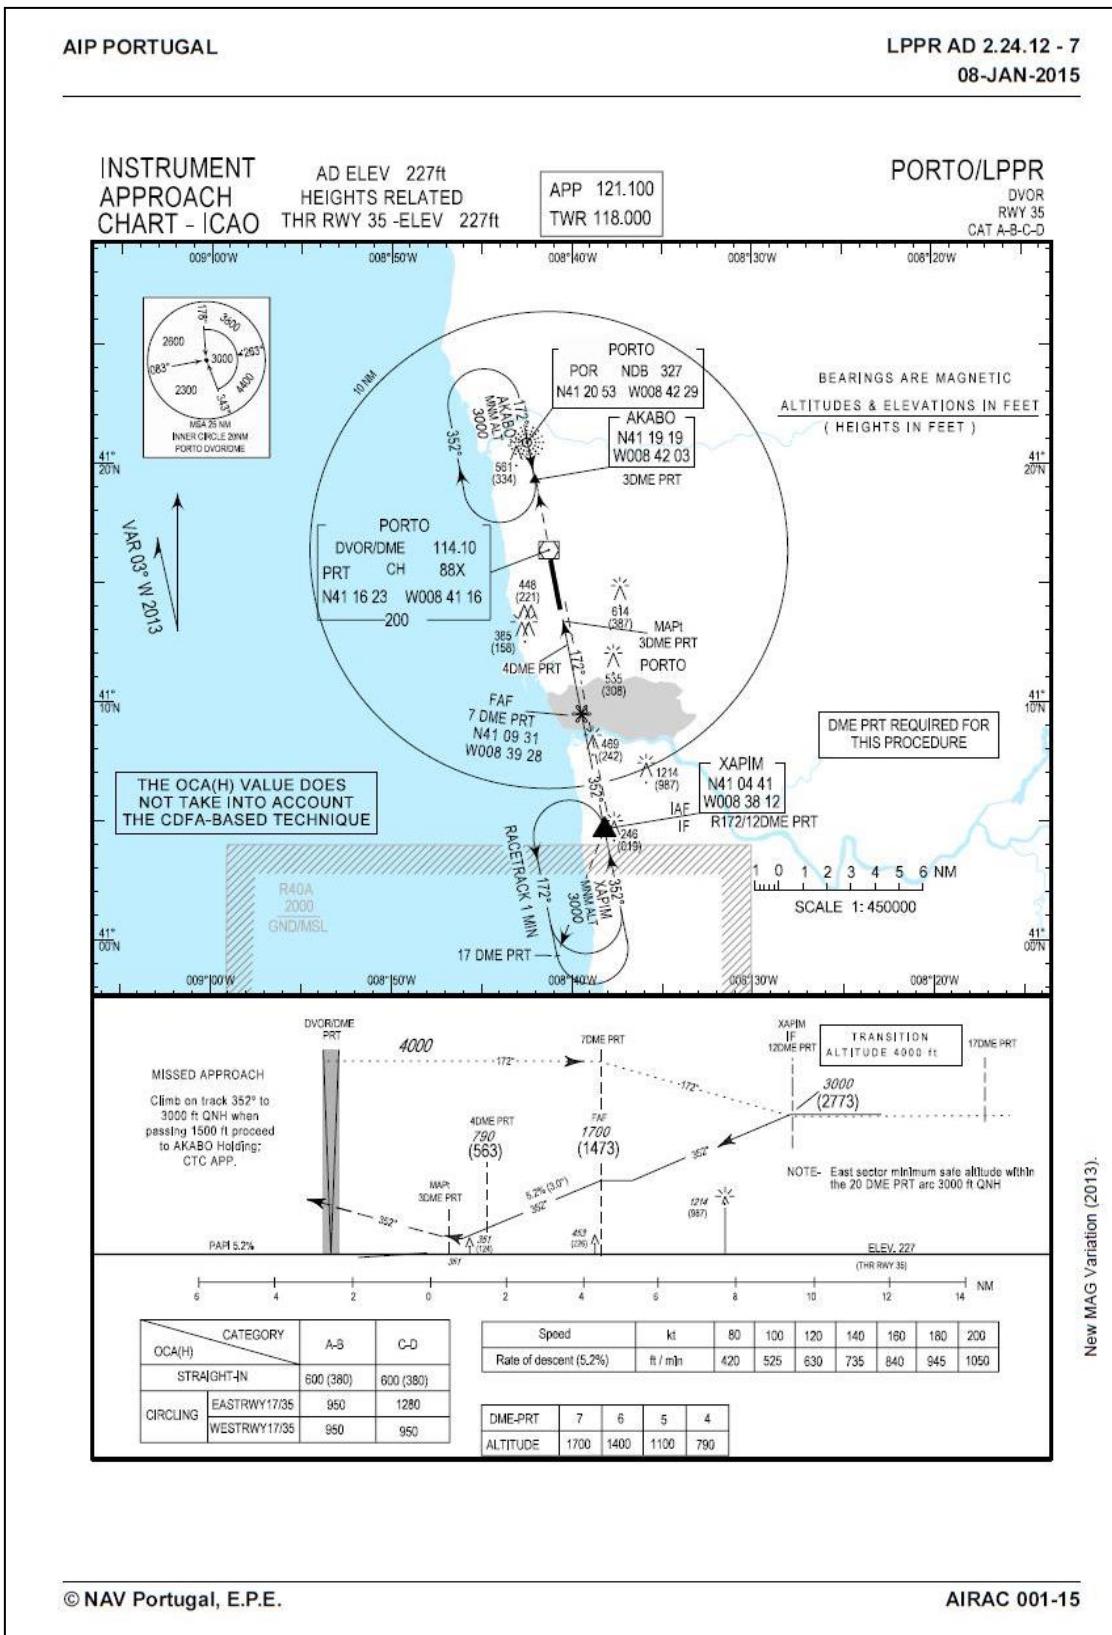
## Appendix A

<sup>7</sup> **XAPIM:** The initial approach fix reporting point on the approach to runway 35 at LPPR, see **Appendix A**.

LPPR is served by a number of Navigation Aids which provide guidance for the Precision Approach and for the Non-Precision Approaches (NPAs) to the airport. There is a Precision Approach (ILS<sup>9</sup>) for RWY 17. However, there is no ILS approach to RWY 35 at LPPR. Two NPA procedures are available for RWY 35, a DVOR/DME<sup>10</sup> and a Localiser approach. At the time of the event the aircraft was using the DVOR/DME Approach to RWY 35. None of the Navigation Aids were reported as being unserviceable. The DVOR/DME Approach Chart for RWY 35 at LPPR as published in the Portuguese AIP<sup>11</sup> is reproduced in **Appendix A**.
