Air Accident Investigation Unit Ireland

SYNOPTIC REPORT

**Serious Incident
Airbus A320-214, EI-DVJ
Dublin, Ireland**

3 October 2015

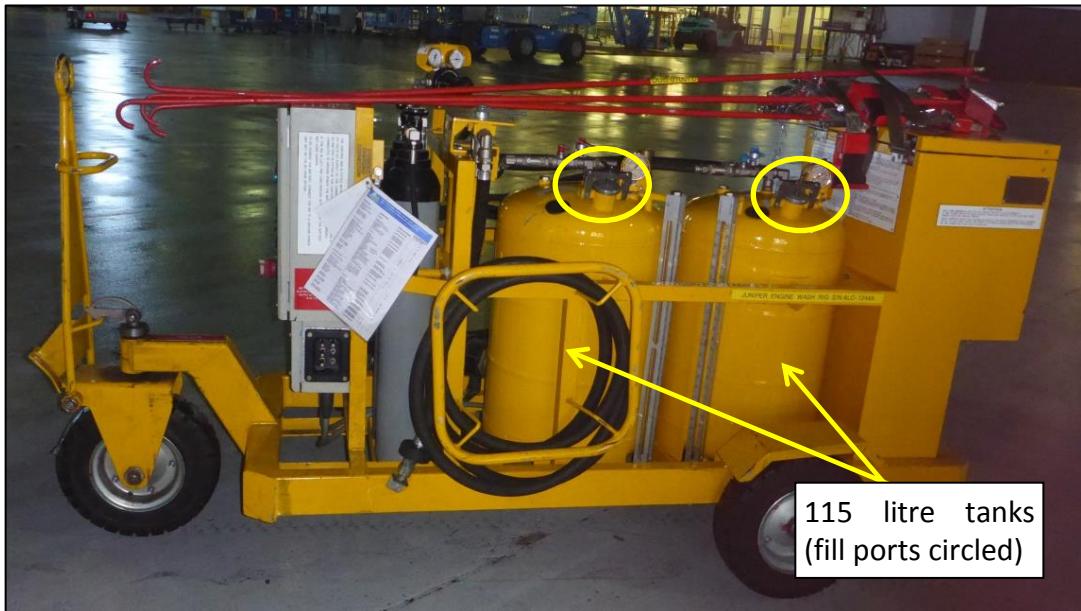
The engine wash rig used, which is fitted with two 115 litre (25 imperial gallons) stainless steel fluid tanks, is shown in **Photo No. 1**. During operation, the water/detergent added to the tanks is pressurised by two rechargeable on-board nitrogen cylinders. Once pressurised, the fluid can be directed through lances, which dispense water/detergent into the engine compressors. Operating instructions are included, in the form of placards affixed to the rig and an attached booklet.

Photo No. 1: Engine wash rig used before occurrence flight

4. In preparation for the wash procedure, one eight US fluid ounce (236.6 millilitres) can of corrosion inhibitor was erroneously added to each of two 115 litre water-filled engine wash rig tanks.
