# Air Accident Investigation Unit Ireland

**SYNOPTIC REPORT**

**ACCIDENT**  
**CFM Streak Shadow, G-BVTD**  
**Tory Island, Co. Donegal, Ireland**

**9 May 2016**

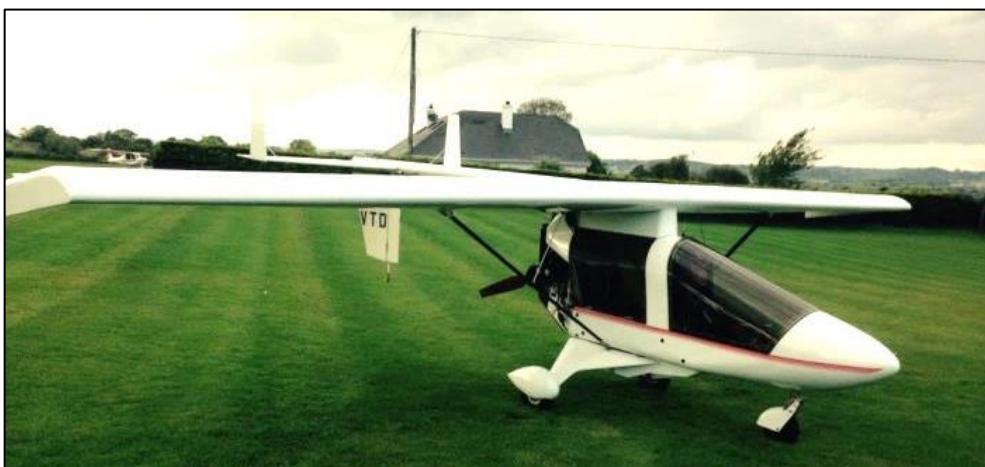
**Photo No. 1:** G-BVTD (Source: *Microlight Owner*)

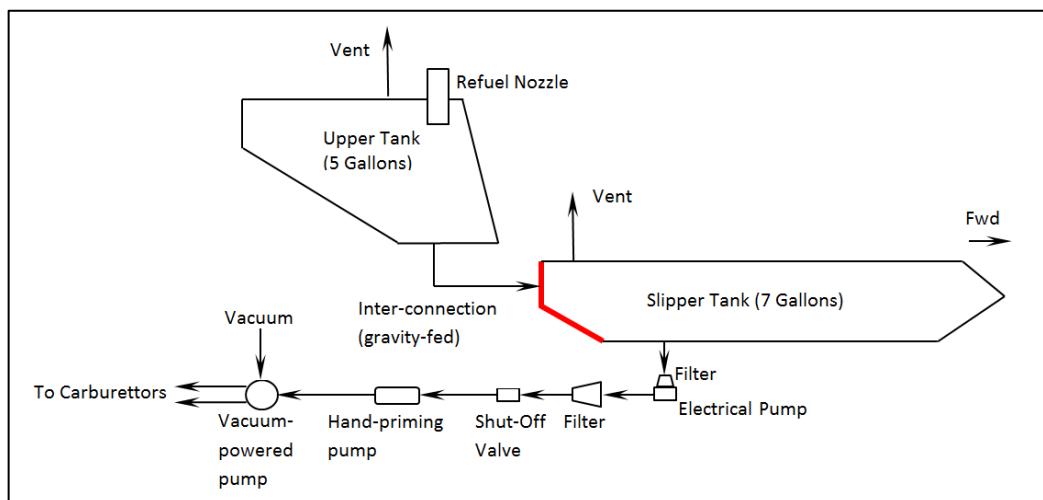
On the fuel system fitted to G-BVTD, fuel was gravity-fed from the upper fuel tank through an interconnecting hose to the slipper tank. It was supplied from the slipper tank through an electric fuel pump (the inlet adapter of which contained a filter), a plastic in-line fuel filter, a mechanical fuel shut-off valve, a hand-operated priming pump and a vacuum powered fuel pump, to twin carburettors fitted to the engine (**Figure No. 1**). Regarding the electric fuel pump, the Pilot informed the Investigation that he used this during take-offs, landings and when crossing water. He said that “*the pump was on when the engine stopped*”.

**Figure No. 1:** Fuel system schematic (area highlighted in red is discussed in **Section 1.8.1**)

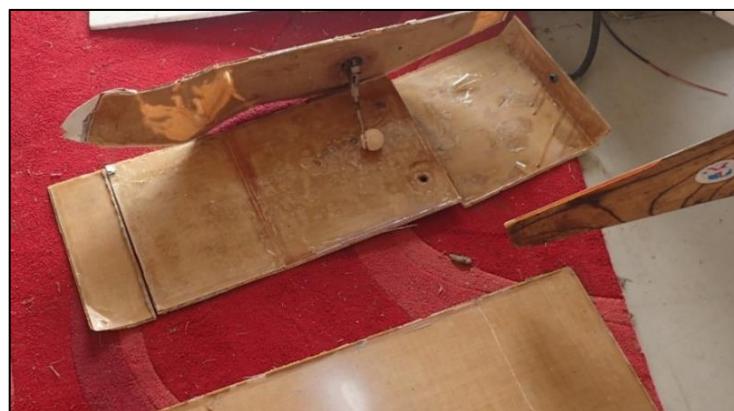
The microlight sustained substantial damage to its undercarriage, which separated from the fuselage, the underside of which was also damaged. The lower fuel tank (the 'slipper' tank) had split into its constituent flat panels. The right wingtip sustained impact damage. The left wing was damaged at the wing root.

The slipper tank, as inspected by the Investigation, had been largely separated into its constituent flat panels (**Photo No. 2**).

**Photo No. 2:** Slipper tank separated into its constituent flat panels

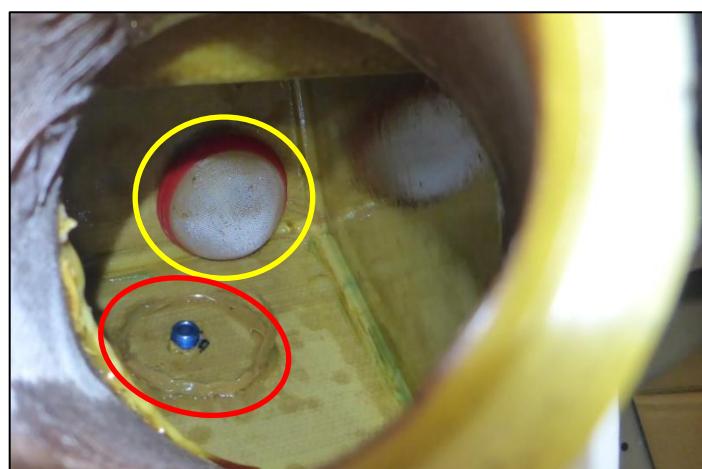
The upper fuel tank was undamaged in the accident. A visual inspection performed through the fuel filler neck of this fuel tank indicated that there was no deterioration of the coating on the inside of the tank. However, a hemispherical plastic gauze strainer was found to be loose inside the fuel tank (**Photo No. 3**). A circular marking of similar diameter to the strainer and concentric with the fuel outlet was also visible. The Pilot told the Investigation that the strainer was in place when he refuelled the microlight prior to the accident flight.

**Photo No. 3:** Gauze strainer loose inside the five gallon tank (circled in yellow) and circular marking surrounding the outlet (circled in red), as seen through the fuel filler neck

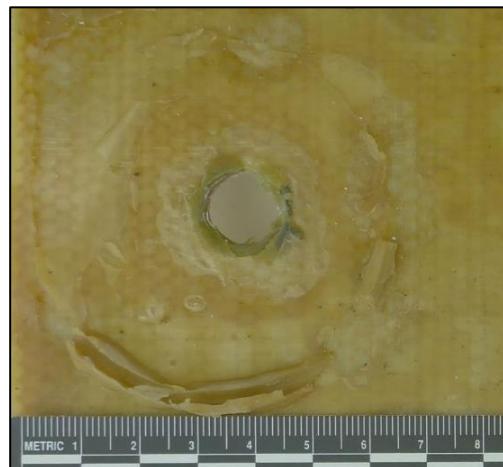
As stated earlier, a “filter” with the same part number as the upper tank strainer (F204) is included in the parts list in the Manufacturer’s assembly instructions for the slipper tank. The assembly instructions describe how this should be bonded in place. The Pilot, who recovered the wreckage before the AAIU was informed of the event, reported that a strainer was not found at the accident site. However, on inspection of the fuel tank panels, a circular marking of similar diameter to that observed in the upper tank was evident on the inside of the fuel tank, concentric with the fuel outlet (**Photo No. 4**).

**Photo No. 4:** Circular marking at slipper tank outlet

- The flaking of the coating on the inside of the slipper tank was extensive, yet the fuel supply hose from the slipper tank outlet was unobstructed.
- The inlet filter of the electrical pump was found to be debris-free, which is the first filter that the fuel passes through after it leaves the slipper tank, and due to the flaking of the tank coating would have contained at least some debris if the strainer was not present.
- The existence of a circular witness mark, on the inside to the slipper tank concentric with the tank outlet.

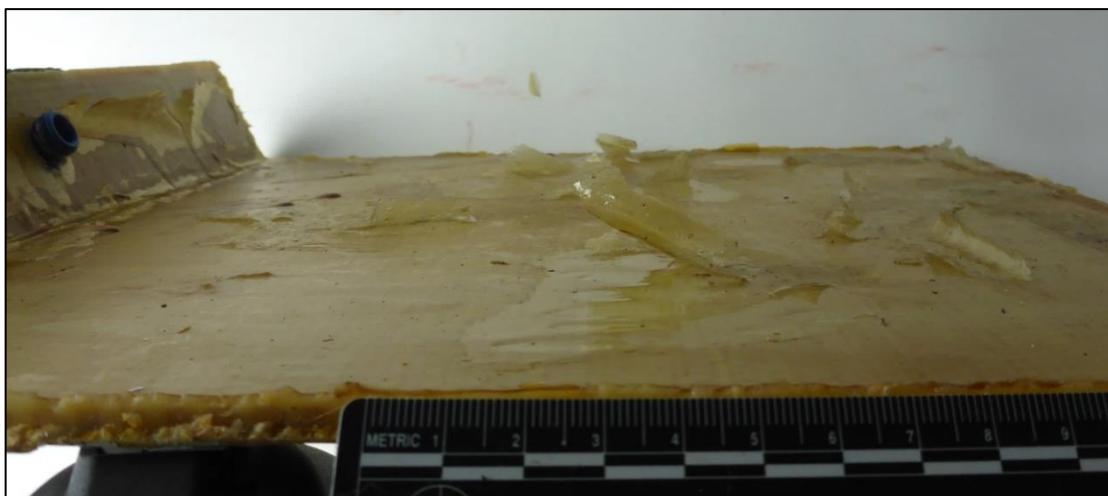
The coating on the interior of the slipper tank was found to be flaking and separating from the panels of the tank, with significant deterioration of the coating on the rear panels (**Photo No. 5**). These are coloured red in **Figure No. 1** in **Section 1.6.3**. The Pilot, who was present when the Investigation examined the aircraft, observed the condition of the slipper tank and commented that he considered that fuel starvation due to a blockage caused by the flaking coating was the likely cause of the engine shutting down in flight.

**Photo No 5:** Coating separating from interior of rear panel of slipper tank

The results of the laboratory analysis indicate that the flaking observed in the slipper fuel tank was likely as a result sub-optimal adhesion between the epoxy and phenoxy material, combined with deterioration caused by the presence of ethanol in the fuel.

It is Recommended that:	Recommendation Ref.
1. The UK Light Aircraft Association (LAA) should consider developing fuel tank inspection instructions for Streak Shadow/Shadow variants for which it has oversight for action by its members and verify compliance with the instructions during the Permit to Fly validity certificate renewal process.	<a href="#"><u>IRLD2017007</u></a>

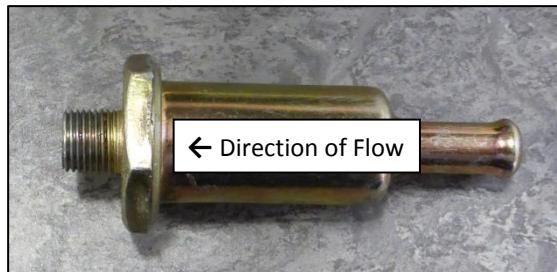
An information decal affixed to the microlight's 12V Fuel Pump stated that the pump was compatible with "*blended alcohol and fuel additives*". The Investigation connected the fuel pump to a 12V battery and found the pump to be operational. The inlet side of the electrical fuel pump was fitted with a screw-in fuel filter which had a metal housing. The pump filter had been connected to the flexible hose that was coming directly from the outlet of the slipper tank (see **Figure No. 1**). The Investigation unscrewed the filter from the fuel pump and cut the filter housing open to facilitate a visual inspection. No debris was evident in the exposed filter or the housing (**Photo No. 6** and **Photo No. 7**).

**Photo No. 6:** Fuel filter as removed

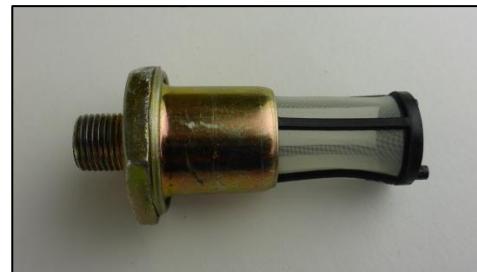
**Photo No. 7:** Fuel filter exposed and found to be free from debris
