Air Accident Investigation Unit Ireland

SYNOPTIC REPORT

ACCIDENT
Cessna FA152, EI-EDC
Adamstown Airfield, Co. Meath

31 March 2017

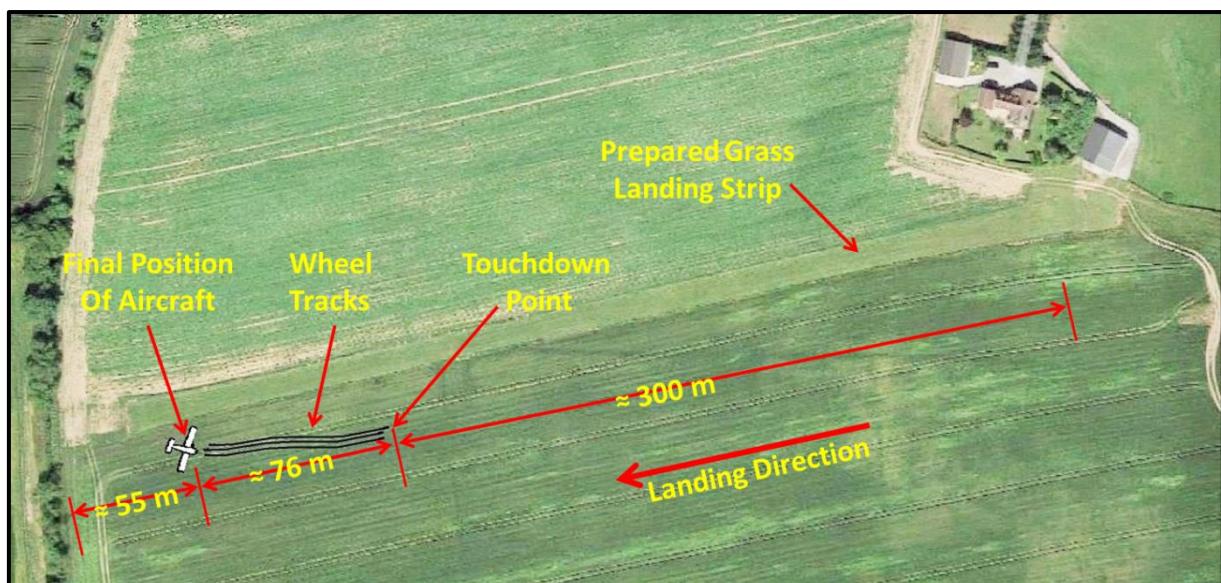
However, the aircraft did not touch down until approximately three quarters of the way into the field, see **Figure No. 1**. The Pilot told the Investigation that although the touchdown was deep into the field, she felt that a further go-round and circuit was not an option as the rain shower was now virtually overhead the field.

Figure No. 1: Location of aircraft and touchdown witness marks.

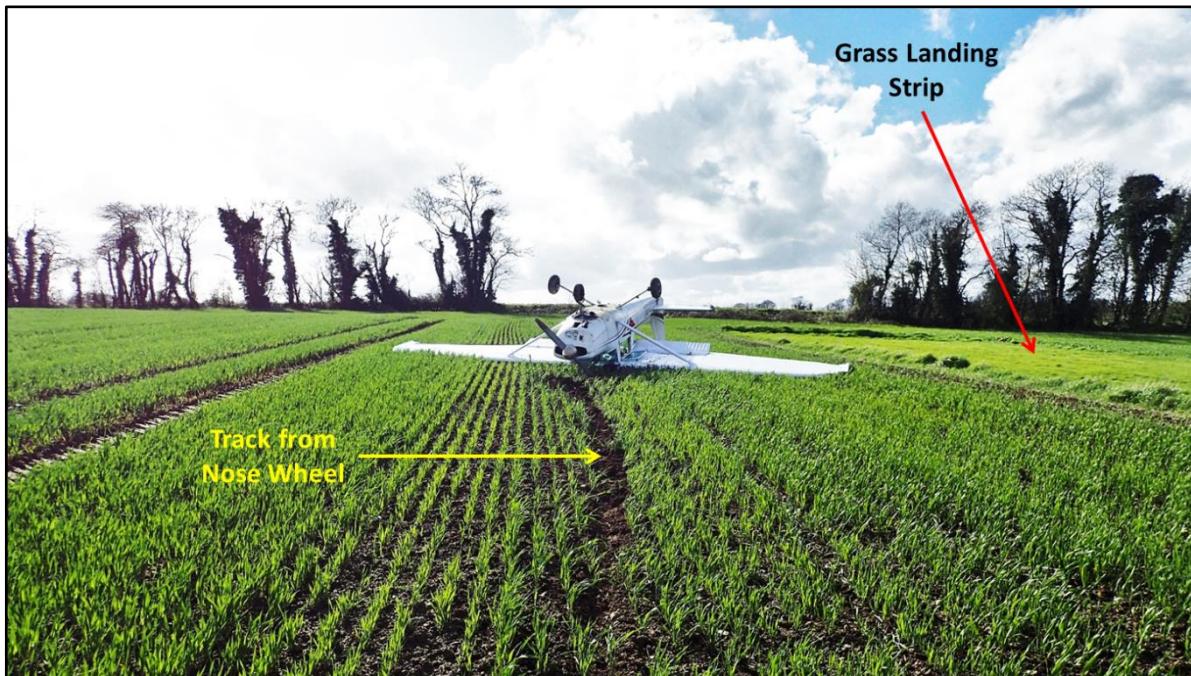
Upon touchdown, the Pilot became concerned that the aircraft would impact with the hedge and raised bank at the end of the field, and applied brakes. This resulted in the aircraft nose wheel digging into the soft tilled soil, which contained a recently sown cereal crop. The soil was broken, loose and damp, and the aircraft overturned nose first and came to rest inverted, on a magnetic heading of approximately 120° (**Photo No. 1**).

Photo No. 1: Final resting position of EI-EDC, south of RWY 26

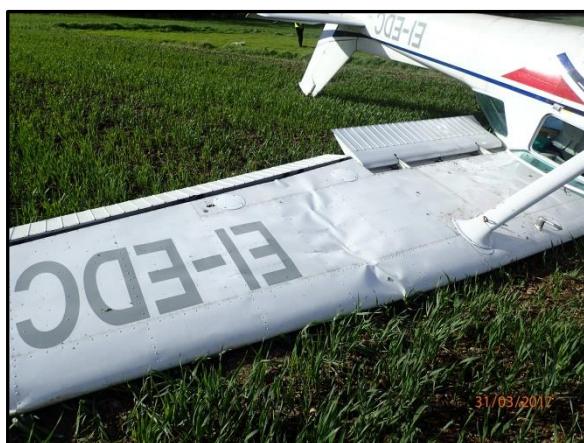
Initial inspection of the aircraft at the scene showed that the propeller had contacted the ground whilst under low power, resulting in damage to the propeller and therefore possible shock-load damage to the engine. There was substantial damage to both wings and the main spar. The rudder and tail fin along with the upper fuselage skin were also damaged; see **Photo Nos. 2 and 3.**

Photo No. 2: Port wing

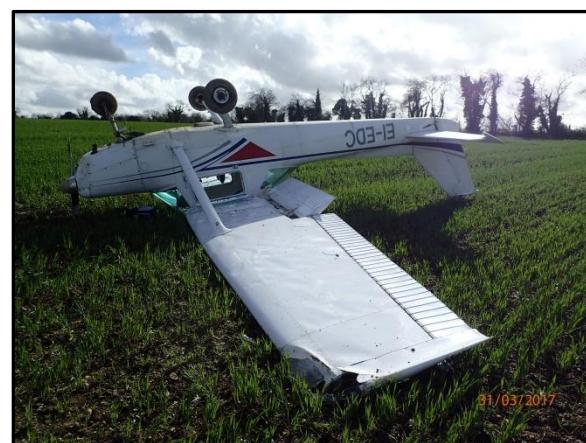
Photo No. 3: Starboard wing
