Air Accident Investigation Unit Ireland

FACTUAL REPORT

Coopavia, PIEL CP301A, G-ASLX Mullinahone Airfield, Co. Tipperary

5 July 2017

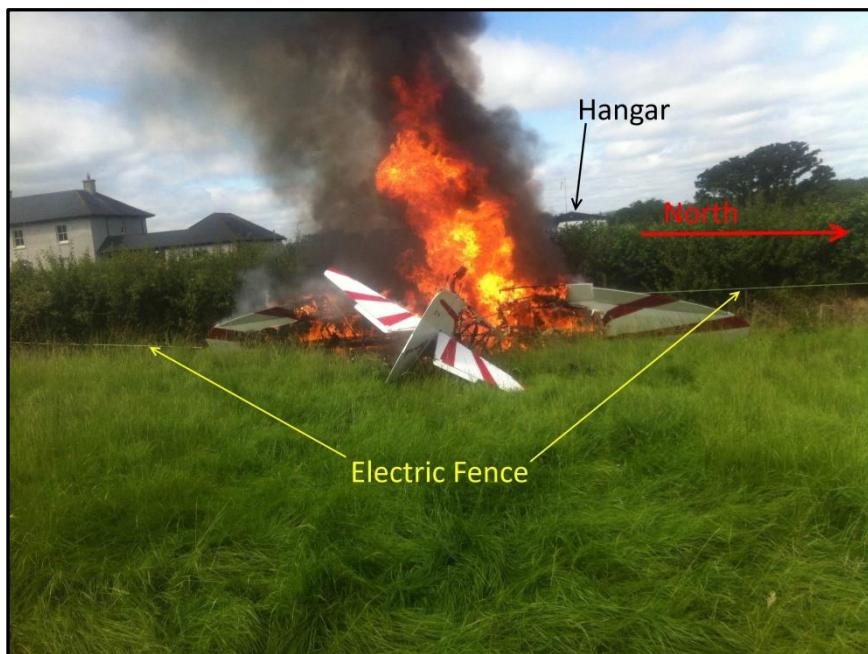
The Pilot had intended flying the aircraft from his private airfield at Mullinahone, Co. Tipperary, to Sligo airport (EISG). At approximately 10.15 hrs the Pilot took the aircraft out of the hangar, set the ignition switch to the '*ON*' position, advanced the throttle, and commenced an engine start by hand-swinging the propeller. There was no one aboard the aircraft and the brakes were not set. The main wheels were not chocked. When the engine started the aircraft began to move forward. The aircraft travelled approximately 70 metres east across the airfield and impacted a ditch and hedge. On impact with the ditch, the aircraft overturned and came to rest inverted on an electric fence on the other side of the hedge. The propeller impacted the ground and the engine stopped. The Pilot stated that fuel began leaking from the aircraft, and that the electric fence may have acted as a source of ignition for the fuel spillage. The fuel ignited and the aircraft was destroyed, see **Photo No. 1**. The Pilot, who had pursued the aircraft on foot, remained at a safe distance, and was not injured.

Photo No. 1: G-ASLX in its final resting position (Courtesy of Pilot/Owner)

The Pilot submitted a detailed description of the event, including a photographic survey of the site. He also provided his assessment of the cause of the accident. He stated that on the day of the accident he was in somewhat of a hurry to get airborne; he had not chocked the aircraft and set the throttle '*a little too high*', all of which he stated, contributed to the accident.
