Air Accident Investigation Unit Ireland

FACTUAL REPORT

ACCIDENT
Robin R1180TD, EI-ROB
Kerry Airport, Co. Kerry

5 November 2016

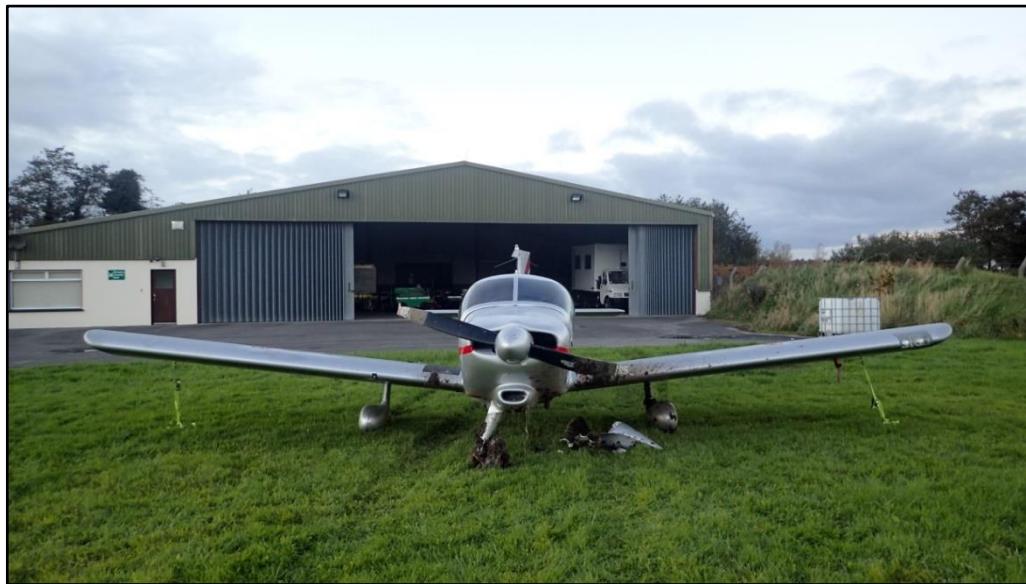
Photo No. 1 shows EI-ROB after it had been recovered from the airfield. **Photo No. 2** shows the damage suffered by the propeller during the runway excursion.

Photo No. 1: Aircraft following recovery from the airfield

The aircraft suffered substantial damage in the accident; the nose-wheel strut was bent backwards (but remained attached); the bottom cowling was damaged; both propeller blades were damaged and bent; the front wheel spat was damaged and the left hand exhaust assembly was damaged. As a result of the propeller blade impacts, the engine suffered shock loading.

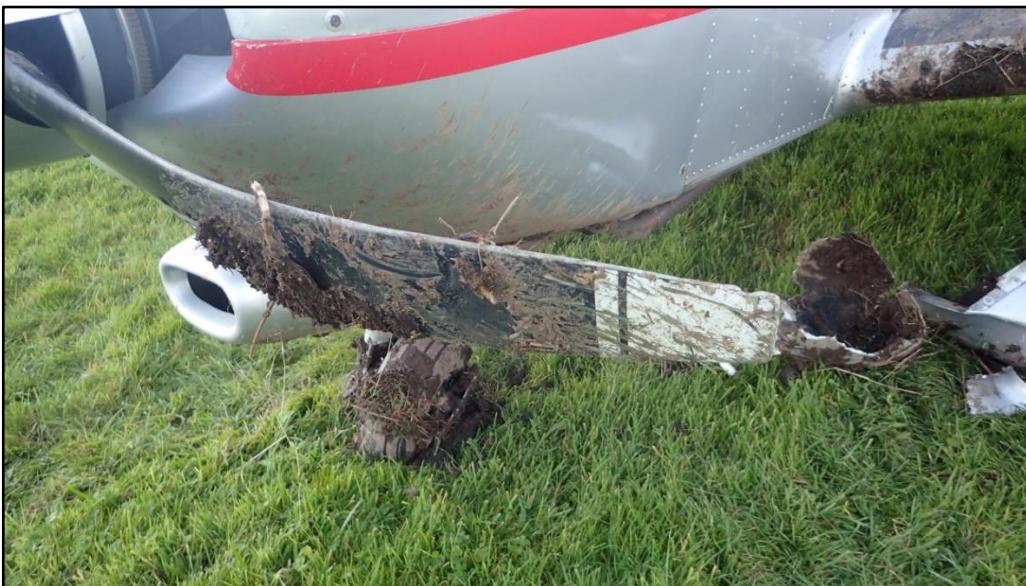
Photo No. 2: Propeller damage suffered during the runway excursion
